RedZone
ROBOTICS

Total Length Surveyed (ft): **306.5**

M-604-006

M-604-004

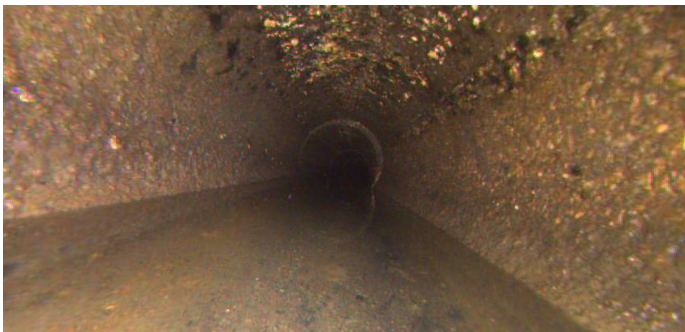
Code: **AMH**
Description: **Manhole**

Distance (ft): **.0**
Structural Grade: **0**
O&M Grade: **0**
Clock Start/From:
Clock To:
1st Value:
2nd Value:
Value Percent:
Continuous Index:
Within 8" of Joint: **NO**
Remarks: **M-604-006**

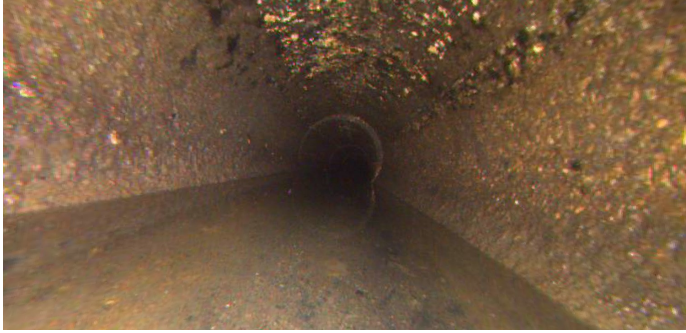
Code: **MWL**
Description: **Water Level**

Distance (ft): **.0**
Structural Grade: **0**
O&M Grade: **0**
Clock Start/From:
Clock To:
1st Value:
2nd Value:
Value Percent: **30.000**
Continuous Index:
Within 8" of Joint: **NO**
Remarks:

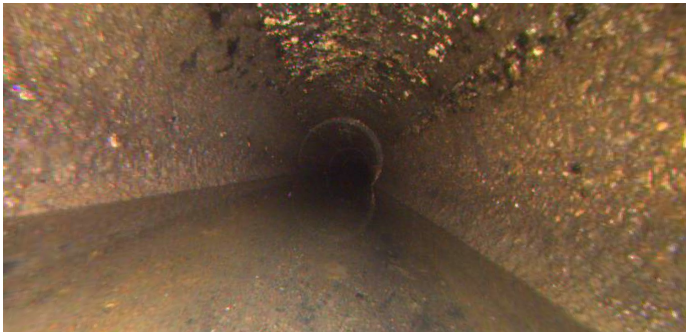
Code: **SAP**
Description: **Surface Aggregate Projecting**

Distance (ft): **.0**
Structural Grade: **3**
O&M Grade: **0**
Clock Start/From: **8**
Clock To: **4**
1st Value:
2nd Value:
Value Percent:
Continuous Index: **S01**
Within 8" of Joint:
Remarks:

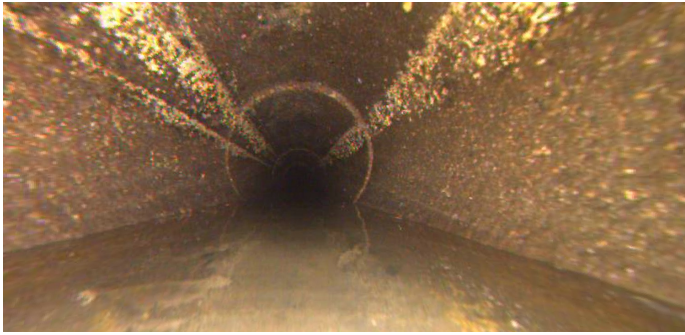
Code: **DAGS**
Description: **Deposits Attached Grease**

Distance (ft): **14.1**
Structural Grade: **0**
O&M Grade: **2**
Clock Start/From: **8**
Clock To: **4**
1st Value:
2nd Value:
Value Percent: **5.000**
Continuous Index: **S02**
Within 8" of Joint: **NO**
Remarks:

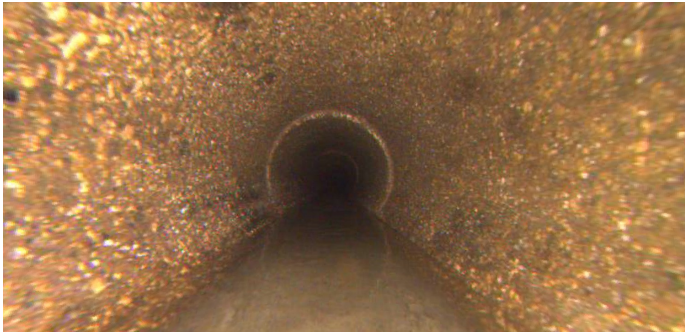
Code: **DAGS**
Description: **Deposits Attached Grease**

Distance (ft): **52.9**
Structural Grade: **0**
O&M Grade: **2**
Clock Start/From: **8**
Clock To: **4**
1st Value:
2nd Value:
Value Percent: **5.000**
Continuous Index: **F02**
Within 8" of Joint: **NO**
Remarks:

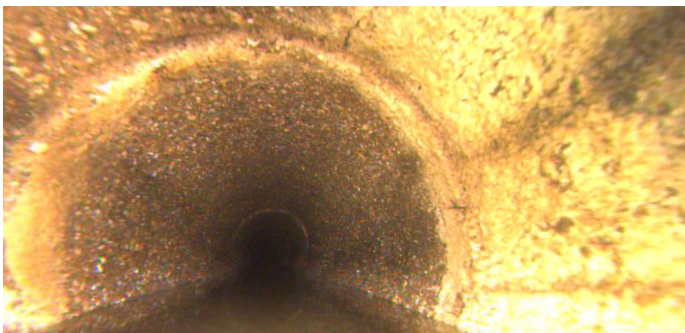
Code: **FM**
Description: **Fracture Multiple**

Distance (ft): **75.3**
Structural Grade: **4**
O&M Grade: **0**
Clock Start/From: **1**
Clock To: **4**
1st Value:
2nd Value:
Value Percent:
Continuous Index:
Within 8" of Joint: **YES**
Remarks:

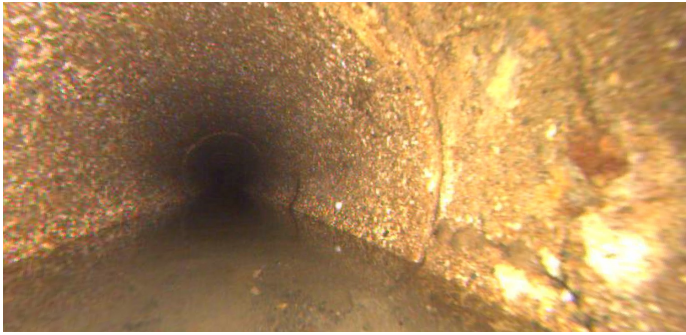
Code: **FM**
Description: **Fracture Multiple**

Distance (ft): **84.4**
Structural Grade: **4**
O&M Grade: **0**
Clock Start/From: **2**
Clock To: **4**
1st Value:
2nd Value:
Value Percent:
Continuous Index:
Within 8" of Joint: **YES**
Remarks:

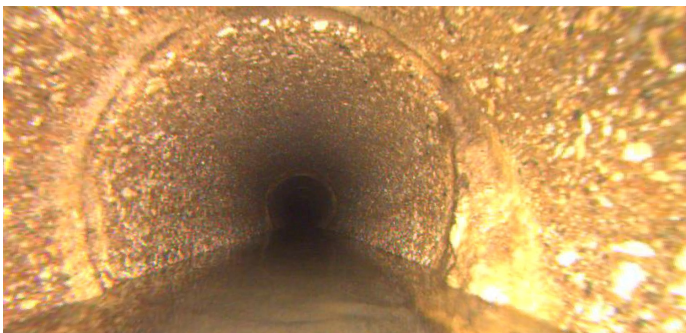
Code: **DAE**
Description: **Deposits Attached Encrustation**

Distance (ft): **99.3**
Structural Grade: **0**
O&M Grade: **2**
Clock Start/From: **8**
Clock To: **4**
1st Value:
2nd Value:
Value Percent: **5.000**
Continuous Index:
Within 8" of Joint: **YES**
Remarks:

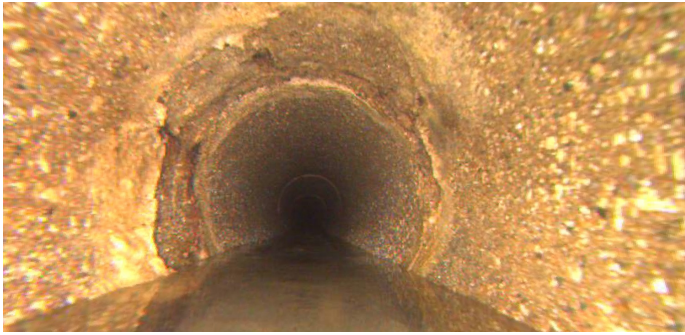
Code: **DAE**
Description: **Deposits Attached Encrustation**

Distance (ft): **101.9**
Structural Grade: **0**
O&M Grade: **2**
Clock Start/From: **8**
Clock To: **4**
1st Value:
2nd Value:
Value Percent: **5.000**
Continuous Index:
Within 8" of Joint: **YES**
Remarks:

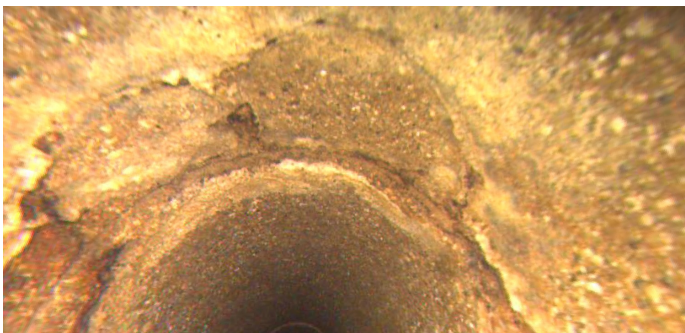
Code: **FM**
Description: **Fracture Multiple**

Distance (ft): **102.4**
Structural Grade: **4**
O&M Grade: **0**
Clock Start/From: **8**
Clock To: **4**
1st Value:
2nd Value:
Value Percent:
Continuous Index:
Within 8" of Joint: **YES**
Remarks:

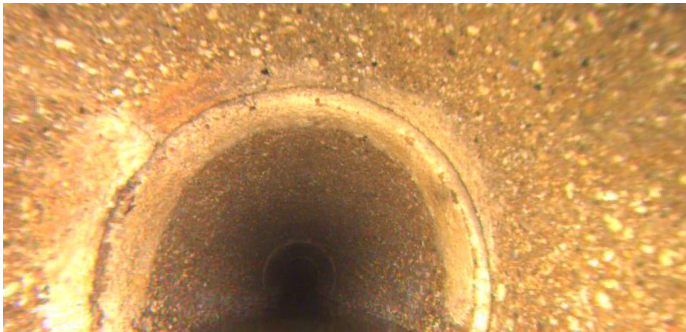
Code: **FL**
Description: **Fracture Longitudinal**

Distance (ft): **117.3**
Structural Grade: **3**
O&M Grade: **0**
Clock Start/From: **10**
Clock To:
1st Value:
2nd Value:
Value Percent:
Continuous Index:
Within 8" of Joint: **YES**
Remarks:

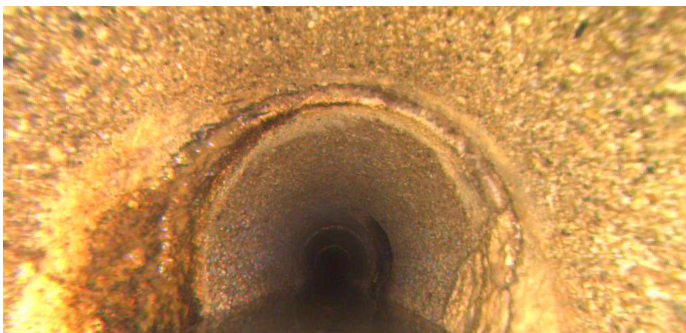
Code: **IW**
Description: **Infil Weeper**

Distance (ft): **126.5**
Structural Grade: **0**
O&M Grade: **2**
Clock Start/From: **8**
Clock To: **4**
1st Value:
2nd Value:
Value Percent:
Continuous Index:
Within 8" of Joint: **YES**
Remarks:

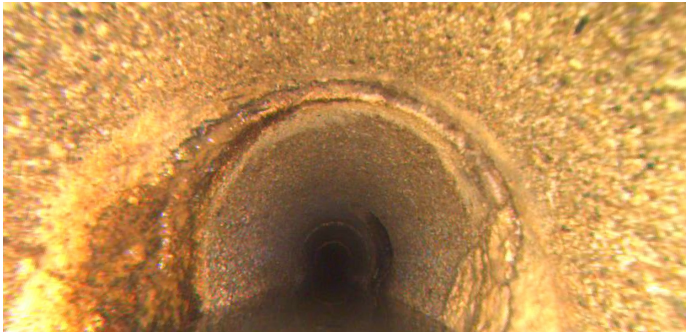
Code: **DAE**
Description: **Deposits Attached Encrustation**

Distance (ft): **126.5**
Structural Grade: **0**
O&M Grade: **2**
Clock Start/From: **8**
Clock To: **4**
1st Value:
2nd Value:
Value Percent: **5.000**
Continuous Index:
Within 8" of Joint: **YES**
Remarks:

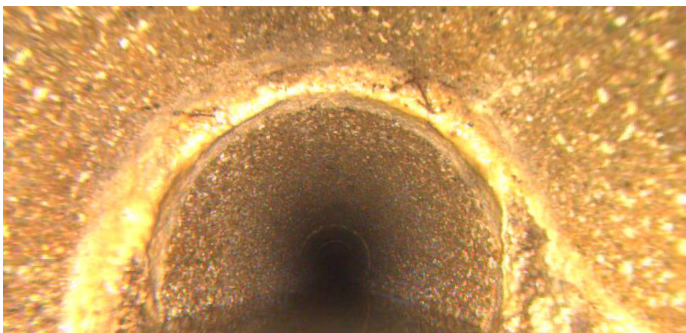
Code: **RFJ**
Description: **Roots Fine Joint**

Distance (ft): **132.5**
Structural Grade: **0**
O&M Grade: **1**
Clock Start/From: **11**
Clock To: **12**
1st Value:
2nd Value:
Value Percent:
Continuous Index:
Within 8" of Joint: **YES**
Remarks:

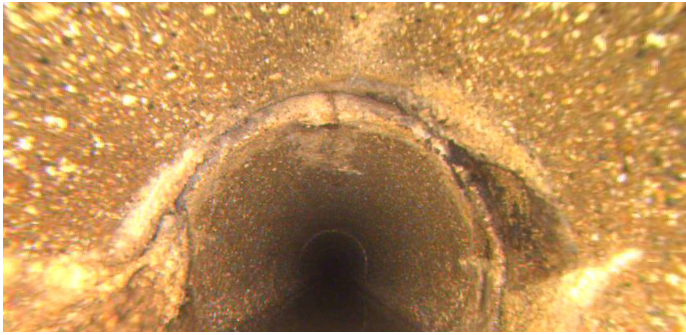
Code: **DAE**
Description: **Deposits Attached Encrustation**

Distance (ft): **156.4**
Structural Grade: **0**
O&M Grade: **2**
Clock Start/From: **8**
Clock To: **4**
1st Value:
2nd Value:
Value Percent: **5.000**
Continuous Index:
Within 8" of Joint: **YES**
Remarks:

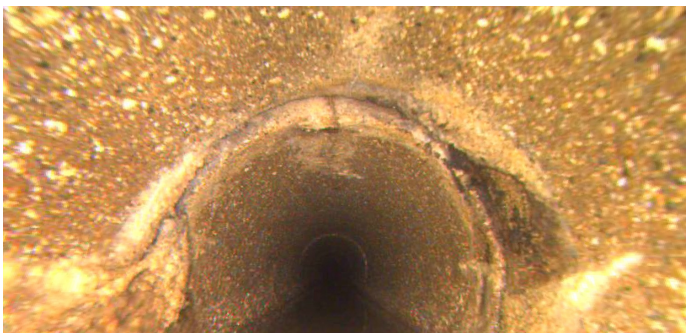
Code: **FL**
Description: **Fracture Longitudinal**

Distance (ft): **156.4**
Structural Grade: **3**
O&M Grade: **0**
Clock Start/From: **12**
Clock To:
1st Value:
2nd Value:
Value Percent:
Continuous Index:
Within 8" of Joint: **YES**
Remarks:

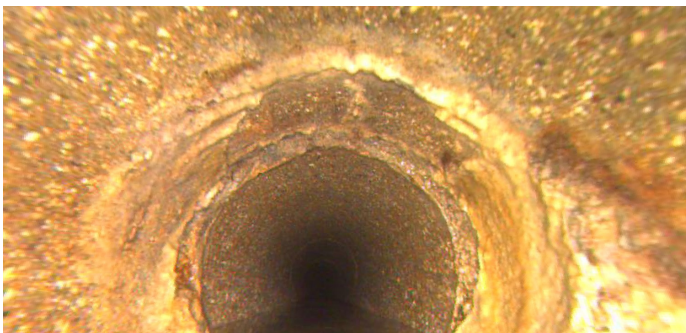
Code: **DAE**
Description: **Deposits Attached Encrustation**

Distance (ft): **177.5**
Structural Grade: **0**
O&M Grade: **2**
Clock Start/From: **8**
Clock To: **4**
1st Value:
2nd Value:
Value Percent: **5.000**
Continuous Index:
Within 8" of Joint: **YES**
Remarks:

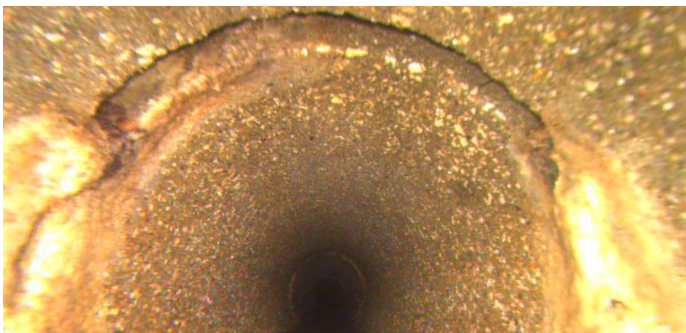
Code: **DAE**
Description: **Deposits Attached Encrustation**

Distance (ft): **187.0**
Structural Grade: **0**
O&M Grade: **2**
Clock Start/From: **8**
Clock To: **4**
1st Value:
2nd Value:
Value Percent: **5.000**
Continuous Index: **S03**
Within 8" of Joint: **YES**
Remarks:

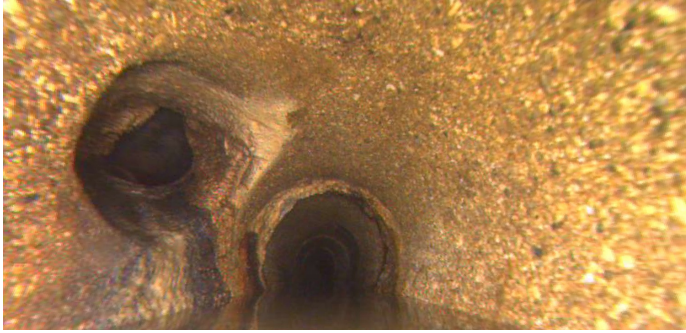
Code: **TF**
Description: **Tap Factory**

Distance (ft): **200.6**
Structural Grade: **0**
O&M Grade: **0**
Clock Start/From: **10**
Clock To:
1st Value: **4.000**
2nd Value:
Value Percent:
Continuous Index:
Within 8" of Joint:
Remarks:

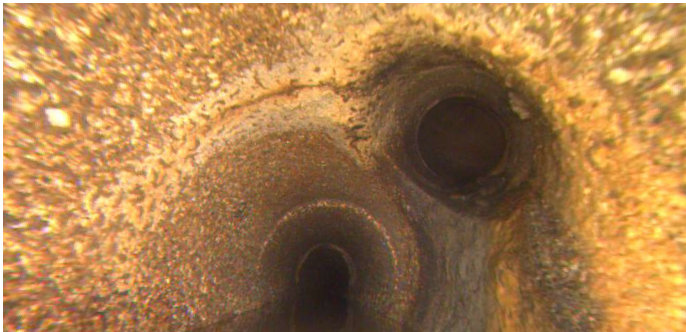
Code: **TF**
Description: **Tap Factory**

Distance (ft): **203.6**
Structural Grade: **0**
O&M Grade: **0**
Clock Start/From: **2**
Clock To:
1st Value: **4.000**
2nd Value:
Value Percent:
Continuous Index:
Within 8" of Joint:
Remarks:

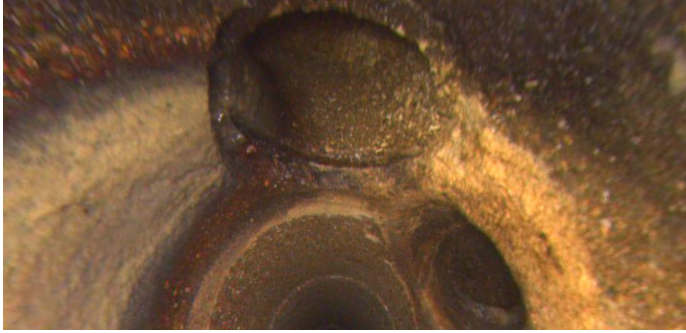
Code: **TB**
Description: **Tap Break-in**

Distance (ft): **266.4**
Structural Grade: **0**
O&M Grade: **0**
Clock Start/From: **12**
Clock To:
1st Value: **4.000**
2nd Value:
Value Percent:
Continuous Index:
Within 8" of Joint:
Remarks:

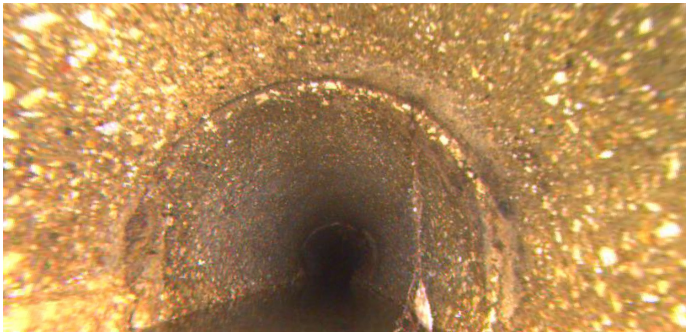
Code: **RFJ**
Description: **Roots Fine Joint**

Distance (ft): **280.0**
Structural Grade: **0**
O&M Grade: **1**
Clock Start/From: **8**
Clock To: **4**
1st Value:
2nd Value:
Value Percent:
Continuous Index:
Within 8" of Joint: **YES**
Remarks:

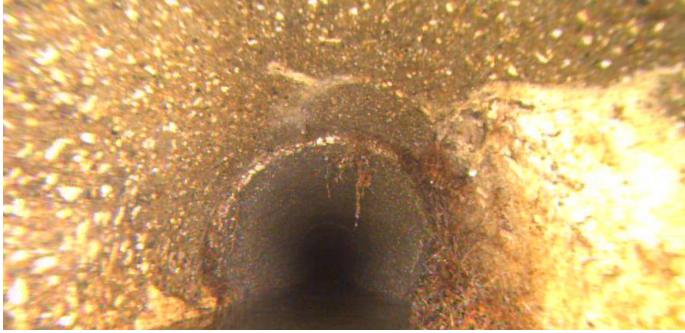
Code: **FM**
Description: **Fracture Multiple**

Distance (ft): **282.6**
Structural Grade: **4**
O&M Grade: **0**
Clock Start/From: **8**
Clock To: **12**
1st Value:
2nd Value:
Value Percent:
Continuous Index:
Within 8" of Joint: **YES**
Remarks:

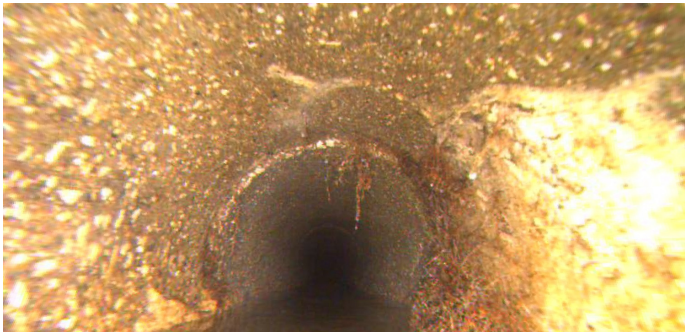
Code: **RMJ**
Description: **Roots Medium Joint**

Distance (ft): **282.6**
Structural Grade: **0**
O&M Grade: **3**
Clock Start/From: **8**
Clock To: **4**
1st Value:
2nd Value:
Value Percent: **5.000**
Continuous Index:
Within 8" of Joint: **YES**
Remarks:

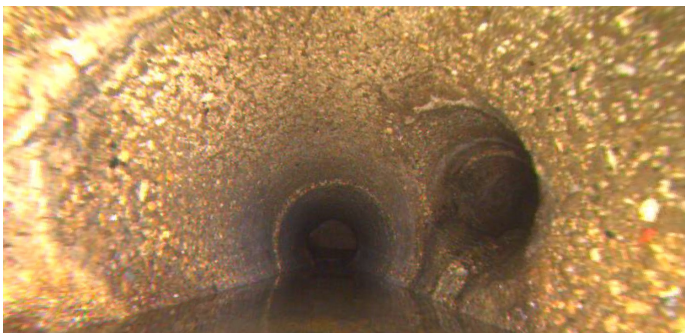
Code: **TF**
Description: **Tap Factory**

Distance (ft): **299.7**
Structural Grade: **0**
O&M Grade: **0**
Clock Start/From: **3**
Clock To:
1st Value: **4.000**
2nd Value:
Value Percent:
Continuous Index:
Within 8" of Joint:
Remarks:

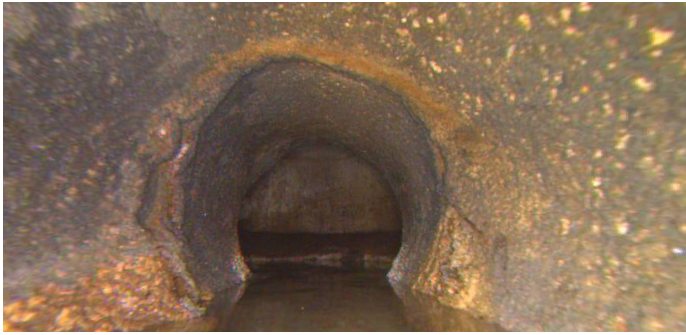
Code: **FC**
Description: **Fracture Circumferential**

Distance (ft): **303.1**
Structural Grade: **2**
O&M Grade: **0**
Clock Start/From: **8**
Clock To: **4**
1st Value:
2nd Value:
Value Percent:
Continuous Index:
Within 8" of Joint:
Remarks:

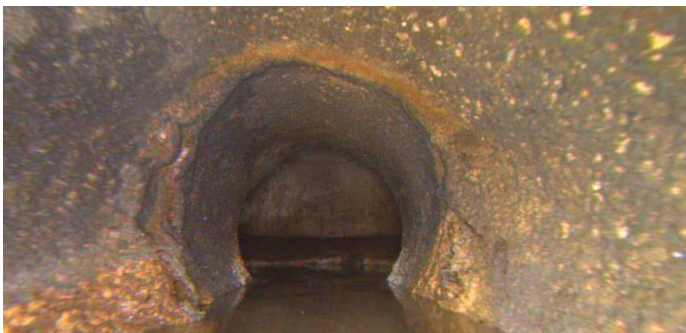
Code: **DAE**
Description: **Deposits Attached Encrustation**

Distance (ft): **303.1**
Structural Grade: **0**
O&M Grade: **2**
Clock Start/From: **8**
Clock To: **4**
1st Value:
2nd Value:
Value Percent: **5.000**
Continuous Index: **F03**
Within 8" of Joint: **YES**
Remarks:

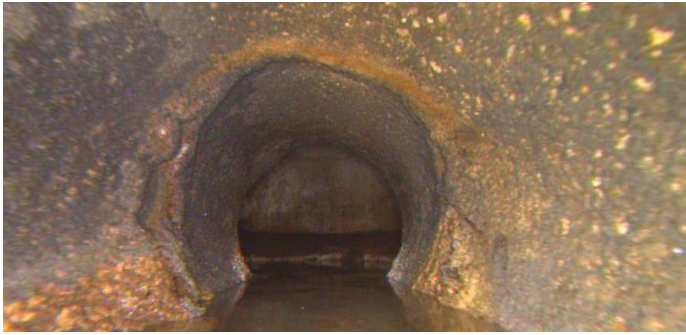
Code: **SAP**
Description: **Surface Aggregate Projecting**

Distance (ft): **303.1**
Structural Grade: **3**
O&M Grade: **0**
Clock Start/From: **8**
Clock To: **4**
1st Value:
2nd Value:
Value Percent:
Continuous Index: **F01**
Within 8" of Joint:
Remarks:

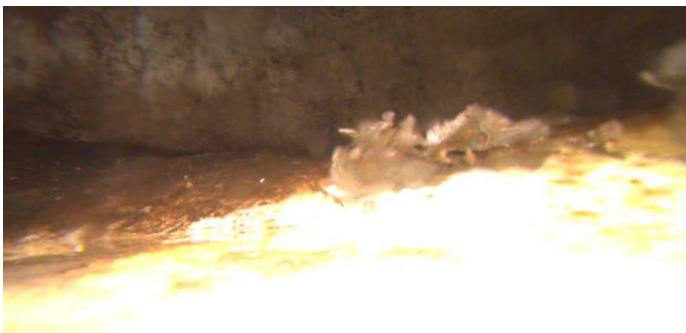
Code: **AMH**
Description: **Manhole**

Distance (ft): **306.5**
Structural Grade: **0**
O&M Grade: **0**
Clock Start/From:
Clock To:
1st Value:
2nd Value:
Value Percent:
Continuous Index:
Within 8" of Joint: **NO**
Remarks: **M-604-004**
