Profile/Photo Observation Report

Street:	W CLEVELAND AVE & BEVERLY BLVD	Flow Control:	Not Controlled
City:	Hobart, IN	Year Renewed:	
Location:	Other	Tape/Media #:	
Purpose:	Not Known	Dia/Height:	12"
Use:	Sanitary	Material:	CP
Drain Area:	NA	Lining:	
Category:	NA		
Comment:

Location Details:		Direction of Survey:	Upstream
US MH:	M-604-006	DS MH:	M-605-067
		Total Length Surveyed (ft):	11.2

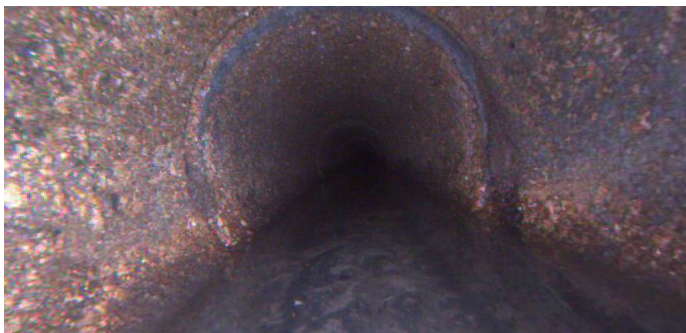
Code: **AMH**
Description: **Manhole**

Distance (ft): **.0**
Structural Grade: **0**
O&M Grade: **0**
Clock Start/From:
Clock To:
1st Value:
2nd Value:
Value Percent:
Continuous Index:
Within 8" of Joint: **NO**
Remarks: **M-605-067**

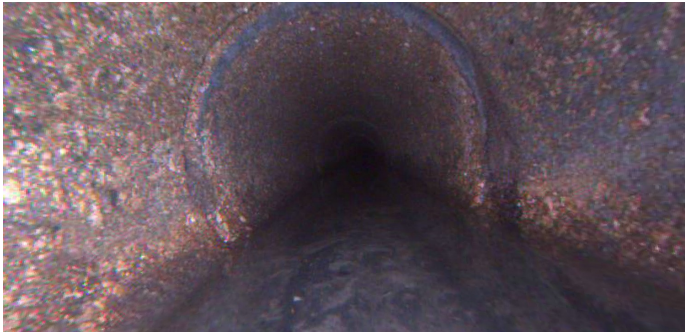
Code:	MWL
Description:	Water Level

Distance (ft):	.0
Structural Grade:	0
O&M Grade:	0
Clock Start/From:	
Clock To:	
1st Value:	
2nd Value:	
Value Percent:	10.000
Continuous Index:	
Within 8" of Joint:	NO
Remarks:

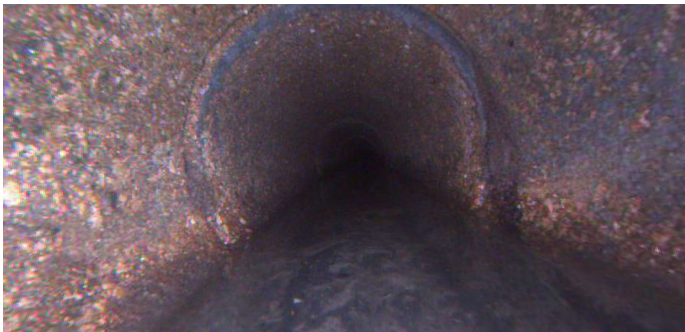
Code:	SAP
Description:	Surface Aggregate Projecting

Distance (ft):	.0
Structural Grade:	3
O&M Grade:	0
Clock Start/From:	8
Clock To:	4
1st Value:	
2nd Value:	
Value Percent:	
Continuous Index:	S01
Within 8" of Joint:	
Remarks:

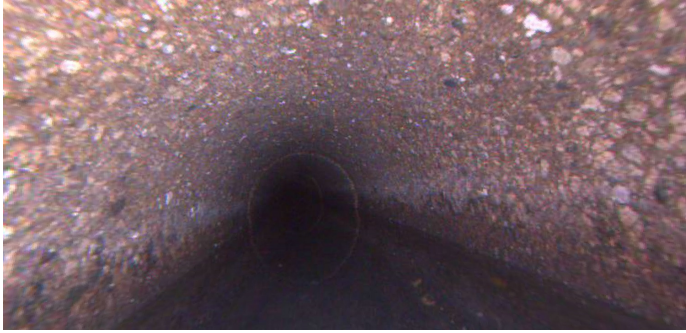
Code: **MSA**
Description: **Abandoned Survey**

Distance (ft): **11.2**
Structural Grade: **0**
O&M Grade: **0**
Clock Start/From:
Clock To:
1st Value:
2nd Value:
Value Percent:
Continuous Index:
Within 8" of Joint: **NO**
Remarks: **sap**

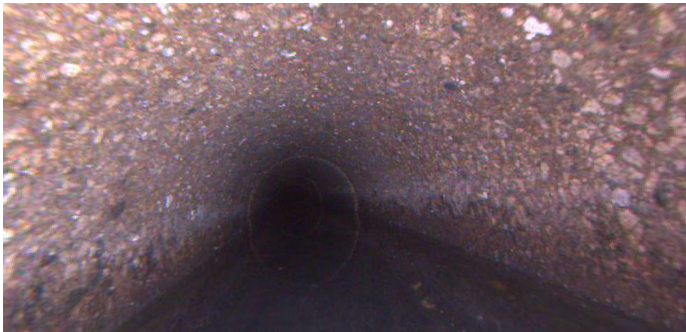
Code: **SAP**
Description: **Surface Aggregate Projecting**

Distance (ft): **11.2**
Structural Grade: **3**
O&M Grade: **0**
Clock Start/From: **8**
Clock To: **4**
1st Value:
2nd Value:
Value Percent:
Continuous Index: **F01**
Within 8" of Joint:
Remarks:
