Profile/Photo Observation Report

Date:	04/25/2018	Weather:		Coding:	PACP 6.0
Pipe Length (ft):	237.4	Owner:	NA	Pre Clean:	Not Known
P.O.#:		Surveyor:	Jen Costello	PSR:	P-604-006-067
Customer:		Clean Date:	01/01/1900	Shape:	C

Street:	Beverly Blvd.	Flow Control:	Not Controlled
City:	Hobart, IN	Year Renewed:	
Location:	Other	Tape/Media #:	
Purpose:	Not Known	Dia/Height:	12"
Use:	Sanitary	Material:	CP
Drain Area:	NA	Lining:	
Category:	NA		
Comment:

Location Details:		Direction of Survey:	Upstream
US MH:	M-604-006	DS MH:	M-605-067
		Total Length Surveyed (ft):	11.2

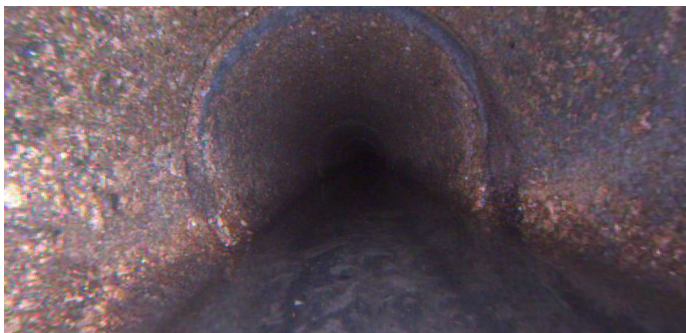
Code: **AMH**
Description: **Manhole**

Distance (ft): **.0**
Structural Grade: **0**
O&M Grade: **0**
Clock Start/From:
Clock To:
1st Value:
2nd Value:
Value Percent:
Continuous Index:
Within 8" of Joint: **NO**
Remarks: **M-605-067**

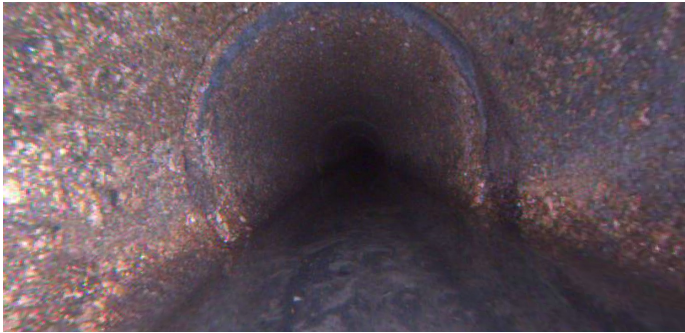
Code:	MWL
Description:	Water Level

Distance (ft):	.0
Structural Grade:	0
O&M Grade:	0
Clock Start/From:	
Clock To:	
1st Value:	
2nd Value:	
Value Percent:	10.000
Continuous Index:	
Within 8" of Joint:	NO
Remarks:

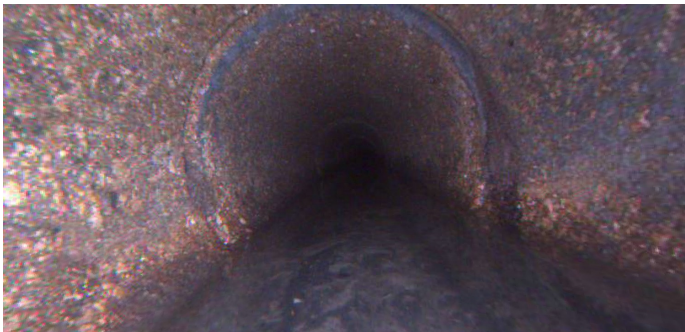
Code:	SAP
Description:	Surface Aggregate Projecting

Distance (ft):	.0
Structural Grade:	3
O&M Grade:	0
Clock Start/From:	8
Clock To:	4
1st Value:	
2nd Value:	
Value Percent:	
Continuous Index:	S01
Within 8" of Joint:	
Remarks:

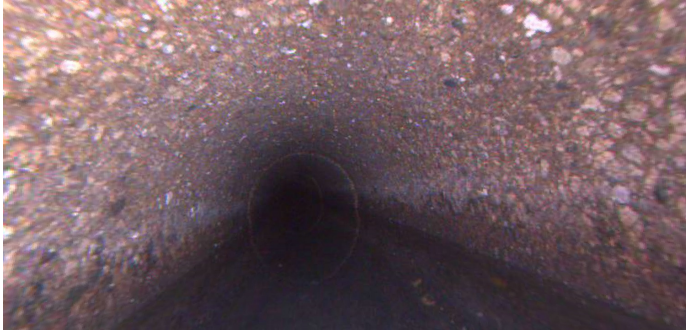
Code: **MSA**
Description: **Abandoned Survey**

Distance (ft): **11.2**
Structural Grade: **0**
O&M Grade: **0**
Clock Start/From:
Clock To:
1st Value:
2nd Value:
Value Percent:
Continuous Index:
Within 8" of Joint: **NO**
Remarks: **sap**

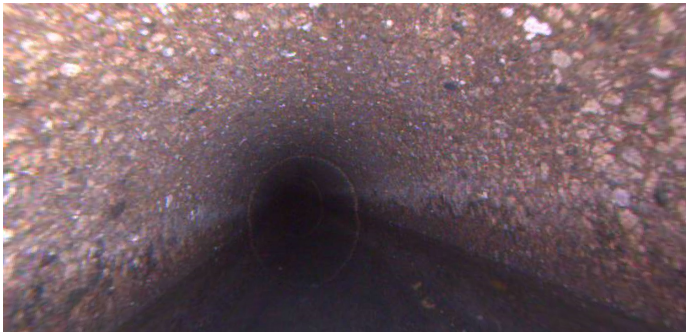
Code: **SAP**
Description: **Surface Aggregate Projecting**

Distance (ft): **11.2**
Structural Grade: **3**
O&M Grade: **0**
Clock Start/From: **8**
Clock To: **4**
1st Value:
2nd Value:
Value Percent:
Continuous Index: **F01**
Within 8" of Joint:
Remarks:
