## Profile/Photo Observation Report

Street:	<b>North Ash Street</b>	Flow Control:	<b>Not Controlled</b>
City:	<b>Hobart, IN</b>	Year Renewed:	
Location:	<b>Light Highway</b>	Tape/Media #:	<b>DEP244</b>
Purpose:	<b>Routine Assessment</b>	Dia/Height:	<b>15"</b>
Use:	<b>Sanitary</b>	Material:	<b>VCP</b>
Drain Area:		Lining:	
Category:	<b>NA</b>		
Comment:	<b>YES501824 Submittal 2</b>		
Location Details:		Direction of Survey:	<b>Downstream</b>
US MH:	<b>M-604-017</b>	DS MH:	<b>M-604-043</b>
		Total Length Surveyed (ft):	<b>109.9</b>

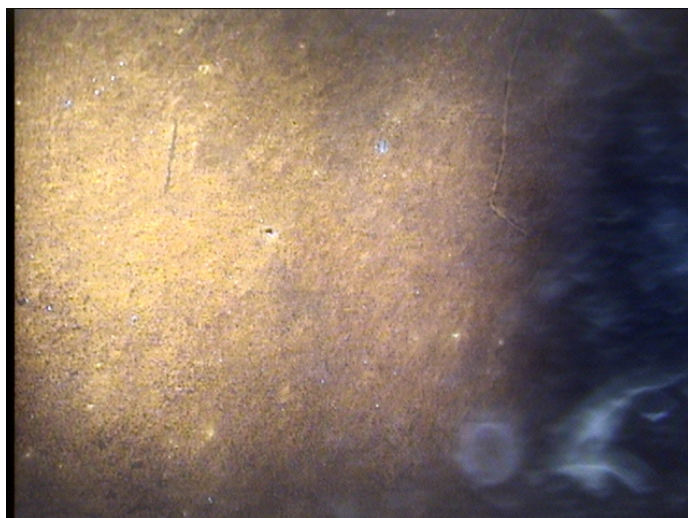
Code: **AMH**  
 Description: **Manhole**

Distance (ft): **.0**  
 Structural Grade: **0**  
 O&M Grade: **0**  
 Clock Start/From:  
 Clock To:  
 1st Value:  
 2nd Value:  
 Value Percent:  
 Continuous Index:  
 Within 8" of Joint: **NO**  
 Remarks: **M-604-017**

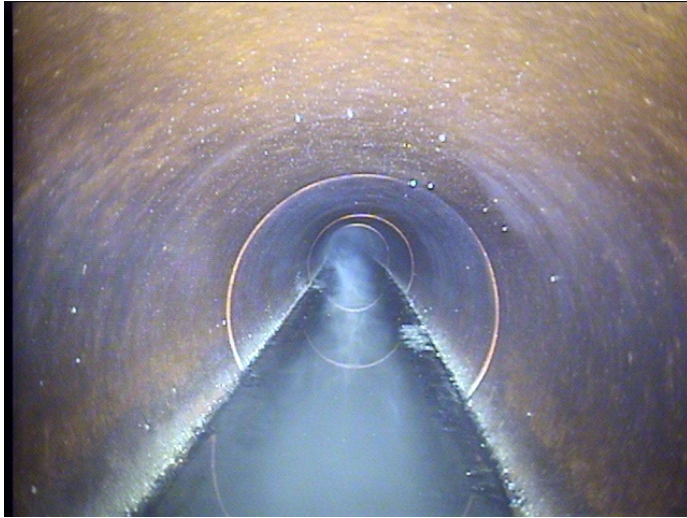
Code: **MWL**  
Description: **Water Level**

Distance (ft): **.0**  
Structural Grade: **0**  
O&M Grade: **0**  
Clock Start/From:  
Clock To:  
1st Value:  
2nd Value:  
Value Percent: **5.000**  
Continuous Index:  
Within 8" of Joint: **NO**  
Remarks:

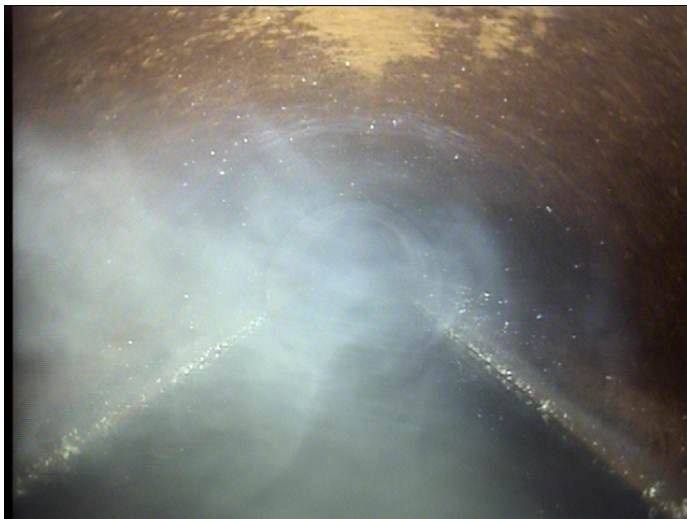
Code: **DSF**  
Description: **Deposits Settled Fine**

Distance (ft): **14.8**  
Structural Grade: **0**  
O&M Grade: **3**  
Clock Start/From: **4**  
Clock To: **8**  
1st Value:  
2nd Value:  
Value Percent: **20.000**  
Continuous Index: **S01**  
Within 8" of Joint: **NO**  
Remarks:

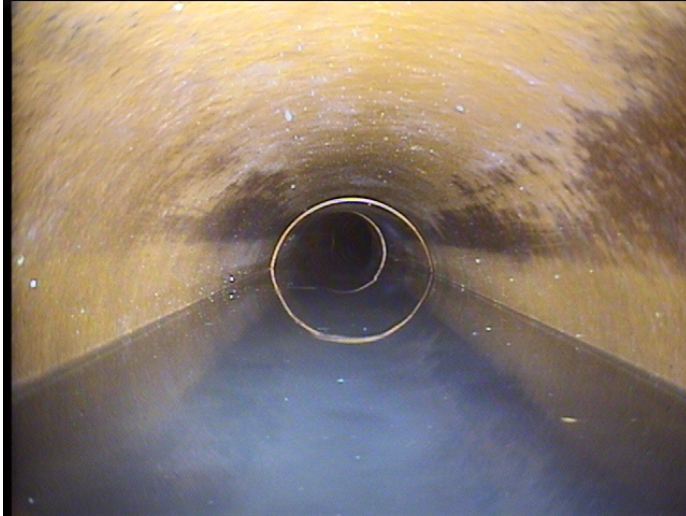
Code: **DSF**  
Description: **Deposits Settled Fine**

Distance (ft): **109.9**  
Structural Grade: **0**  
O&M Grade: **3**  
Clock Start/From: **4**  
Clock To: **8**  
1st Value:  
2nd Value:  
Value Percent: **20.000**  
Continuous Index: **F01**  
Within 8" of Joint: **NO**  
Remarks:

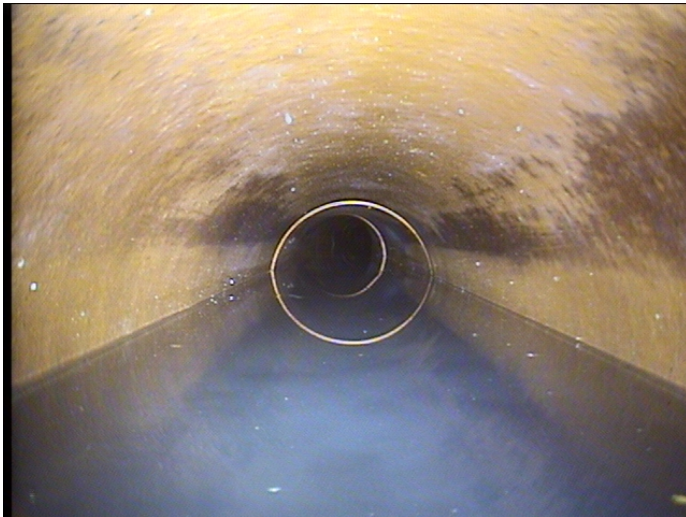
Code: **MSA**  
Description: **Abandoned Survey**

Distance (ft): **109.9**  
Structural Grade: **0**  
O&M Grade: **0**  
Clock Start/From:  
Clock To:  
1st Value:  
2nd Value:  
Value Percent:  
Continuous Index:  
Within 8" of Joint: **NO**  
Remarks: **Heavy sediment**
