Profile/Photo Observation Report

Date:	04/12/2018	Weather:		Coding:	PACP 6.0
Pipe Length (ft):		Owner:	City of Hobart	Pre Clean:	Not Known
P.O.#:	239	Surveyor:	B. Helbling	PSR:	P-604-043-017
Customer:	City of Hobart	Clean Date:		Shape:	C

Street:	North Ash Street	Flow Control:	Not Controlled
City:	Hobart, IN	Year Renewed:	
Location:	Light Highway	Tape/Media #:	DEP239
Purpose:	Routine Assessment	Dia/Height:	15"
Use:	Sanitary	Material:	VCP
Drain Area:		Lining:	
Category:	NA		
Comment:	YES501824 Submittal 2		
Location Details:		Direction of Survey:	Downstream
US MH:	M-604-017	DS MH:	M-604-043
		Total Length Surveyed (ft):	4.6

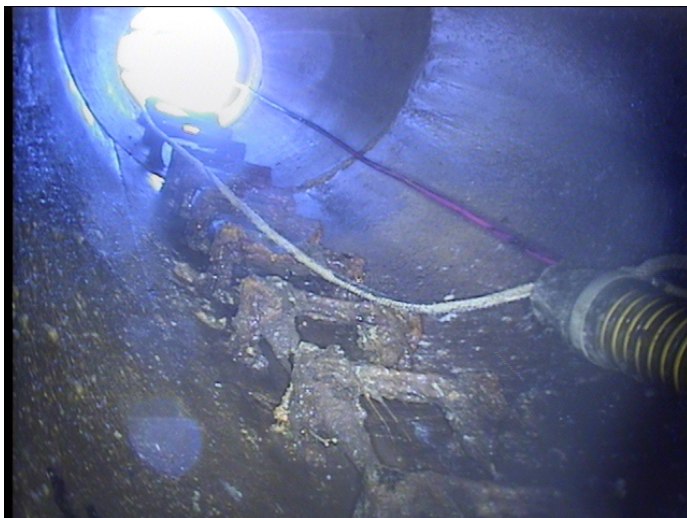
Code: **AMH**
 Description: **Manhole**

Distance (ft): **.0**
 Structural Grade: **0**
 O&M Grade: **0**
 Clock Start/From:
 Clock To:
 1st Value:
 2nd Value:
 Value Percent:
 Continuous Index:
 Within 8" of Joint: **NO**
 Remarks: **M-604-043**

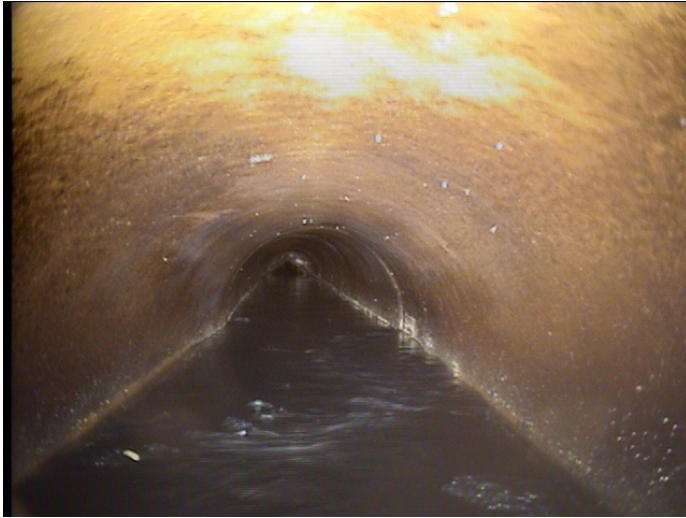
Code: **MWL**
Description: **Water Level**

Distance (ft): **.0**
Structural Grade: **0**
O&M Grade: **0**
Clock Start/From:
Clock To:
1st Value:
2nd Value:
Value Percent: **35.000**
Continuous Index:
Within 8" of Joint: **NO**
Remarks:

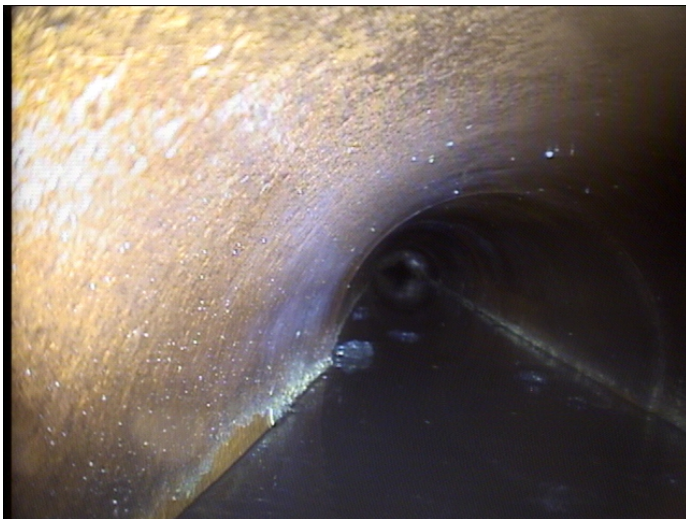
Code: **DSF**
Description: **Deposits Settled Fine**

Distance (ft): **3.0**
Structural Grade: **0**
O&M Grade: **4**
Clock Start/From: **4**
Clock To: **8**
1st Value:
2nd Value:
Value Percent: **30.000**
Continuous Index:
Within 8" of Joint: **NO**
Remarks:

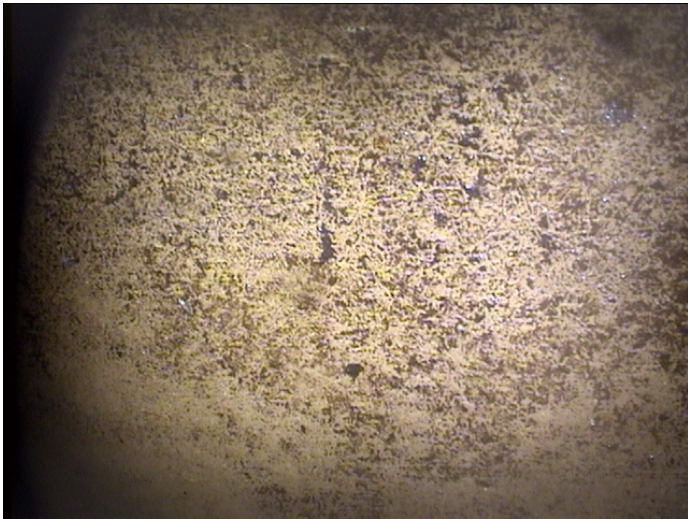
Code:	MSA
Description:	Abandoned Survey
Distance (ft):	3.6
Structural Grade:	0
O&M Grade:	0
Clock Start/From:	
Clock To:	
1st Value:	
2nd Value:	
Value Percent:	
Continuous Index:	
Within 8" of Joint:	NO
Remarks:	Heavy sediment
