Profile/Photo Observation Report

Date:	08/12/2022	Weather:		Coding:	PACP 7.0
Pipe Length (ft):	277.0	Owner:	City of Hobart	Pre Clean:	Heavy Cleaning
P.O.#:	YES502259	Surveyor:	S. Bucklin	PSR:	P-604-043-017
Customer:	City of Hobart	Clean Date:	08/05/2022	Shape:	C

Street:	North Ash Street	Flow Control:	Not Controlled
City:	Hobart, IN	Year Renewed:	
Location:	Local rural streets with light traffic, t	Tape/Media #:	
Purpose:	Routine Assessment	Dia/Height:	15"
Use:	Sanitary Sewage Pipe	Material:	VCP
Drain Area:		Lining:	None
Category:	NA		
Comment:			
Location Details:		Direction of Survey:	Downstream
US MH:	M-604-017	DS MH:	M-604-043
		Total Length Surveyed (ft):	274.9

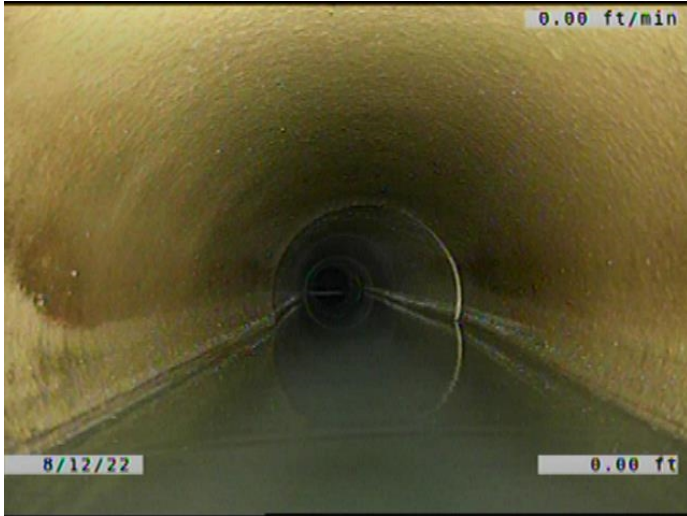
Code: **MWL**
Description: **Miscellaneous Water Level**

Distance (ft): **.0**
Structural Grade: **0**
O&M Grade: **0**
Clock Start/From:
Clock To:
1st Value:
2nd Value:
Value Percent: **45.000**
Continuous Index:
Within 8" of Joint: **NO**
Remarks:

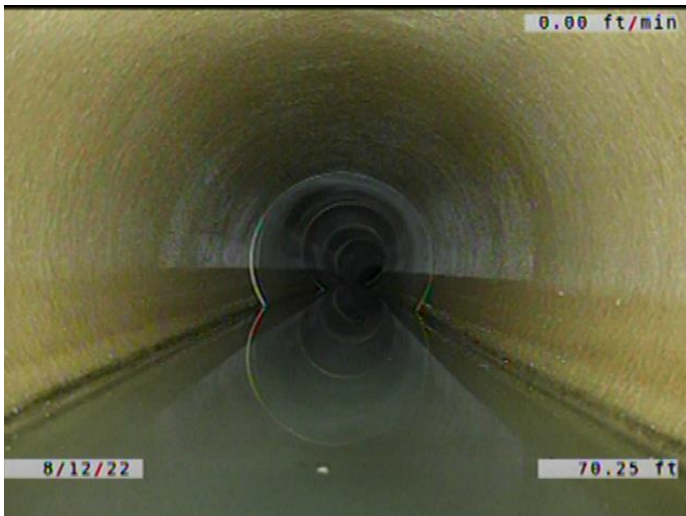
Code: **MWL**
Description: **Miscellaneous Water Level**

Distance (ft): **70.2**
Structural Grade: **0**
O&M Grade: **0**
Clock Start/From:
Clock To:
1st Value:
2nd Value:
Value Percent: **15.000**
Continuous Index:
Within 8" of Joint: **NO**
Remarks:

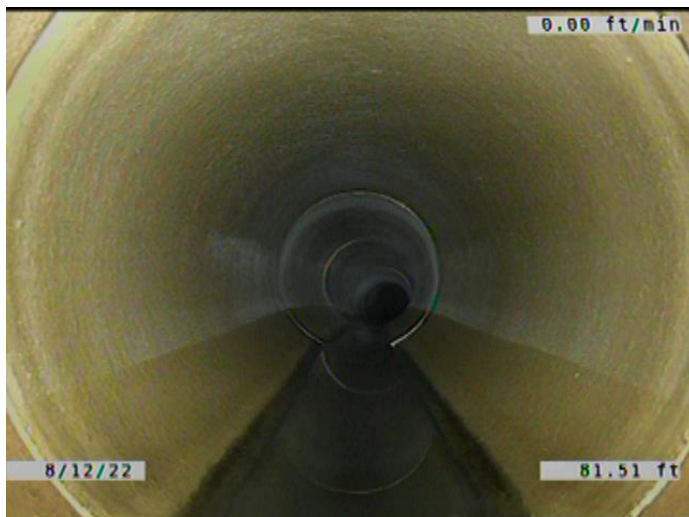
Code: **MWL**
 Description: **Miscellaneous Water Level**

Distance (ft): **81.5**
 Structural Grade: **0**
 O&M Grade: **0**
 Clock Start/From:
 Clock To:
 1st Value:
 2nd Value:
 Value Percent: **5.000**
 Continuous Index:
 Within 8" of Joint: **NO**
 Remarks:

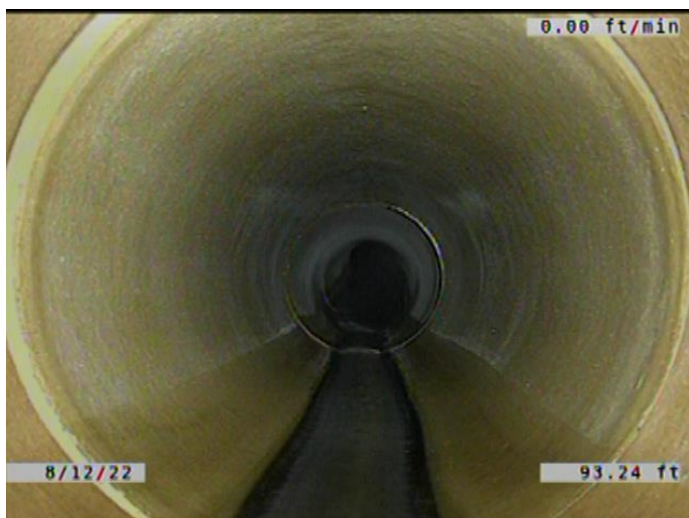
Code: **LD**
 Description: **Line Down**

Distance (ft): **93.2**
 Structural Grade: **0**
 O&M Grade: **1**
 Clock Start/From:
 Clock To:
 1st Value:
 2nd Value:
 Value Percent: **5.000**
 Continuous Index:
 Within 8" of Joint: **NO**
 Remarks:

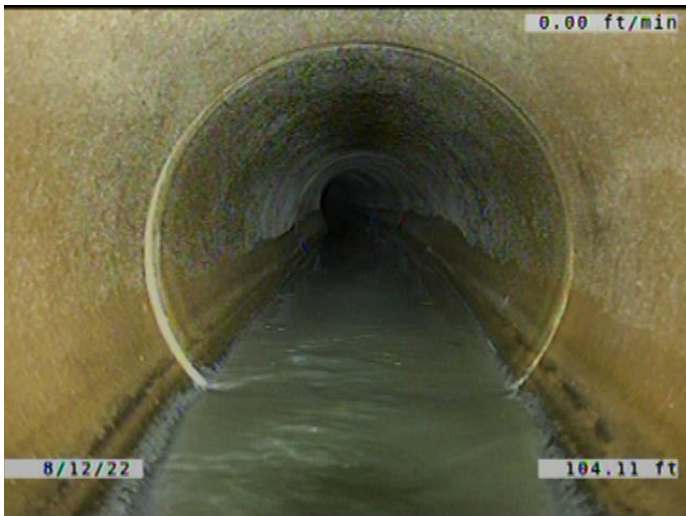
Code: **MWL**
Description: **Miscellaneous Water Level**

Distance (ft): **104.1**
Structural Grade: **0**
O&M Grade: **0**
Clock Start/From:
Clock To:
1st Value:
2nd Value:
Value Percent: **15.000**
Continuous Index:
Within 8" of Joint: **NO**
Remarks:

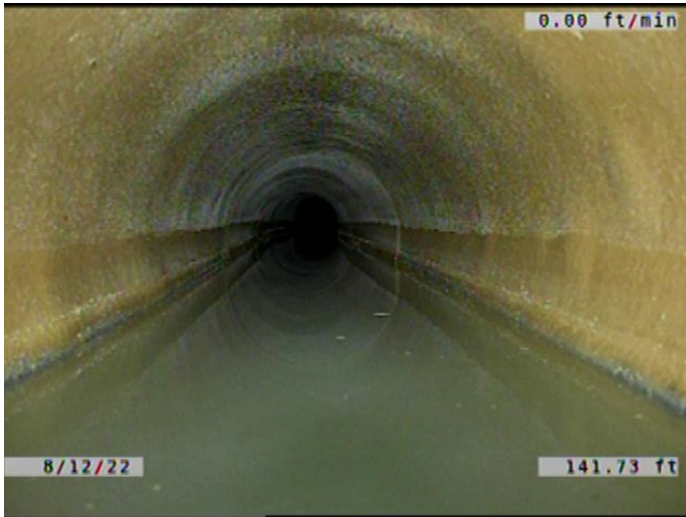
Code: **MWLS**
Description: **Miscellaneous Water Level Sag**

Distance (ft): **141.7**
Structural Grade: **3**
O&M Grade: **0**
Clock Start/From:
Clock To:
1st Value:
2nd Value:
Value Percent: **45.000**
Continuous Index: **S01**
Within 8" of Joint: **NO**
Remarks:

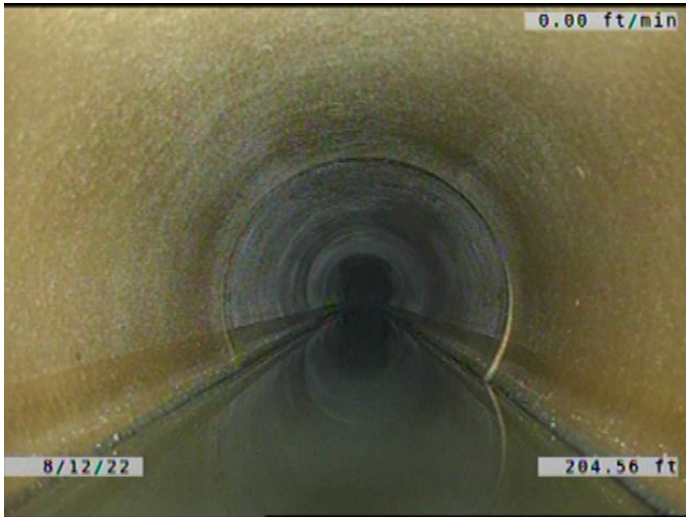
Code: **MWLS**
 Description: **Miscellaneous Water Level Sag**

Distance (ft): **204.6**
 Structural Grade: **2**
 O&M Grade: **0**
 Clock Start/From:
 Clock To:
 1st Value:
 2nd Value:
 Value Percent: **15.000**
 Continuous Index: **S02**
 Within 8" of Joint: **NO**
 Remarks:

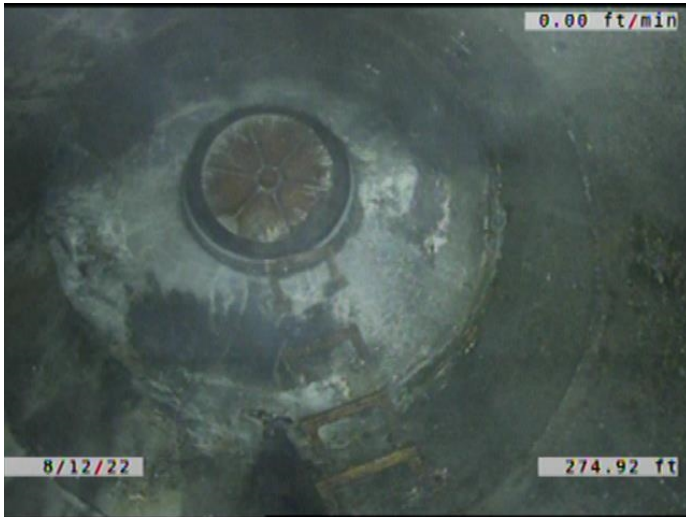
Code:	AMH
Description:	Manhole
Distance (ft):	274.9
Structural Grade:	0
O&M Grade:	0
Clock Start/From:	
Clock To:	
1st Value:	
2nd Value:	
Value Percent:	
Continuous Index:	
Within 8" of Joint:	NO
Remarks:	M-604-043
