## Profile/Photo Observation Report

Date:	<b>04/23/2018</b>	Weather:		Coding:	<b>PACP 6.0</b>
Pipe Length (ft):	<b>428.2</b>	Owner:	<b>NA</b>	Pre Clean:	<b>Not Known</b>
P.O.#:		Surveyor:	<b>Jen Costello</b>	PSR:	<b>P-604-031-029</b>
Customer:		Clean Date:	<b>01/01/1900</b>	Shape:	<b>C</b>

Street:	<b>N LAKE PARK AVE</b>	Flow Control:	<b>Not Controlled</b>
City:	<b>Hobart, IN</b>	Year Renewed:	
Location:	<b>Light Highway</b>	Tape/Media #:	
Purpose:	<b>Not Known</b>	Dia/Height:	<b>12"</b>
Use:	<b>Sanitary</b>	Material:	<b>VCP</b>
Drain Area:	<b>NA</b>	Lining:	
Category:	<b>NA</b>		
Comment:

Location Details:		Direction of Survey:	<b>Downstream</b>
US MH:	<b>M-604-029</b>	DS MH:	<b>M-604-031</b>
		Total Length Surveyed (ft):	<b>308.0</b>

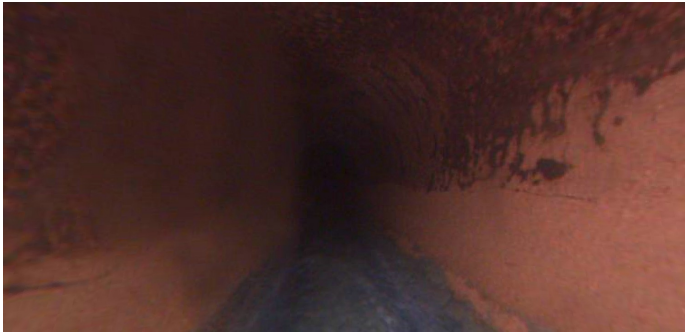
Code:	<b>MWL</b>
Description:	<b>Water Level</b>

Distance (ft):	<b>.0</b>
Structural Grade:	<b>0</b>
O&M Grade:	<b>0</b>
Clock Start/From:	
Clock To:	
1st Value:	
2nd Value:	
Value Percent:	<b>10.000</b>
Continuous Index:	
Within 8" of Joint:	<b>NO</b>
Remarks:

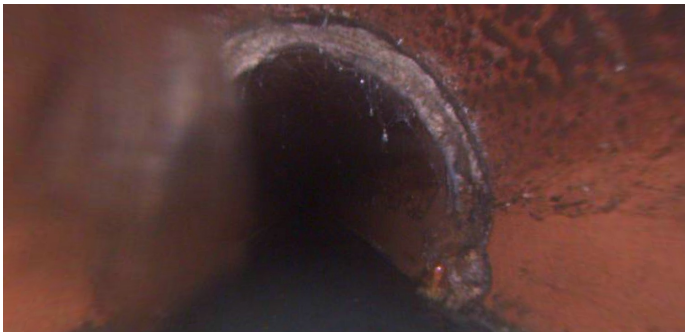
Code:	<b>DAE</b>
Description:	<b>Deposits Attached Encrustation</b>

Distance (ft):	<b>28.6</b>
Structural Grade:	<b>0</b>
O&M Grade:	<b>2</b>
Clock Start/From:	<b>8</b>
Clock To:	<b>4</b>
1st Value:	
2nd Value:	
Value Percent:	<b>5.000</b>
Continuous Index:	
Within 8" of Joint:	<b>YES</b>
Remarks:

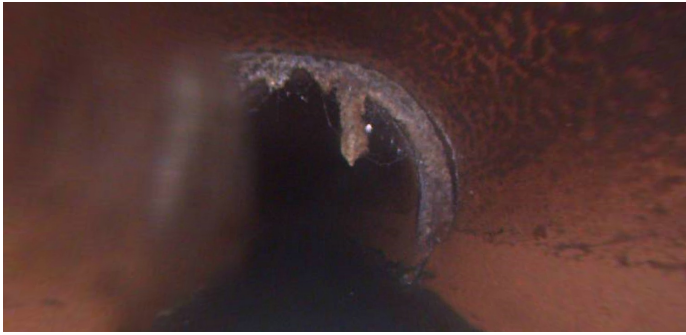
Code: **DAE**  
Description: **Deposits Attached Encrustation**

Distance (ft): **58.6**  
Structural Grade: **0**  
O&M Grade: **2**  
Clock Start/From: **8**  
Clock To: **4**  
1st Value:  
2nd Value:  
Value Percent: **5.000**  
Continuous Index:  
Within 8" of Joint: **YES**  
Remarks:

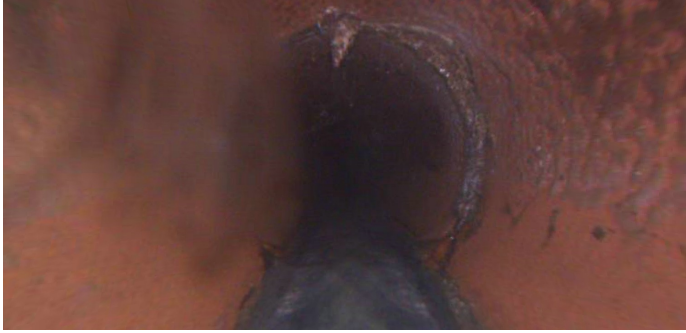
Code: ID  
Description: Infil Dripper

Distance (ft): 114.7  
Structural Grade: 0  
O&M Grade: 3  
Clock Start/From: 12  
Clock To:  
1st Value:  
2nd Value:  
Value Percent:  
Continuous Index:  
Within 8" of Joint: YES  
Remarks:

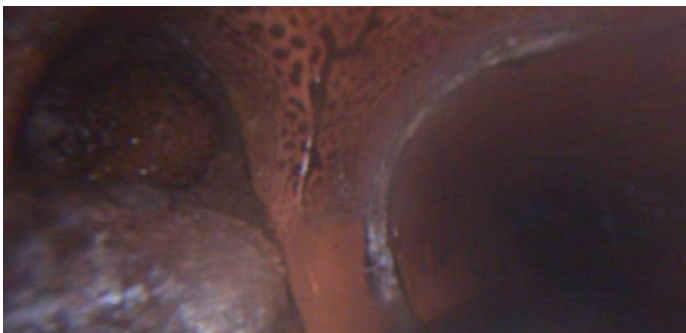
Code: TFC  
Description: Tap Factory Capped

Distance (ft): 122.8  
Structural Grade: 0  
O&M Grade: 0  
Clock Start/From: 3  
Clock To:  
1st Value: 4.000  
2nd Value:  
Value Percent:  
Continuous Index:  
Within 8" of Joint:  
Remarks: DAE

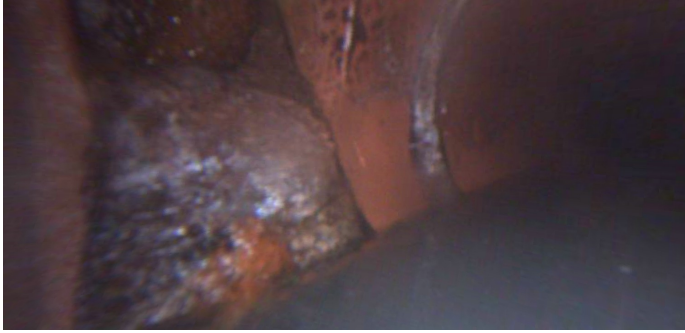
Code: **DAE**  
Description: **Deposits Attached Encrustation**

Distance (ft): **122.8**  
Structural Grade: **0**  
O&M Grade: **2**  
Clock Start/From: **3**  
Clock To: **4**  
1st Value:  
2nd Value:  
Value Percent: **5.000**  
Continuous Index:  
Within 8" of Joint: **NO**  
Remarks:

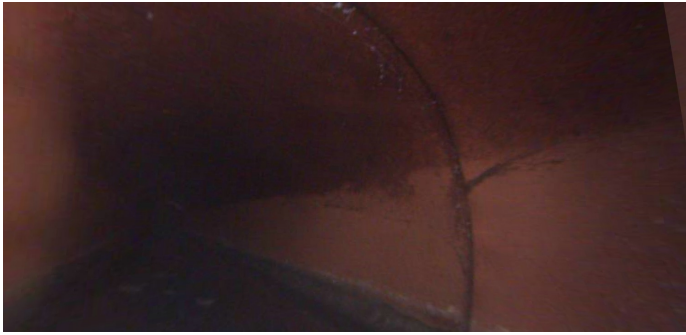
Code: **RFJ**  
Description: **Roots Fine Joint**

Distance (ft): **207.7**  
Structural Grade: **0**  
O&M Grade: **1**  
Clock Start/From: **3**  
Clock To:  
1st Value:  
2nd Value:  
Value Percent:  
Continuous Index:  
Within 8" of Joint: **YES**  
Remarks:

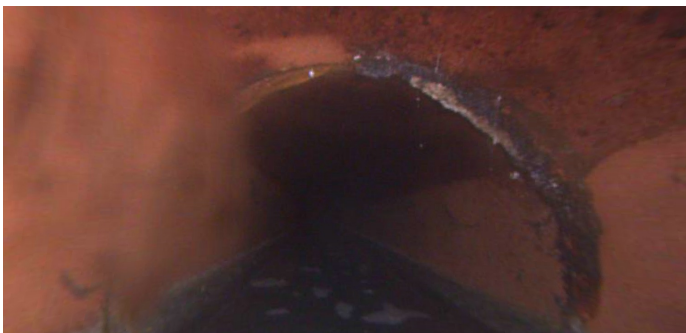
Code: **DAE**  
Description: **Deposits Attached Encrustation**

Distance (ft): **213.5**  
Structural Grade: **0**  
O&M Grade: **2**  
Clock Start/From: **12**  
Clock To: **4**  
1st Value:  
2nd Value:  
Value Percent: **5.000**  
Continuous Index:  
Within 8" of Joint: **YES**  
Remarks:

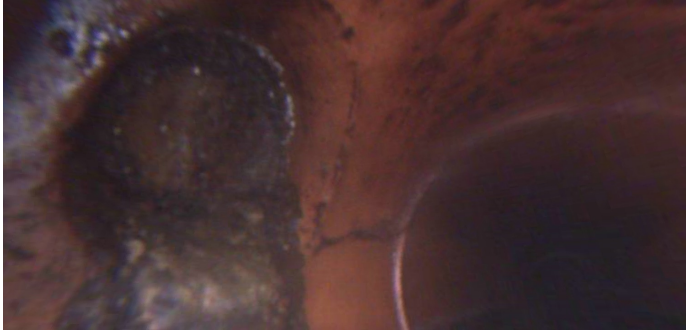
Code: **TFC**  
Description: **Tap Factory Capped**

Distance (ft): **233.1**  
Structural Grade: **0**  
O&M Grade: **0**  
Clock Start/From: **3**  
Clock To:  
1st Value: **4.000**  
2nd Value:  
Value Percent:  
Continuous Index:  
Within 8" of Joint:  
Remarks:

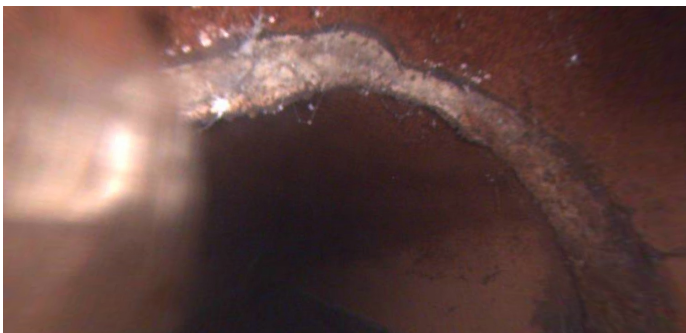
Code: **DAE**  
Description: **Deposits Attached Encrustation**

Distance (ft): **269.6**  
Structural Grade: **0**  
O&M Grade: **2**  
Clock Start/From: **8**  
Clock To: **4**  
1st Value:  
2nd Value:  
Value Percent: **10.000**  
Continuous Index:  
Within 8" of Joint: **YES**  
Remarks:

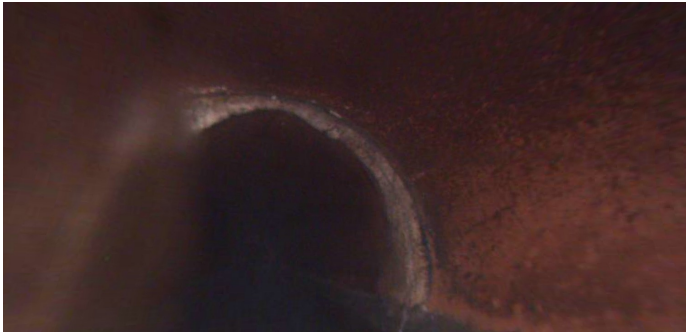
Code: **DAE**  
Description: **Deposits Attached Encrustation**

Distance (ft): **299.2**  
Structural Grade: **0**  
O&M Grade: **2**  
Clock Start/From: **8**  
Clock To: **4**  
1st Value:  
2nd Value:  
Value Percent: **5.000**  
Continuous Index:  
Within 8" of Joint: **YES**  
Remarks:
