Profile/Photo Observation Report

Street:	Summerlin	Flow Control:	Not Controlled
City:	Hobart, IN	Year Renewed:	
Location:	Light Highway	Tape/Media #:	
Purpose:	Not Known	Dia/Height:	10"
Use:	Sanitary	Material:	VCP
Drain Area:	NA	Lining:	
Category:	NA		
Comment:

Location Details:		Direction of Survey:	Downstream
US MH:	M-604-030	DS MH:	M-604-032
		Total Length Surveyed (ft):	16.4

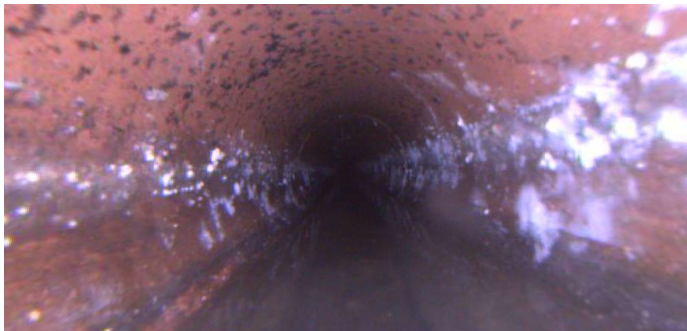
Code: **AMH**
Description: **Manhole**

Distance (ft): **.0**
Structural Grade: **0**
O&M Grade: **0**
Clock Start/From:
Clock To:
1st Value:
2nd Value:
Value Percent:
Continuous Index:
Within 8" of Joint: **NO**
Remarks: **M-604-030**

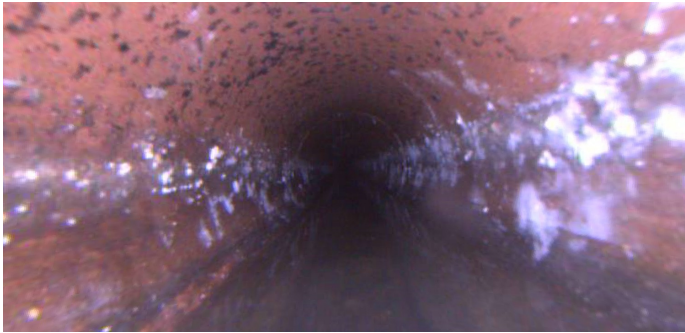
Code:	MWL
Description:	Water Level

Distance (ft):	.0
Structural Grade:	0
O&M Grade:	0
Clock Start/From:	
Clock To:	
1st Value:	
2nd Value:	
Value Percent:	5.000
Continuous Index:	
Within 8" of Joint:	NO
Remarks:

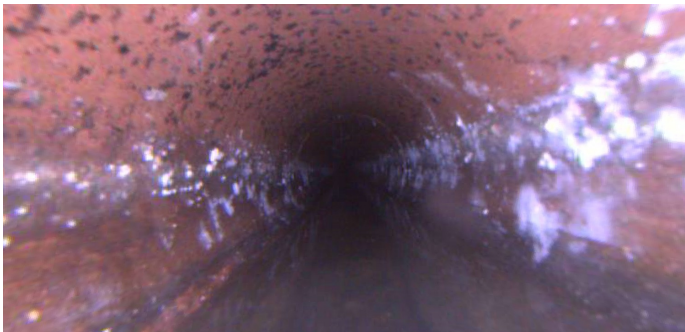
Code:	MWL
Description:	Water Level

Distance (ft):	.0
Structural Grade:	0
O&M Grade:	0
Clock Start/From:	
Clock To:	
1st Value:	
2nd Value:	
Value Percent:	20.000
Continuous Index:	
Within 8" of Joint:	NO
Remarks:

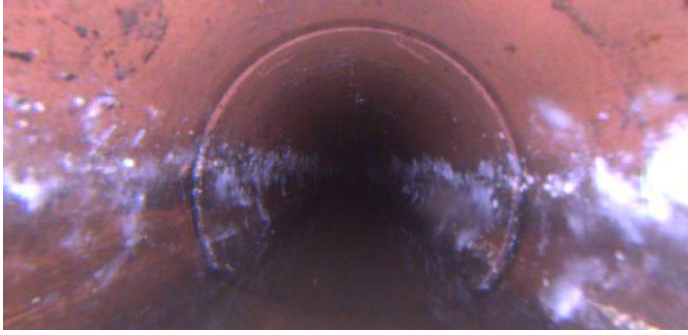
Code:	MSA
Description:	Abandoned Survey
Distance (ft):	16.4
Structural Grade:	0
O&M Grade:	0
Clock Start/From:	
Clock To:	
1st Value:	
2nd Value:	
Value Percent:	
Continuous Index:	
Within 8" of Joint:	NO
Remarks:	UNKNOWN
