Profile/Photo Observation Report

Street:	N LAKE PARK AVE & NERINGA LN	Flow Control:	Not Controlled
City:	Hobart, IN	Year Renewed:	
Location:	Light Highway	Tape/Media #:	
Purpose:	Not Known	Dia/Height:	12"
Use:	Sanitary	Material:	VCP
Drain Area:	NA	Lining:	
Category:	NA		
Comment:

Location Details:		Direction of Survey:	Downstream
US MH:	M-604-031	DS MH:	M-604-033
		Total Length Surveyed (ft):	277.1

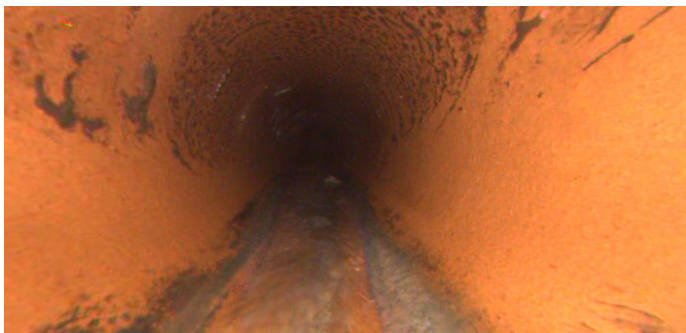
Code: **AMH**
Description: **Manhole**

Distance (ft): **.0**
Structural Grade: **0**
O&M Grade: **0**
Clock Start/From:
Clock To:
1st Value:
2nd Value:
Value Percent:
Continuous Index:
Within 8" of Joint: **NO**
Remarks: **M-604-031**

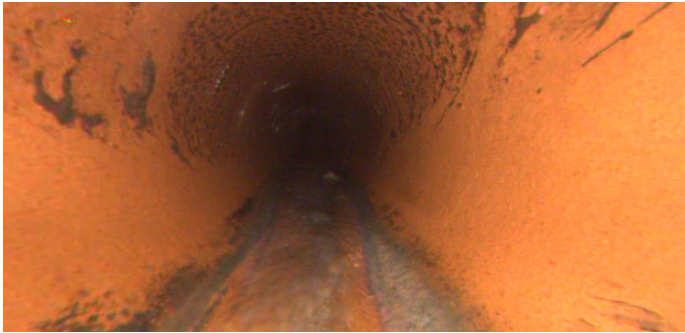
Code:	MWL
Description:	Water Level

Distance (ft):	.0
Structural Grade:	0
O&M Grade:	0
Clock Start/From:	
Clock To:	
1st Value:	
2nd Value:	
Value Percent:	5.000
Continuous Index:	
Within 8" of Joint:	NO
Remarks:

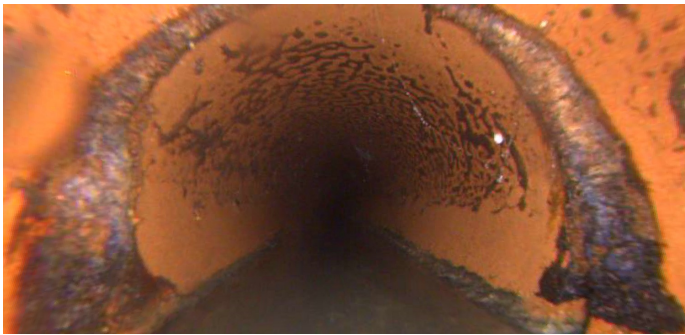
Code:	DAE
Description:	Deposits Attached Encrustation

Distance (ft):	40.0
Structural Grade:	0
O&M Grade:	2
Clock Start/From:	7
Clock To:	5
1st Value:	
2nd Value:	
Value Percent:	5.000
Continuous Index:	
Within 8" of Joint:	YES
Remarks:

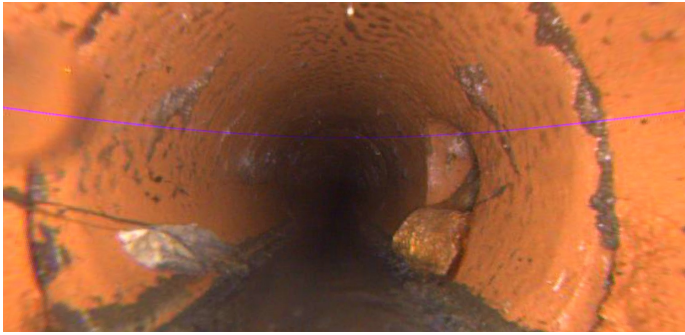
Code: **RFJ**
Description: **Roots Fine Joint**

Distance (ft): **75.5**
Structural Grade: **0**
O&M Grade: **1**
Clock Start/From: **9**
Clock To:
1st Value:
2nd Value:
Value Percent:
Continuous Index:
Within 8" of Joint: **YES**
Remarks:

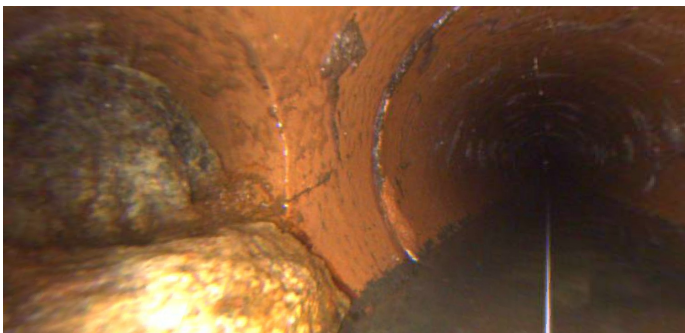
Code: **TF**
Description: **Tap Factory**

Distance (ft): **77.0**
Structural Grade: **0**
O&M Grade: **0**
Clock Start/From: **3**
Clock To:
1st Value: **4.000**
2nd Value:
Value Percent:
Continuous Index:
Within 8" of Joint:
Remarks: **DAE**

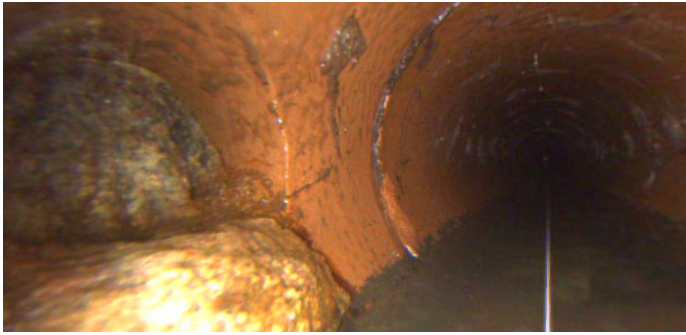
Code: **DAE**
Description: **Deposits Attached Encrustation**

Distance (ft): **77.0**
Structural Grade: **0**
O&M Grade: **2**
Clock Start/From: **3**
Clock To: **5**
1st Value:
2nd Value:
Value Percent: **10.000**
Continuous Index:
Within 8" of Joint: **NO**
Remarks:

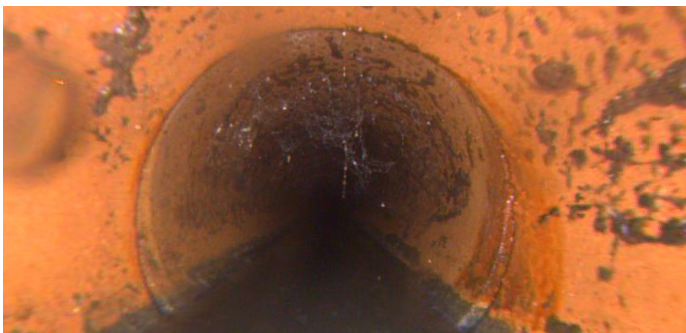
Code: **IW**
Description: **Infil Weeper**

Distance (ft): **95.2**
Structural Grade: **0**
O&M Grade: **2**
Clock Start/From: **1**
Clock To: **4**
1st Value:
2nd Value:
Value Percent:
Continuous Index:
Within 8" of Joint: **YES**
Remarks:

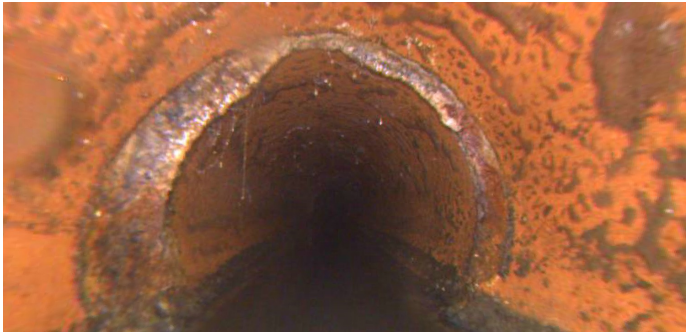
Code: **DAE**
Description: **Deposits Attached Encrustation**

Distance (ft): **136.2**
Structural Grade: **0**
O&M Grade: **2**
Clock Start/From: **8**
Clock To: **4**
1st Value:
2nd Value:
Value Percent: **5.000**
Continuous Index: **S01**
Within 8" of Joint: **YES**
Remarks:

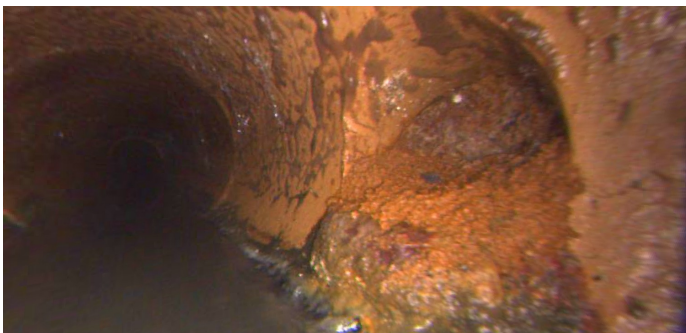
Code: **TFC**
Description: **Tap Factory Capped**

Distance (ft): **154.9**
Structural Grade: **0**
O&M Grade: **0**
Clock Start/From: **3**
Clock To:
1st Value: **4.000**
2nd Value:
Value Percent:
Continuous Index:
Within 8" of Joint:
Remarks: **DAE**

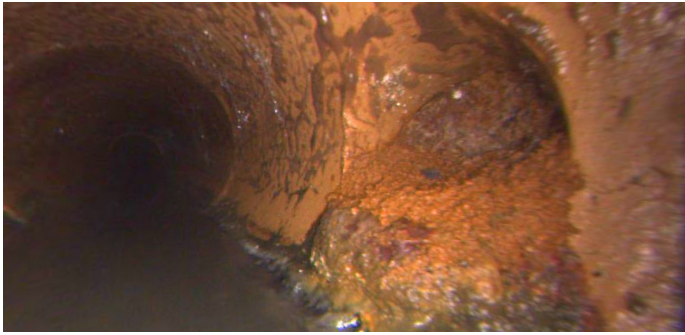
Code: **DAE**
Description: **Deposits Attached Encrustation**

Distance (ft): **154.9**
Structural Grade: **0**
O&M Grade: **2**
Clock Start/From: **3**
Clock To: **4**
1st Value:
2nd Value:
Value Percent: **10.000**
Continuous Index:
Within 8" of Joint: **NO**
Remarks:

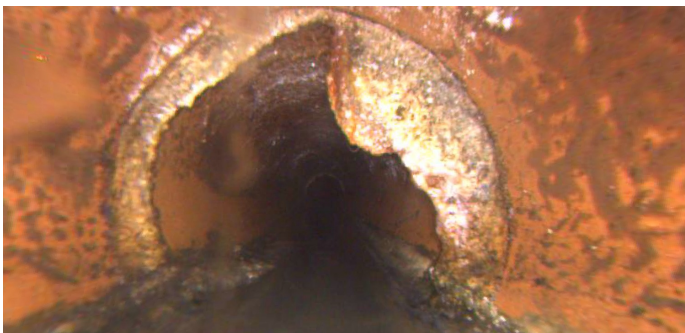
Code: **DAE**
Description: **Deposits Attached Encrustation**

Distance (ft): **185.4**
Structural Grade: **0**
O&M Grade: **4**
Clock Start/From: **8**
Clock To: **4**
1st Value:
2nd Value:
Value Percent: **30.000**
Continuous Index:
Within 8" of Joint: **YES**
Remarks:

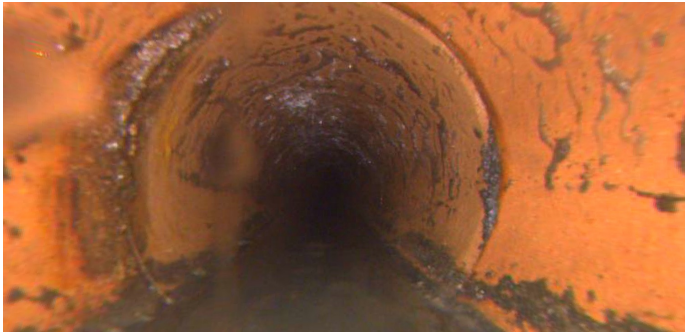
Code: **IW**
Description: **Infil Weeper**

Distance (ft): **203.1**
Structural Grade: **0**
O&M Grade: **2**
Clock Start/From: **8**
Clock To: **11**
1st Value:
2nd Value:
Value Percent:
Continuous Index:
Within 8" of Joint: **YES**
Remarks:

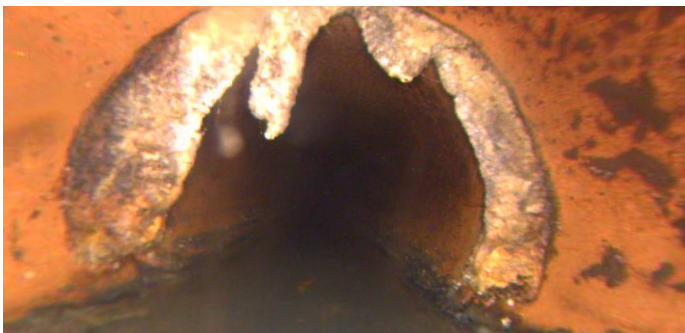
Code: **DAE**
Description: **Deposits Attached Encrustation**

Distance (ft): **256.7**
Structural Grade: **0**
O&M Grade: **2**
Clock Start/From: **8**
Clock To: **4**
1st Value:
2nd Value:
Value Percent: **10.000**
Continuous Index:
Within 8" of Joint: **YES**
Remarks:

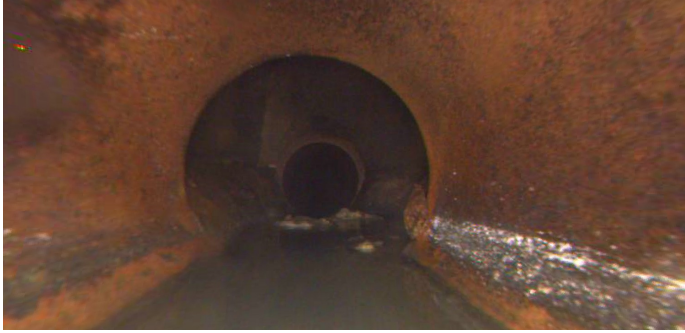
Code: **DAE**
Description: **Deposits Attached Encrustation**

Distance (ft): **274.1**
Structural Grade: **0**
O&M Grade: **2**
Clock Start/From: **8**
Clock To: **4**
1st Value:
2nd Value:
Value Percent: **5.000**
Continuous Index: **F01**
Within 8" of Joint: **YES**
Remarks:

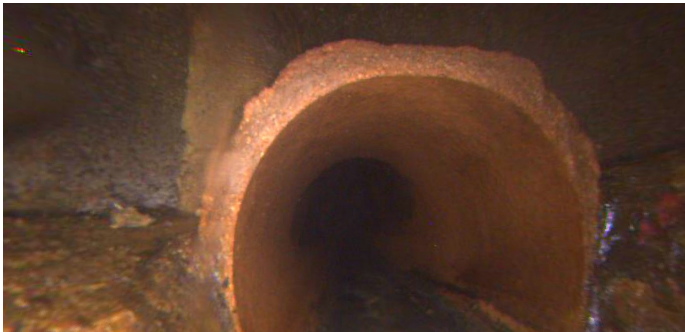
Code: **AMH**
Description: **Manhole**

Distance (ft): **277.1**
Structural Grade: **0**
O&M Grade: **0**
Clock Start/From:
Clock To:
1st Value:
2nd Value:
Value Percent:
Continuous Index:
Within 8" of Joint: **NO**
Remarks: **M-604-033**
