Profile/Photo Observation Report

Date:	04/23/2018	Weather:		Coding:	PACP 6.0
Pipe Length (ft):	263.5	Owner:	NA	Pre Clean:	Not Known
P.O.#:		Surveyor:	Jen Costello	PSR:	P-604-033-031
Customer:		Clean Date:	01/01/1900	Shape:	C

Street:	Summerlin	Flow Control:	Not Controlled
City:	Hobart, IN	Year Renewed:	
Location:	Light Highway	Tape/Media #:	
Purpose:	Not Known	Dia/Height:	12"
Use:	Sanitary	Material:	VCP
Drain Area:	NA	Lining:	
Category:	NA		
Comment:

Location Details:		Direction of Survey:	Downstream
US MH:	M-604-031	DS MH:	M-604-033
		Total Length Surveyed (ft):	277.1

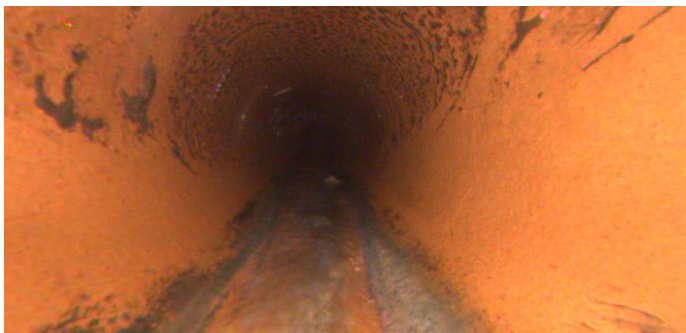
Code: **AMH**
Description: **Manhole**

Distance (ft): **.0**
Structural Grade: **0**
O&M Grade: **0**
Clock Start/From:
Clock To:
1st Value:
2nd Value:
Value Percent:
Continuous Index:
Within 8" of Joint: **NO**
Remarks: **M-604-031**

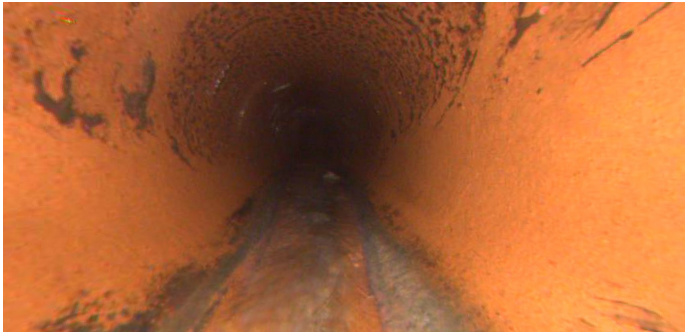
Code:	MWL
Description:	Water Level

Distance (ft):	.0
Structural Grade:	0
O&M Grade:	0
Clock Start/From:	
Clock To:	
1st Value:	
2nd Value:	
Value Percent:	5.000
Continuous Index:	
Within 8" of Joint:	NO
Remarks:

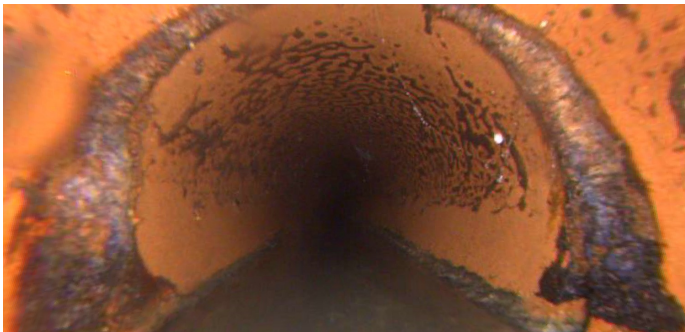
Code:	DAE
Description:	Deposits Attached Encrustation

Distance (ft):	40.0
Structural Grade:	0
O&M Grade:	2
Clock Start/From:	7
Clock To:	5
1st Value:	
2nd Value:	
Value Percent:	5.000
Continuous Index:	
Within 8" of Joint:	YES
Remarks:

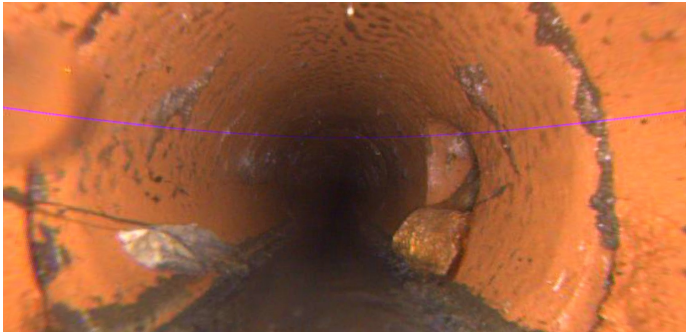
Code: **RFJ**
Description: **Roots Fine Joint**

Distance (ft): **75.5**
Structural Grade: **0**
O&M Grade: **1**
Clock Start/From: **9**
Clock To:
1st Value:
2nd Value:
Value Percent:
Continuous Index:
Within 8" of Joint: **YES**
Remarks:

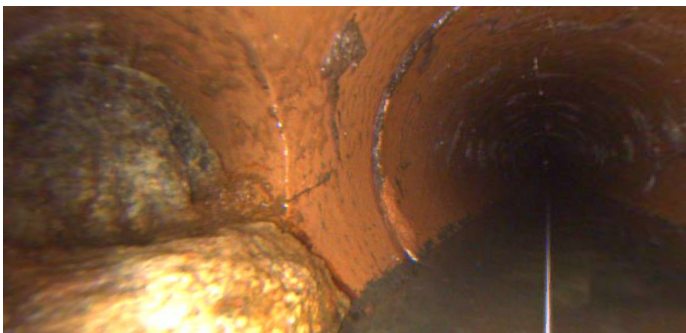
Code: **TF**
Description: **Tap Factory**

Distance (ft): **77.0**
Structural Grade: **0**
O&M Grade: **0**
Clock Start/From: **3**
Clock To:
1st Value: **4.000**
2nd Value:
Value Percent:
Continuous Index:
Within 8" of Joint:
Remarks: **DAE**

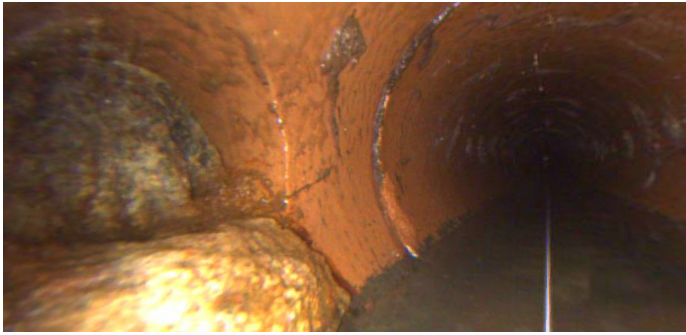
Code: **DAE**
Description: **Deposits Attached Encrustation**

Distance (ft): **77.0**
Structural Grade: **0**
O&M Grade: **2**
Clock Start/From: **3**
Clock To: **5**
1st Value:
2nd Value:
Value Percent: **10.000**
Continuous Index:
Within 8" of Joint: **NO**
Remarks:

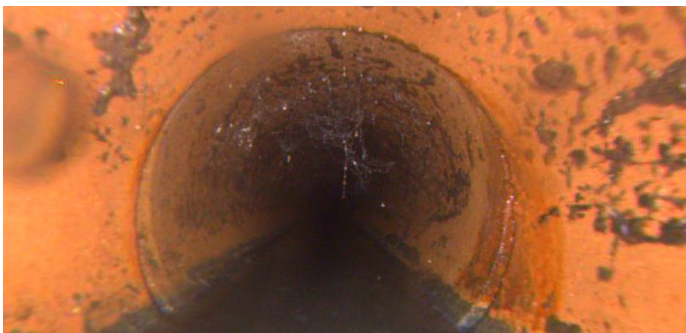
Code: **IW**
Description: **Infil Weeper**

Distance (ft): **95.2**
Structural Grade: **0**
O&M Grade: **2**
Clock Start/From: **1**
Clock To: **4**
1st Value:
2nd Value:
Value Percent:
Continuous Index:
Within 8" of Joint: **YES**
Remarks:

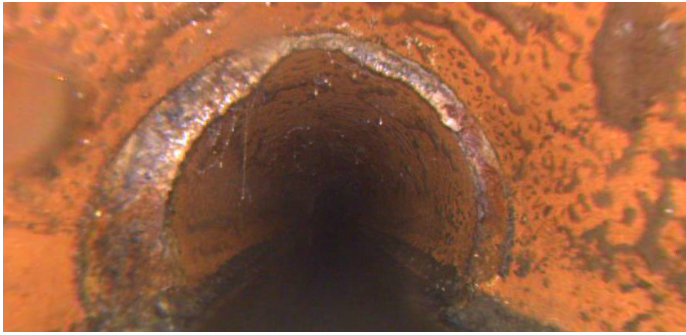
Code: **DAE**
Description: **Deposits Attached Encrustation**

Distance (ft): **136.2**
Structural Grade: **0**
O&M Grade: **2**
Clock Start/From: **8**
Clock To: **4**
1st Value:
2nd Value:
Value Percent: **5.000**
Continuous Index: **S01**
Within 8" of Joint: **YES**
Remarks:

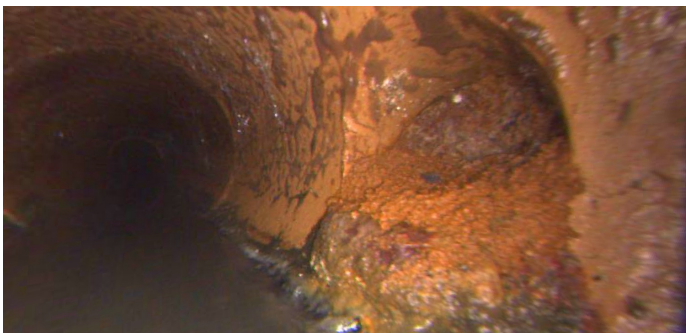
Code: **TFC**
Description: **Tap Factory Capped**

Distance (ft): **154.9**
Structural Grade: **0**
O&M Grade: **0**
Clock Start/From: **3**
Clock To:
1st Value: **4.000**
2nd Value:
Value Percent:
Continuous Index:
Within 8" of Joint:
Remarks: **DAE**

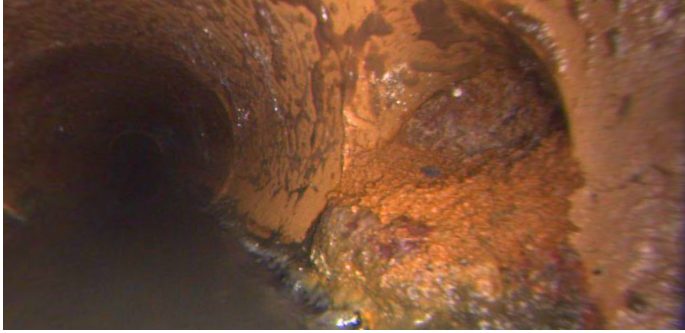
Code: **DAE**
Description: **Deposits Attached Encrustation**

Distance (ft): **154.9**
Structural Grade: **0**
O&M Grade: **2**
Clock Start/From: **3**
Clock To: **4**
1st Value:
2nd Value:
Value Percent: **10.000**
Continuous Index:
Within 8" of Joint: **NO**
Remarks:

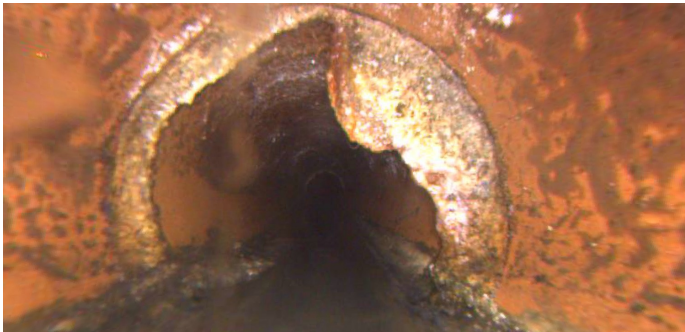
Code: **DAE**
Description: **Deposits Attached Encrustation**

Distance (ft): **185.4**
Structural Grade: **0**
O&M Grade: **4**
Clock Start/From: **8**
Clock To: **4**
1st Value:
2nd Value:
Value Percent: **30.000**
Continuous Index:
Within 8" of Joint: **YES**
Remarks:

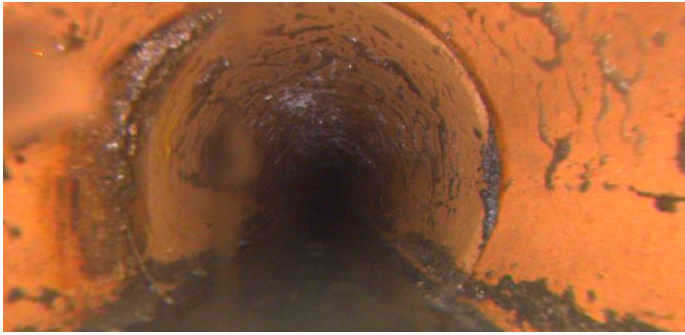
Code: **IW**
Description: **Infil Weeper**

Distance (ft): **203.1**
Structural Grade: **0**
O&M Grade: **2**
Clock Start/From: **8**
Clock To: **11**
1st Value:
2nd Value:
Value Percent:
Continuous Index:
Within 8" of Joint: **YES**
Remarks:

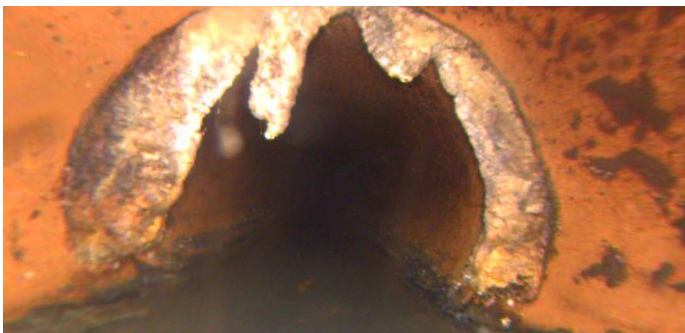
Code: **DAE**
Description: **Deposits Attached Encrustation**

Distance (ft): **256.7**
Structural Grade: **0**
O&M Grade: **2**
Clock Start/From: **8**
Clock To: **4**
1st Value:
2nd Value:
Value Percent: **10.000**
Continuous Index:
Within 8" of Joint: **YES**
Remarks:

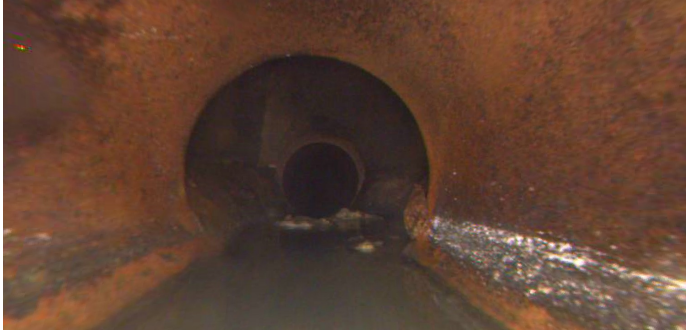
Code: **DAE**
Description: **Deposits Attached Encrustation**

Distance (ft): **274.1**
Structural Grade: **0**
O&M Grade: **2**
Clock Start/From: **8**
Clock To: **4**
1st Value:
2nd Value:
Value Percent: **5.000**
Continuous Index: **F01**
Within 8" of Joint: **YES**
Remarks:

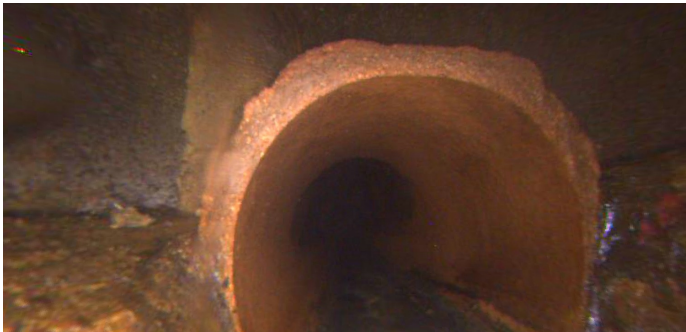
Code: **AMH**
Description: **Manhole**

Distance (ft): **277.1**
Structural Grade: **0**
O&M Grade: **0**
Clock Start/From:
Clock To:
1st Value:
2nd Value:
Value Percent:
Continuous Index:
Within 8" of Joint: **NO**
Remarks: **M-604-033**
