## Profile/Photo Observation Report

Street:	<b>Summerlin</b>	Flow Control:	<b>Not Controlled</b>
City:	<b>Hobart, IN</b>	Year Renewed:	
Location:	<b>Light Highway</b>	Tape/Media #:	
Purpose:	<b>Not Known</b>	Dia/Height:	<b>12"</b>
Use:	<b>Sanitary</b>	Material:	<b>VCP</b>
Drain Area:	<b>NA</b>	Lining:	
Category:	<b>NA</b>		
Comment:

Location Details:		Direction of Survey:	<b>Downstream</b>
US MH:	<b>M-604-033</b>	DS MH:	<b>M-604-034</b>
		Total Length Surveyed (ft):	<b>214.4</b>

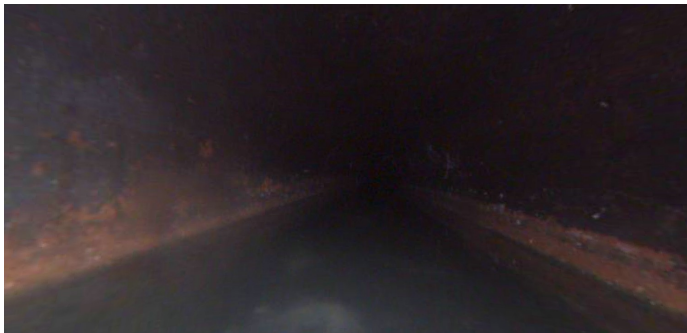
Position	Code	Observation	Video (sec)	Grade
.0	AMH	Manhole	10	NA
.0	MWL	Water Level	21	NA
48.7	TBA	Tap Break-in Active	130	NA
134.1	TBI	Tap Break-in Intruding	313	M 2
197.0	IW	Infil Weeper	451	M 2
214.4	AMH	Manhole	497	NA

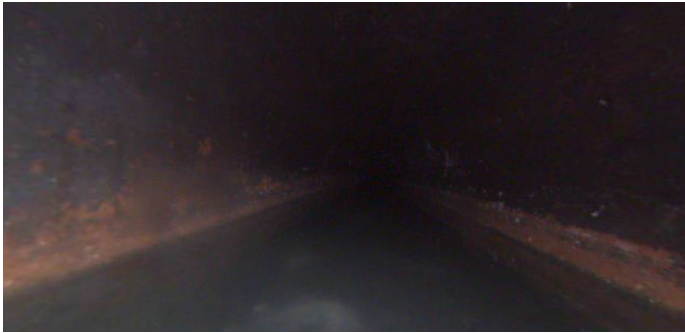
Code:	<b>MWL</b>
Description:	<b>Water Level</b>

Distance (ft):	<b>.0</b>
Structural Grade:	<b>0</b>
O&M Grade:	<b>0</b>
Clock Start/From:	
Clock To:	
1st Value:	
2nd Value:	
Value Percent:	<b>30.000</b>
Continuous Index:	
Within 8" of Joint:	<b>NO</b>
Remarks:

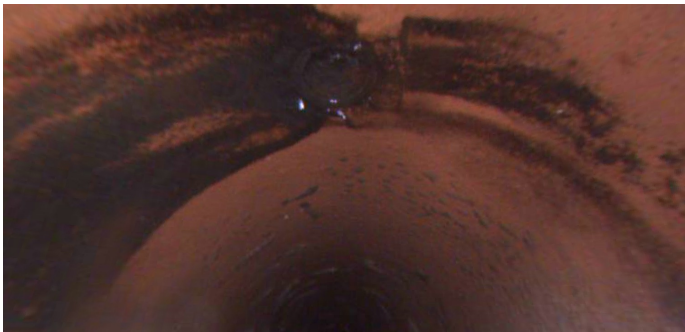
Code:	<b>TBA</b>
Description:	<b>Tap Break-in Active</b>

Distance (ft):	<b>48.7</b>
Structural Grade:	<b>0</b>
O&M Grade:	<b>0</b>
Clock Start/From:	<b>12</b>
Clock To:	
1st Value:	<b>2.000</b>
2nd Value:	
Value Percent:	
Continuous Index:	
Within 8" of Joint:	
Remarks:

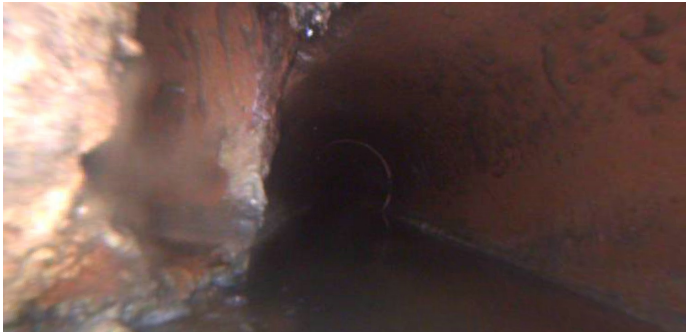
Code: **TBI**  
Description: **Tap Break-in Intruding**

Distance (ft): **134.1**  
Structural Grade: **0**  
O&M Grade: **2**  
Clock Start/From: **9**  
Clock To:  
1st Value: **4.000**  
2nd Value: **2.000**  
Value Percent:  
Continuous Index:  
Within 8" of Joint:  
Remarks:

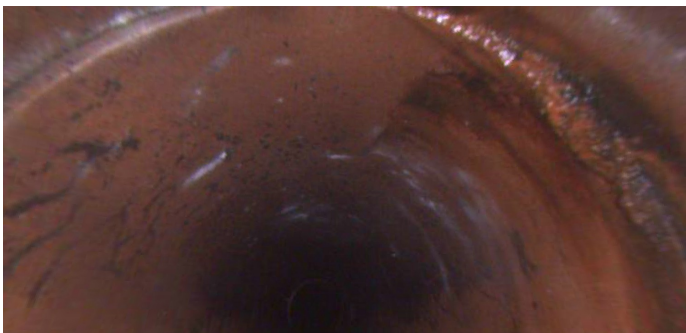
Code: **IW**  
Description: **Infil Weeper**

Distance (ft): **197.0**  
Structural Grade: **0**  
O&M Grade: **2**  
Clock Start/From: **12**  
Clock To: **4**  
1st Value:  
2nd Value:  
Value Percent:  
Continuous Index:  
Within 8" of Joint: **YES**  
Remarks:

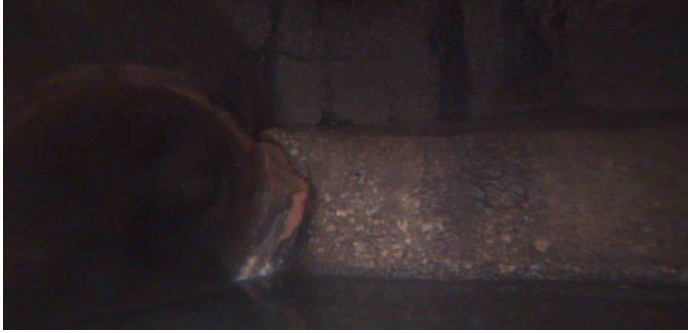
Code:	<b>AMH</b>
Description:	<b>Manhole</b>
Distance (ft):	<b>214.4</b>
Structural Grade:	<b>0</b>
O&M Grade:	<b>0</b>
Clock Start/From:	
Clock To:	
1st Value:	
2nd Value:	
Value Percent:	
Continuous Index:	
Within 8" of Joint:	<b>NO</b>
Remarks:	<b>M-604-034</b>
