## Profile/Photo Observation Report

Date:	<b>04/13/2018</b>	Weather:		Coding:	<b>PACP 6.0</b>
Pipe Length (ft):		Owner:	<b>City of Hobart</b>	Pre Clean:	<b>No Pre-Cleaning</b>
P.O.#:	<b>41-1</b>	Surveyor:	<b>M. Pielacha</b>	PSR:	<b>M-604-037-M-604-037</b>
Customer:	<b>City of Hobart</b>	Clean Date:		Shape:	<b>C</b>

Street:	<b>Off North Lake Park Avenue</b>	Flow Control:	<b>Not Controlled</b>
City:	<b>Hobart, IN</b>	Year Renewed:	
Location:	<b>Yard</b>	Tape/Media #:	<b>DEP 41</b>
Purpose:	<b>Routine Assessment</b>	Dia/Height:	<b>8"</b>
Use:	<b>Sanitary</b>	Material:	<b>VCP</b>
Drain Area:		Lining:	
Category:	<b>NA</b>		
Comment:			
Location Details:		Direction of Survey:	<b>Upstream</b>
US MH:	<b>M-604-037</b>	DS MH:	<b>M-604-037</b>
		Total Length Surveyed (ft):	<b>134.8</b>

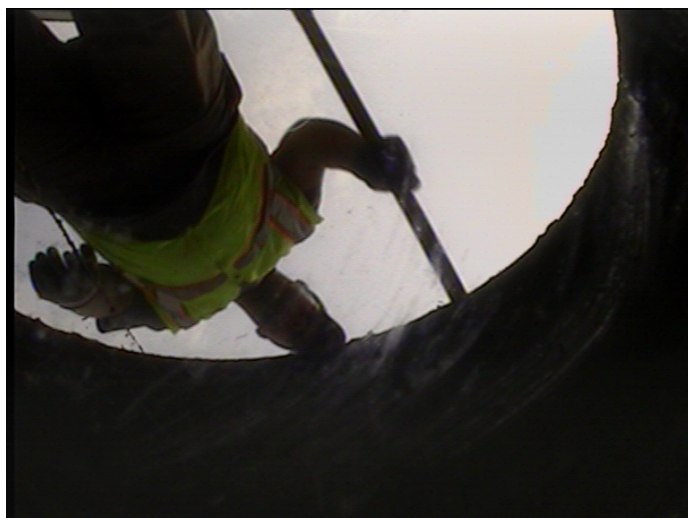
Code: **AMH**  
 Description: **Manhole**

Distance (ft): **.0**  
 Structural Grade: **0**  
 O&M Grade: **0**  
 Clock Start/From:  
 Clock To:  
 1st Value:  
 2nd Value:  
 Value Percent:  
 Continuous Index:  
 Within 8" of Joint: **NO**  
 Remarks: **M-604-037**

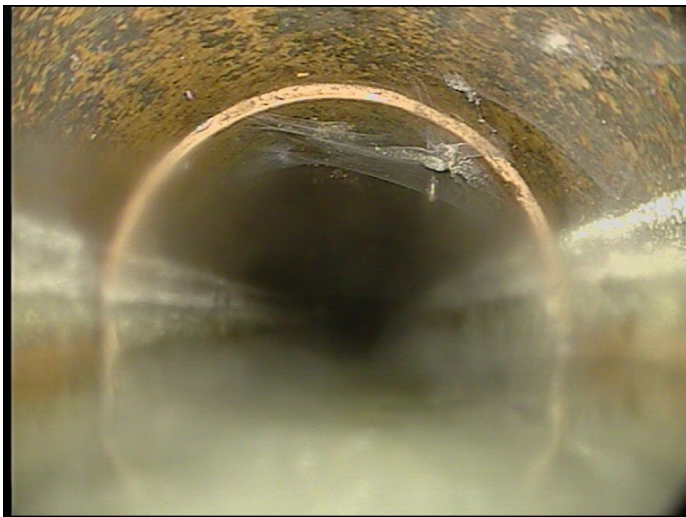
Code:	<b>MWL</b>
Description:	<b>Water Level</b>
Distance (ft):	<b>19.6</b>
Structural Grade:	<b>0</b>
O&M Grade:	<b>0</b>
Clock Start/From:	
Clock To:	
1st Value:	
2nd Value:	
Value Percent:	<b>15.000</b>
Continuous Index:	
Within 8" of Joint:	<b>NO</b>
Remarks:

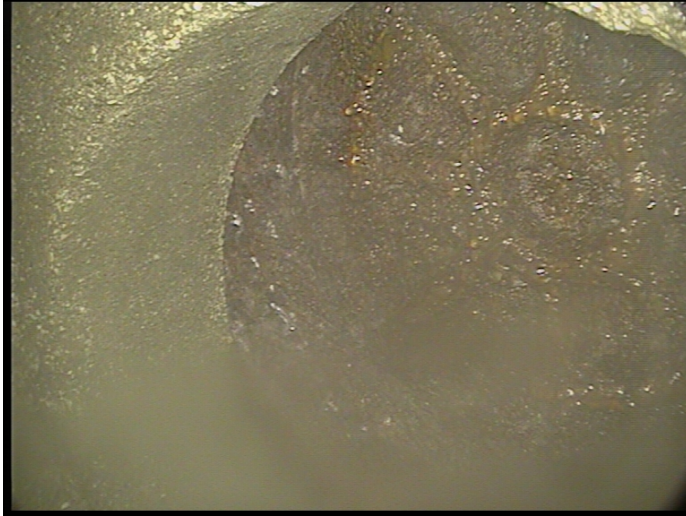
Code:	<b>AMH</b>
Description:	<b>Manhole</b>
Distance (ft):	<b>134.8</b>
Structural Grade:	<b>0</b>
O&M Grade:	<b>0</b>
Clock Start/From:	
Clock To:	
1st Value:	
2nd Value:	
Value Percent:	
Continuous Index:	
Within 8" of Joint:	<b>NO</b>
Remarks:	<b>M-604-037</b>
