Profile/Photo Observation Report

Date:	04/13/2018	Weather:		Coding:	PACP 6.0
Pipe Length (ft):		Owner:	City of Hobart	Pre Clean:	No Pre-Cleaning
P.O.#:	41-1	Surveyor:	M. Pielacha	PSR:	M-604-037-M-604-037
Customer:	City of Hobart	Clean Date:		Shape:	C

Street:	Off North Lake Park Avenue	Flow Control:	Not Controlled
City:	Hobart, IN	Year Renewed:	
Location:	Yard	Tape/Media #:	DEP 41
Purpose:	Routine Assessment	Dia/Height:	8"
Use:	Sanitary	Material:	VCP
Drain Area:		Lining:	
Category:	NA		
Comment:			
Location Details:		Direction of Survey:	Upstream
US MH:	M-604-037	DS MH:	M-604-037
		Total Length Surveyed (ft):	134.8

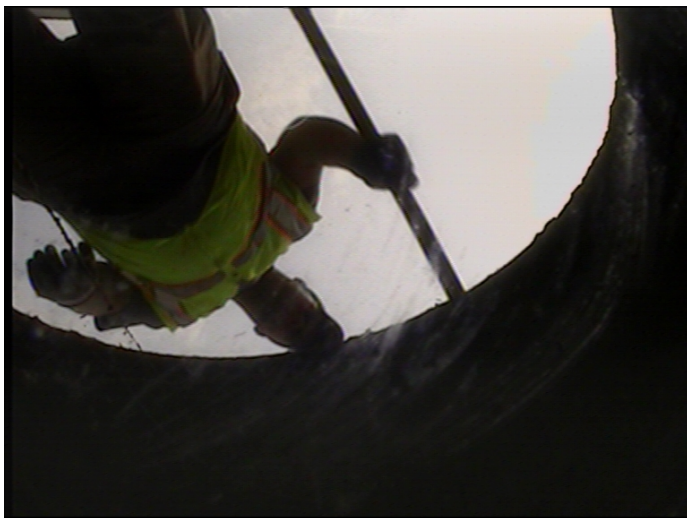
Code: **AMH**
 Description: **Manhole**

Distance (ft): **.0**
 Structural Grade: **0**
 O&M Grade: **0**
 Clock Start/From:
 Clock To:
 1st Value:
 2nd Value:
 Value Percent:
 Continuous Index:
 Within 8" of Joint: **NO**
 Remarks: **M-604-037**

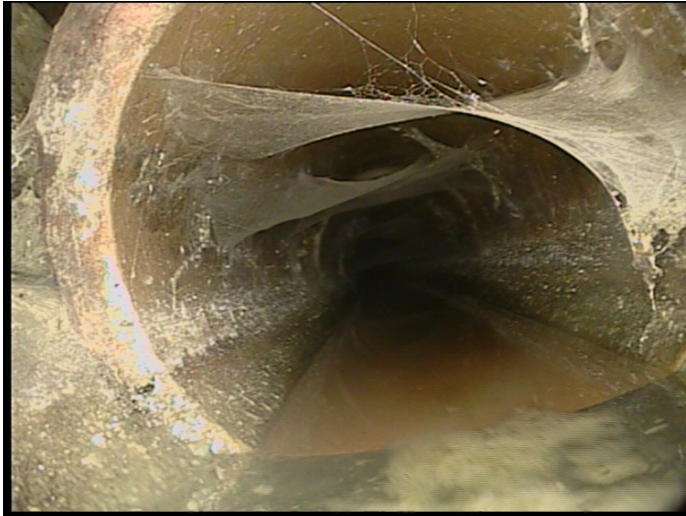
Code:	MWL
Description:	Water Level
Distance (ft):	.0
Structural Grade:	0
O&M Grade:	0
Clock Start/From:	
Clock To:	
1st Value:	
2nd Value:	
Value Percent:	5.000
Continuous Index:	
Within 8" of Joint:	NO
Remarks:

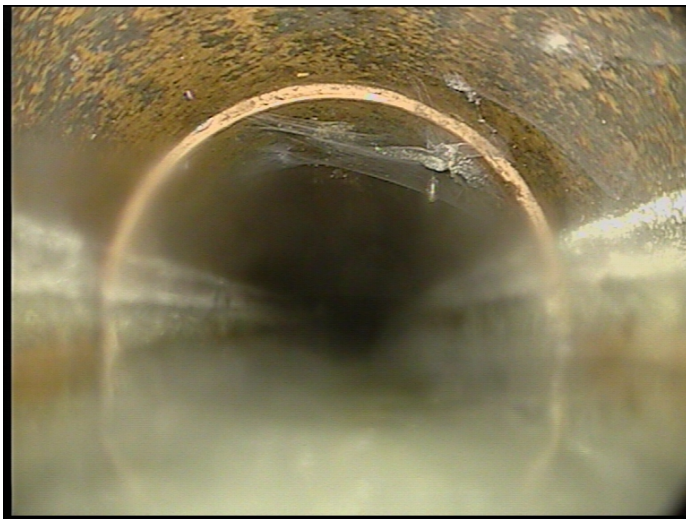
Code:	MWL
Description:	Water Level
Distance (ft):	19.6
Structural Grade:	0
O&M Grade:	0
Clock Start/From:	
Clock To:	
1st Value:	
2nd Value:	
Value Percent:	15.000
Continuous Index:	
Within 8" of Joint:	NO
Remarks:

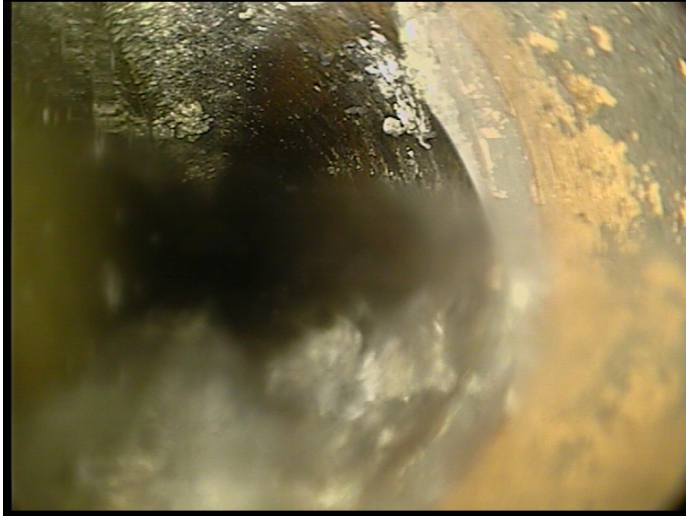
Code:	TF
Description:	Tap Factory
Distance (ft):	27.4
Structural Grade:	0
O&M Grade:	0
Clock Start/From:	9
Clock To:	
1st Value:	6.000
2nd Value:	
Value Percent:	
Continuous Index:	
Within 8" of Joint:	NO
Remarks:

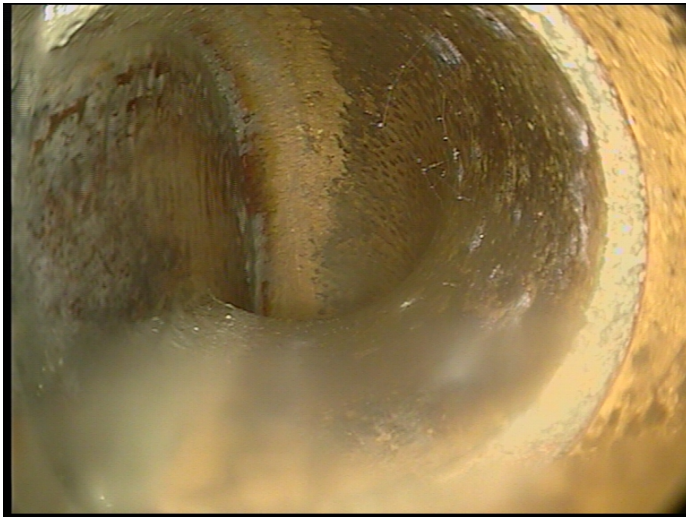
Code:	TF
Description:	Tap Factory
Distance (ft):	89.3
Structural Grade:	0
O&M Grade:	0
Clock Start/From:	9
Clock To:	
1st Value:	6.000
2nd Value:	
Value Percent:	
Continuous Index:	
Within 8" of Joint:	NO
Remarks:

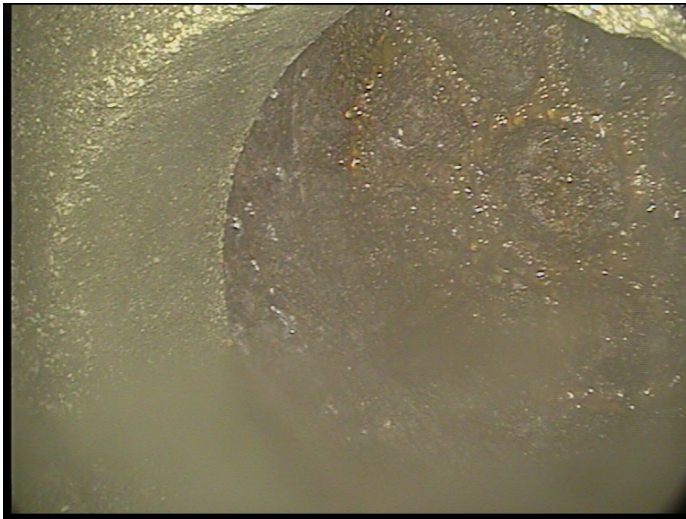
Code:	AMH
Description:	Manhole
Distance (ft):	134.8
Structural Grade:	0
O&M Grade:	0
Clock Start/From:	
Clock To:	
1st Value:	
2nd Value:	
Value Percent:	
Continuous Index:	
Within 8" of Joint:	NO
Remarks:	M-604-037
