Profile/Photo Observation Report

Street:	Off Lake Park Avenue	Flow Control:	
City:	Hobart, IN	Year Renewed:	
Location:	Parking Lot	Tape/Media #:	884
Purpose:	Routine Assessment	Dia/Height:	8"
Use:	Sanitary	Material:	VCP
Drain Area:		Lining:	
Category:	NA		
Comment:

Location Details:		Direction of Survey:	Upstream
US MH:	M-604-39	DS MH:	M-604-37
		Total Length Surveyed (ft):	293.6

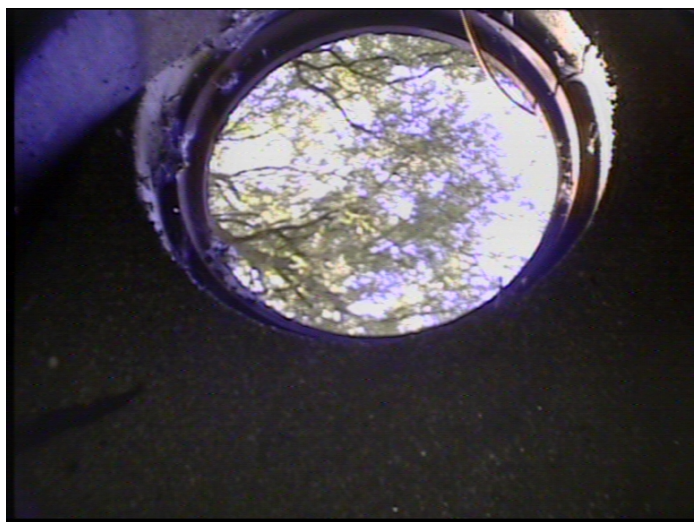
Code: **AMH**
 Description: **Manhole**

Distance (ft): **.0**
 Structural Grade: **0**
 O&M Grade: **0**
 Clock Start/From:
 Clock To:
 1st Value:
 2nd Value:
 Value Percent:
 Continuous Index:
 Within 8" of Joint: **NO**
 Remarks: **M-604-37**

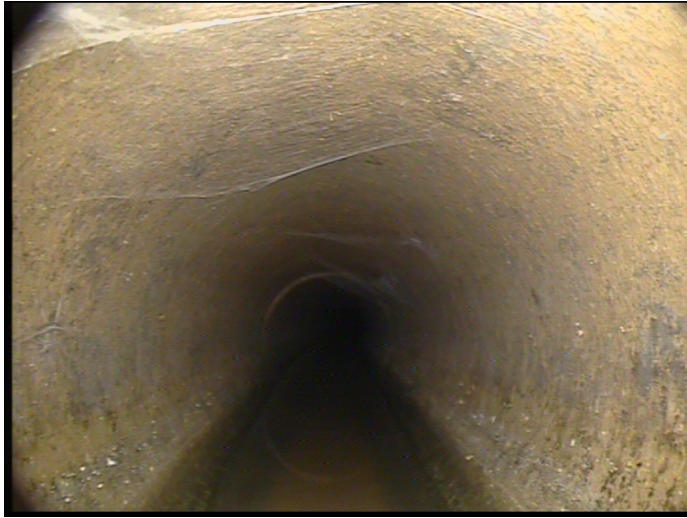
Code:	MWL
Description:	Water Level
Distance (ft):	.0
Structural Grade:	0
O&M Grade:	0
Clock Start/From:	
Clock To:	
1st Value:	
2nd Value:	
Value Percent:	5.000
Continuous Index:	
Within 8" of Joint:	NO
Remarks:

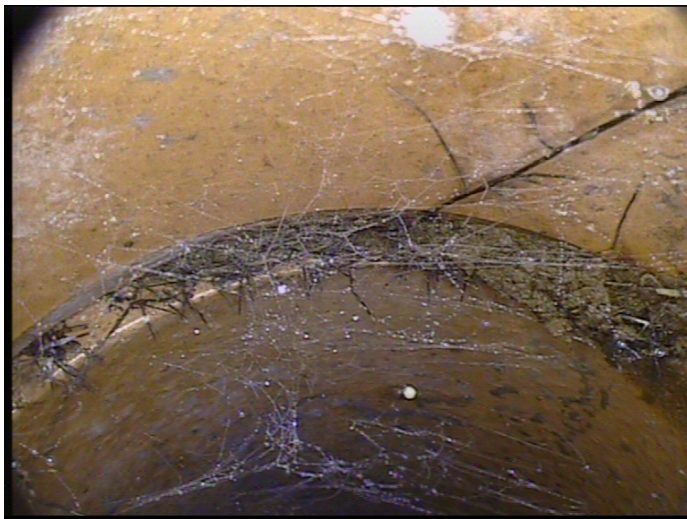
Code:	RFJ
Description:	Roots Fine Joint
Distance (ft):	109.3
Structural Grade:	0
O&M Grade:	1
Clock Start/From:	12
Clock To:	4
1st Value:	
2nd Value:	
Value Percent:	
Continuous Index:	
Within 8" of Joint:	YES
Remarks:

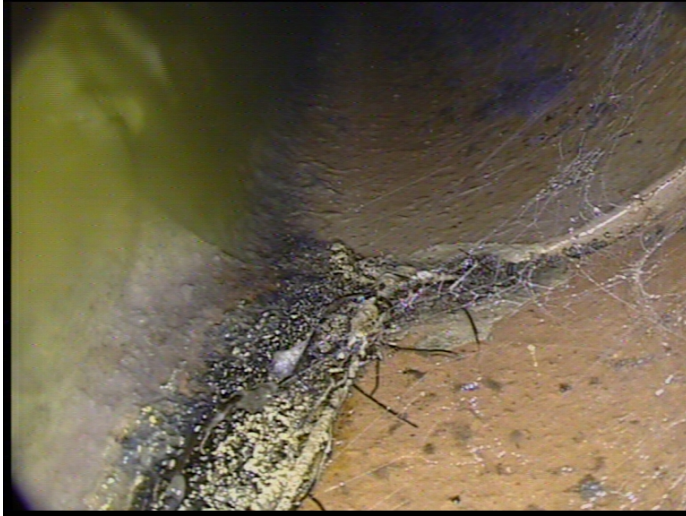
Code: **RFJ**
Description: **Roots Fine Joint**

Distance (ft): **118.5**
Structural Grade: **0**
O&M Grade: **1**
Clock Start/From: **3**
Clock To: **5**
1st Value:
2nd Value:
Value Percent:
Continuous Index:
Within 8" of Joint: **YES**
Remarks:

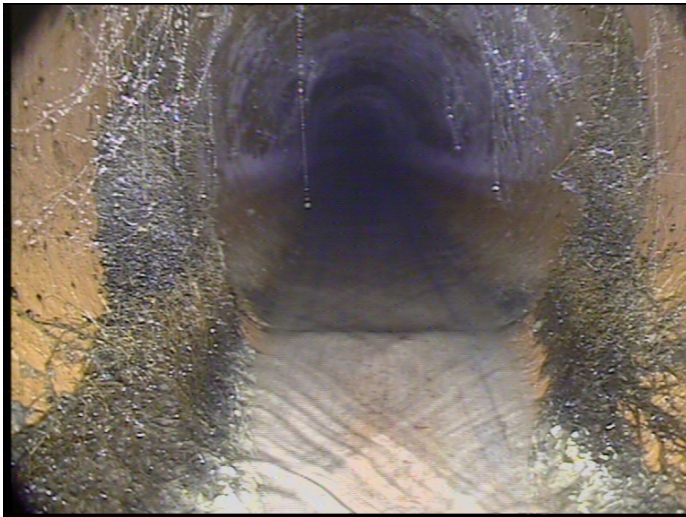
Code: **RMJ**
Description: **Roots Medium Joint**

Distance (ft): **152.9**
Structural Grade: **0**
O&M Grade: **3**
Clock Start/From: **7**
Clock To: **5**
1st Value:
2nd Value:
Value Percent: **5.000**
Continuous Index:
Within 8" of Joint: **YES**
Remarks:

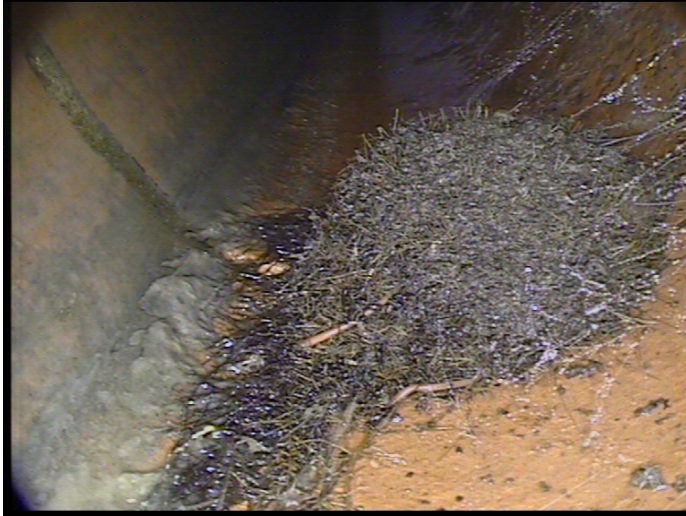
Code:	RMJ
Description:	Roots Medium Joint
Distance (ft):	163.5
Structural Grade:	0
O&M Grade:	3
Clock Start/From:	3
Clock To:	5
1st Value:	
2nd Value:	
Value Percent:	5.000
Continuous Index:	
Within 8" of Joint:	YES
Remarks:

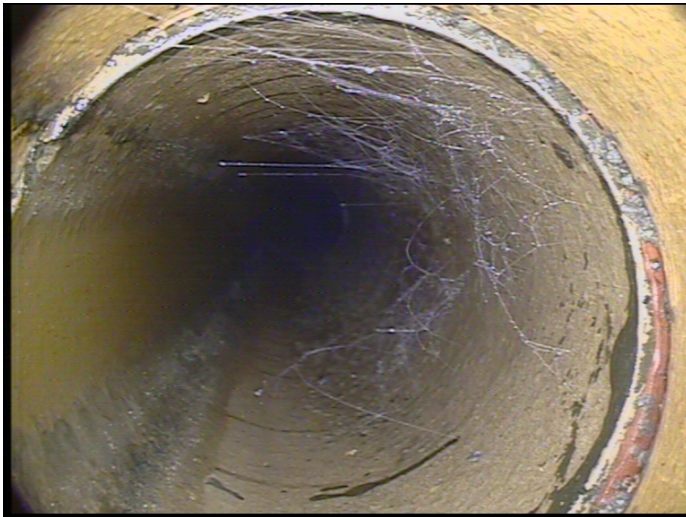
Code:	TF
Description:	Tap Factory
Distance (ft):	180.9
Structural Grade:	0
O&M Grade:	0
Clock Start/From:	9
Clock To:	
1st Value:	4.000
2nd Value:	
Value Percent:	
Continuous Index:	
Within 8" of Joint:	NO
Remarks:

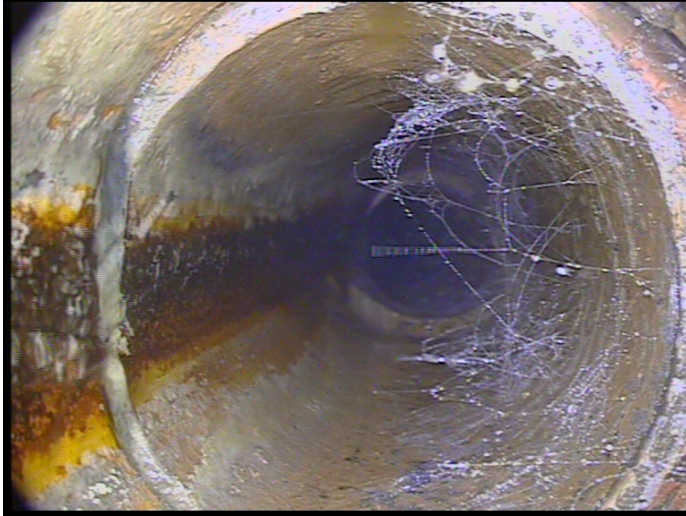
Code: **TF**
Description: **Tap Factory**

Distance (ft): **243.2**
Structural Grade: **0**
O&M Grade: **0**
Clock Start/From: **9**
Clock To:
1st Value: **4.000**
2nd Value:
Value Percent:
Continuous Index:
Within 8" of Joint: **NO**
Remarks:

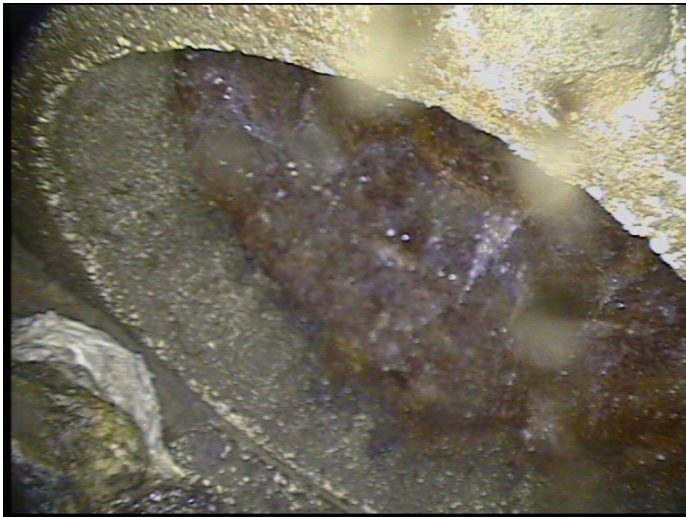
Code: **AMH**
Description: **Manhole**

Distance (ft): **293.6**
Structural Grade: **0**
O&M Grade: **0**
Clock Start/From:
Clock To:
1st Value:
2nd Value:
Value Percent:
Continuous Index:
Within 8" of Joint: **NO**
Remarks: **M-604-39**
