Profile/Photo Observation Report

Date:	04/23/2018	Weather:		Coding:	PACP 6.0
Pipe Length (ft):	358.2	Owner:	NA	Pre Clean:	Not Known
P.O.#:		Surveyor:	Jen Costello	PSR:	P-604-041-030
Customer:		Clean Date:	01/01/1900	Shape:	C

Street:	Summerlin	Flow Control:	Not Controlled
City:	Hobart, IN	Year Renewed:	
Location:	Light Highway	Tape/Media #:	
Purpose:	Not Known	Dia/Height:	8"
Use:	Sanitary	Material:	PVC
Drain Area:	NA	Lining:	
Category:	NA		
Comment:

Location Details:		Direction of Survey:	Downstream
US MH:	M-604-041	DS MH:	M-604-030
		Total Length Surveyed (ft):	353.7

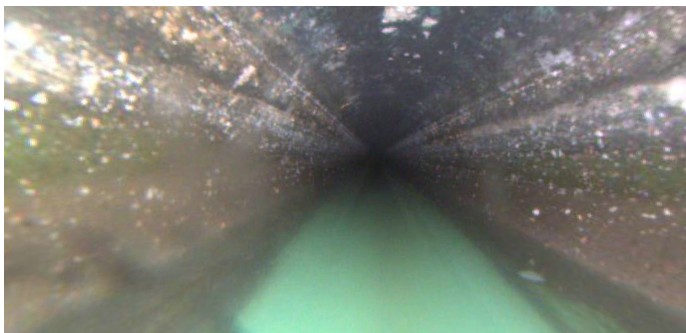
Code: **AMH**
Description: **Manhole**

Distance (ft): **.0**
Structural Grade: **0**
O&M Grade: **0**
Clock Start/From:
Clock To:
1st Value:
2nd Value:
Value Percent:
Continuous Index:
Within 8" of Joint: **NO**
Remarks: **M-604-041**

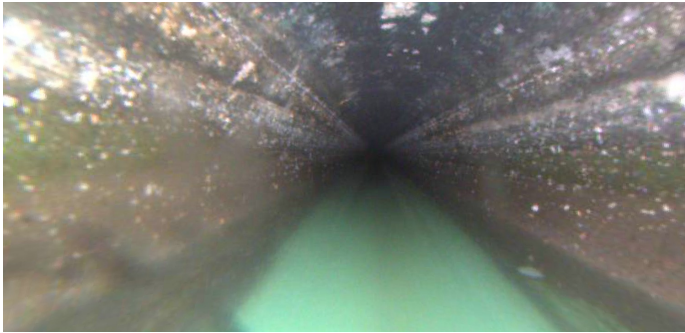
Code:	MWL
Description:	Water Level

Distance (ft):	.0
Structural Grade:	0
O&M Grade:	0
Clock Start/From:	
Clock To:	
1st Value:	
2nd Value:	
Value Percent:	20.000
Continuous Index:	
Within 8" of Joint:	NO
Remarks:

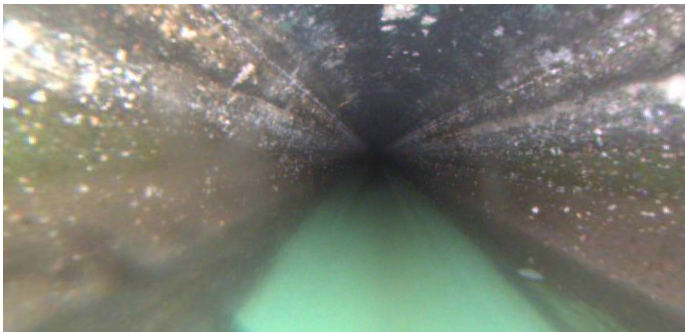
Code:	DAGS
Description:	Deposits Attached Grease

Distance (ft):	.0
Structural Grade:	0
O&M Grade:	2
Clock Start/From:	8
Clock To:	4
1st Value:	
2nd Value:	
Value Percent:	5.000
Continuous Index:	S01
Within 8" of Joint:	NO
Remarks:

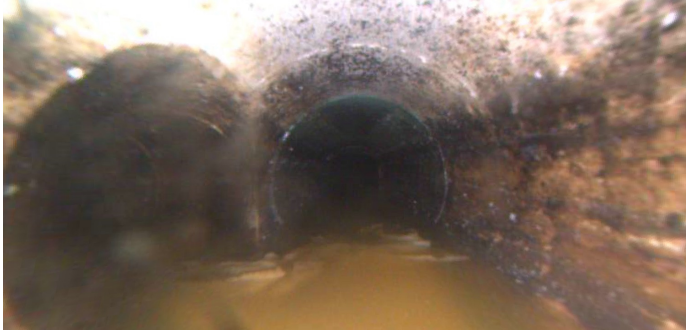
Code: **TFA**
Description: **Tap Factory Active**

Distance (ft): **44.7**
Structural Grade: **0**
O&M Grade: **0**
Clock Start/From: **9**
Clock To:
1st Value: **4.000**
2nd Value:
Value Percent:
Continuous Index:
Within 8" of Joint:
Remarks:

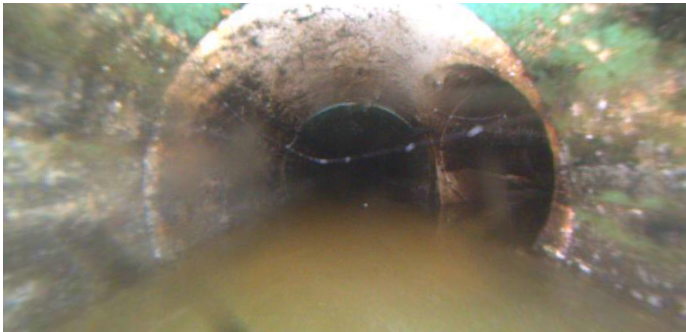
Code: **TFA**
Description: **Tap Factory Active**

Distance (ft): **47.7**
Structural Grade: **0**
O&M Grade: **0**
Clock Start/From: **3**
Clock To:
1st Value: **4.000**
2nd Value:
Value Percent:
Continuous Index:
Within 8" of Joint:
Remarks:

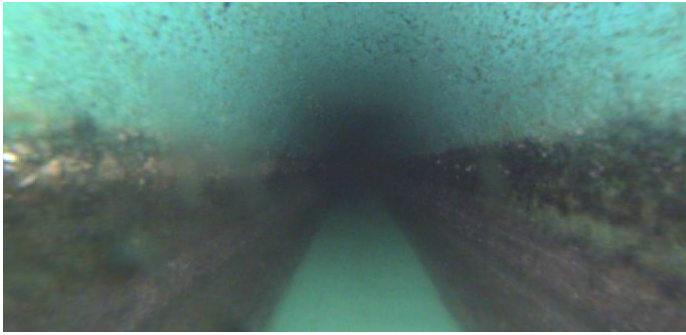
Code: **MWL**
Description: **Water Level**

Distance (ft): **95.3**
Structural Grade: **0**
O&M Grade: **0**
Clock Start/From:
Clock To:
1st Value:
2nd Value:
Value Percent: **5.000**
Continuous Index:
Within 8" of Joint: **NO**
Remarks:

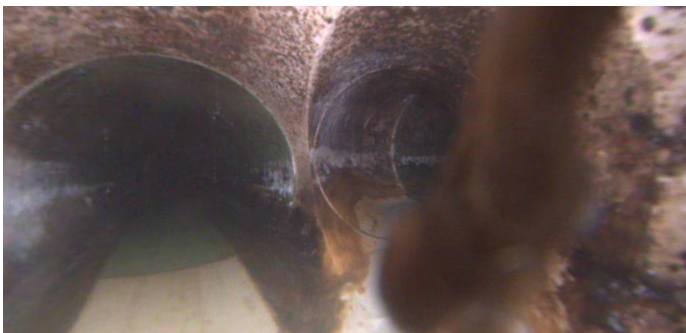
Code: **TFA**
Description: **Tap Factory Active**

Distance (ft): **131.4**
Structural Grade: **0**
O&M Grade: **0**
Clock Start/From: **3**
Clock To:
1st Value: **4.000**
2nd Value:
Value Percent:
Continuous Index:
Within 8" of Joint:
Remarks:

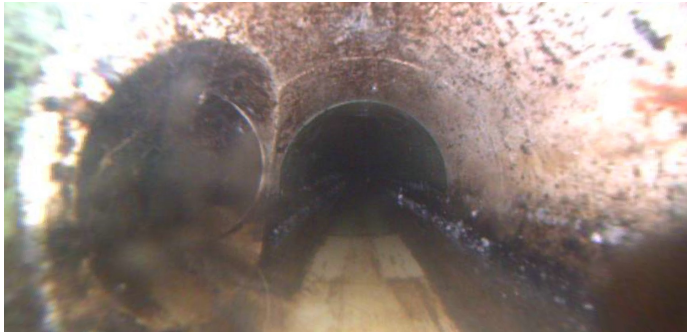
Code: **TFA**
Description: **Tap Factory Active**

Distance (ft): **135.9**
Structural Grade: **0**
O&M Grade: **0**
Clock Start/From: **9**
Clock To:
1st Value: **4.000**
2nd Value:
Value Percent:
Continuous Index:
Within 8" of Joint:
Remarks:

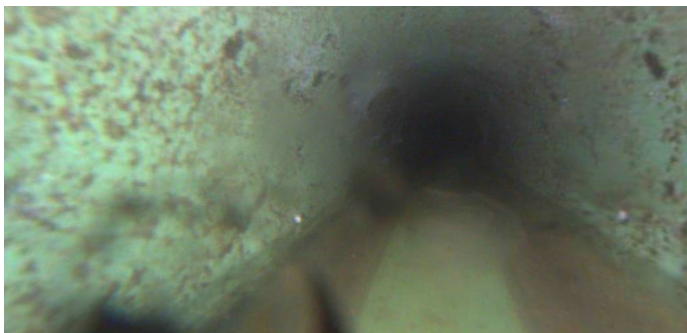
Code: **DAGS**
Description: **Deposits Attached Grease**

Distance (ft): **182.6**
Structural Grade: **0**
O&M Grade: **2**
Clock Start/From: **8**
Clock To: **4**
1st Value:
2nd Value:
Value Percent: **5.000**
Continuous Index: **F01**
Within 8" of Joint: **NO**
Remarks:

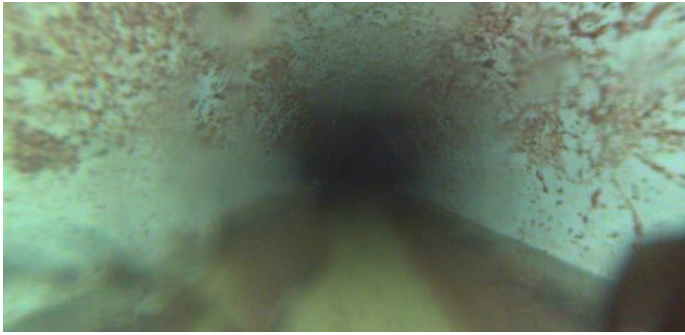
Code: **MWL**
Description: **Water Level**

Distance (ft): **192.1**
Structural Grade: **0**
O&M Grade: **0**
Clock Start/From:
Clock To:
1st Value:
2nd Value:
Value Percent: **30.000**
Continuous Index:
Within 8" of Joint: **NO**
Remarks:

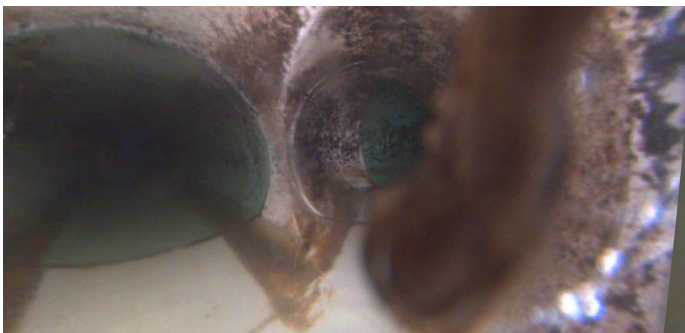
Code: **TFA**
Description: **Tap Factory Active**

Distance (ft): **202.0**
Structural Grade: **0**
O&M Grade: **0**
Clock Start/From: **3**
Clock To:
1st Value: **4.000**
2nd Value:
Value Percent:
Continuous Index:
Within 8" of Joint:
Remarks:

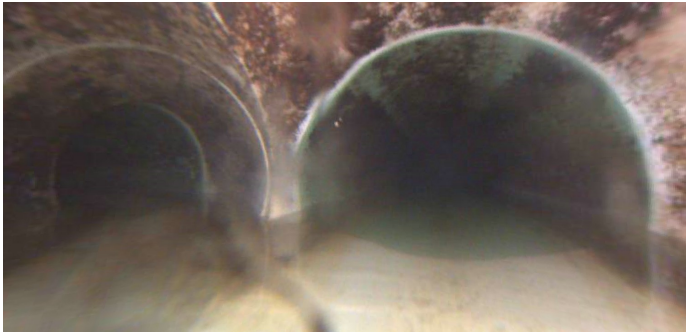
Code: **TFA**
Description: **Tap Factory Active**

Distance (ft): **207.0**
Structural Grade: **0**
O&M Grade: **0**
Clock Start/From: **9**
Clock To:
1st Value: **4.000**
2nd Value:
Value Percent:
Continuous Index:
Within 8" of Joint:
Remarks:

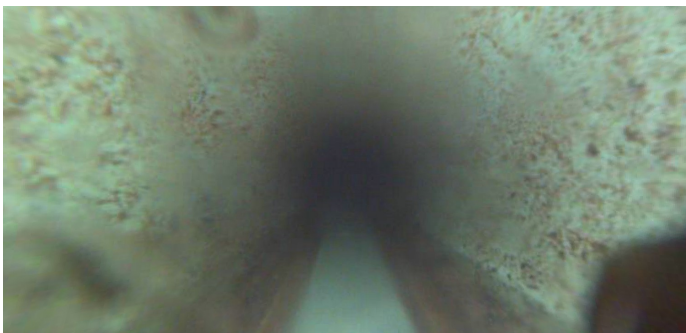
Code: **MWL**
Description: **Water Level**

Distance (ft): **230.6**
Structural Grade: **0**
O&M Grade: **0**
Clock Start/From:
Clock To:
1st Value:
2nd Value:
Value Percent: **5.000**
Continuous Index:
Within 8" of Joint: **NO**
Remarks:

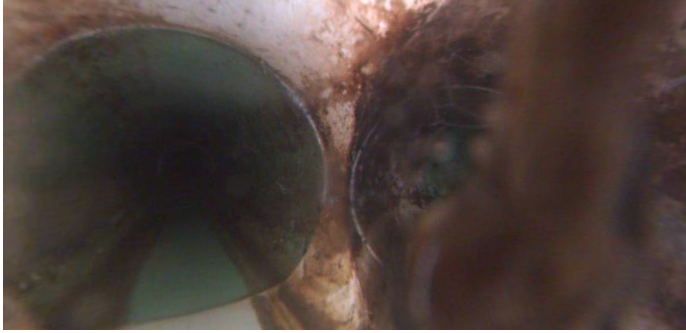
Code: **TF**
Description: **Tap Factory**

Distance (ft): **285.6**
Structural Grade: **0**
O&M Grade: **0**
Clock Start/From: **3**
Clock To:
1st Value: **4.000**
2nd Value:
Value Percent:
Continuous Index:
Within 8" of Joint:
Remarks:

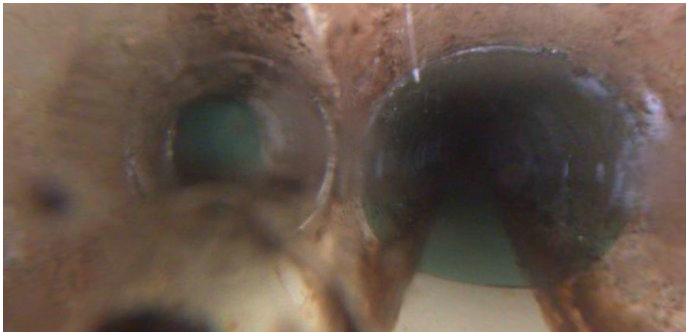
Code: **TFA**
Description: **Tap Factory Active**

Distance (ft): **290.0**
Structural Grade: **0**
O&M Grade: **0**
Clock Start/From: **9**
Clock To:
1st Value: **4.000**
2nd Value:
Value Percent:
Continuous Index:
Within 8" of Joint:
Remarks:

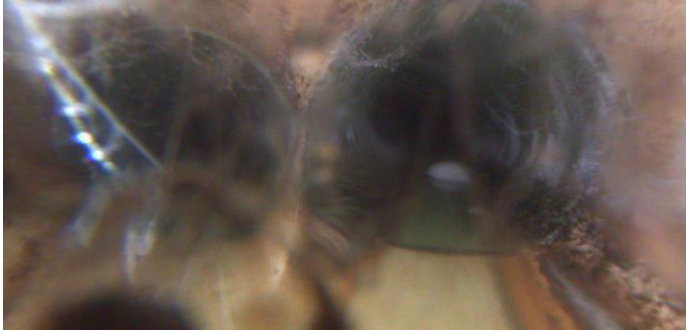
Code: **TFA**
Description: **Tap Factory Active**

Distance (ft): **332.0**
Structural Grade: **0**
O&M Grade: **0**
Clock Start/From: **9**
Clock To:
1st Value: **4.000**
2nd Value:
Value Percent:
Continuous Index:
Within 8" of Joint:
Remarks:

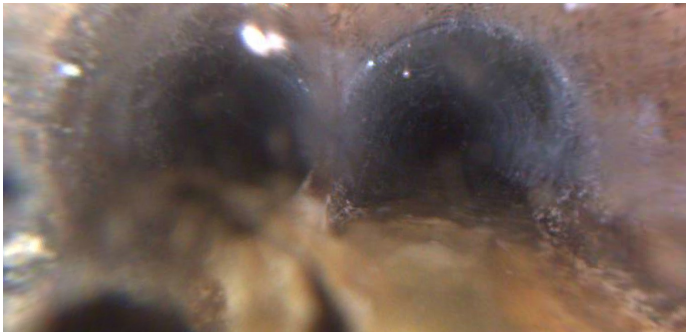
Code: **TFA**
Description: **Tap Factory Active**

Distance (ft): **338.0**
Structural Grade: **0**
O&M Grade: **0**
Clock Start/From: **9**
Clock To:
1st Value: **4.000**
2nd Value:
Value Percent:
Continuous Index:
Within 8" of Joint:
Remarks:

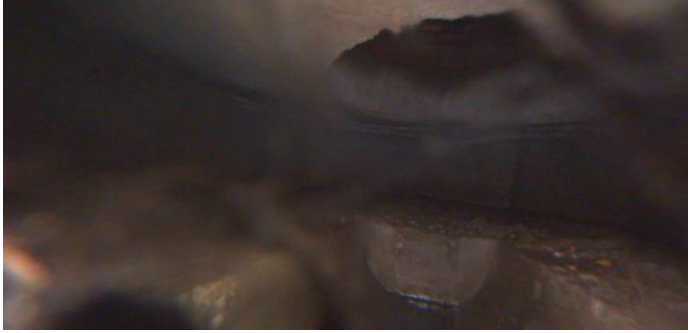
Code:	AMH
Description:	Manhole
Distance (ft):	353.7
Structural Grade:	0
O&M Grade:	0
Clock Start/From:	
Clock To:	
1st Value:	
2nd Value:	
Value Percent:	
Continuous Index:	
Within 8" of Joint:	NO
Remarks:	M-604-030
