## Profile/Photo Observation Report

Street:	<b>North Ash Street</b>	Flow Control:	<b>Not Controlled</b>
City:	<b>Hobart, IN</b>	Year Renewed:	
Location:	<b>Light Highway</b>	Tape/Media #:	<b>DEP238</b>
Purpose:	<b>Routine Assessment</b>	Dia/Height:	<b>15"</b>
Use:	<b>Sanitary</b>	Material:	<b>VCP</b>
Drain Area:		Lining:	
Category:	<b>NA</b>		
Comment:	<b>YES501824 Submittal 2</b>		
Location Details:		Direction of Survey:	<b>Upstream</b>
US MH:	<b>M-604-043</b>	DS MH:	<b>M-604-044</b>
		Total Length Surveyed (ft):	<b>26.8</b>

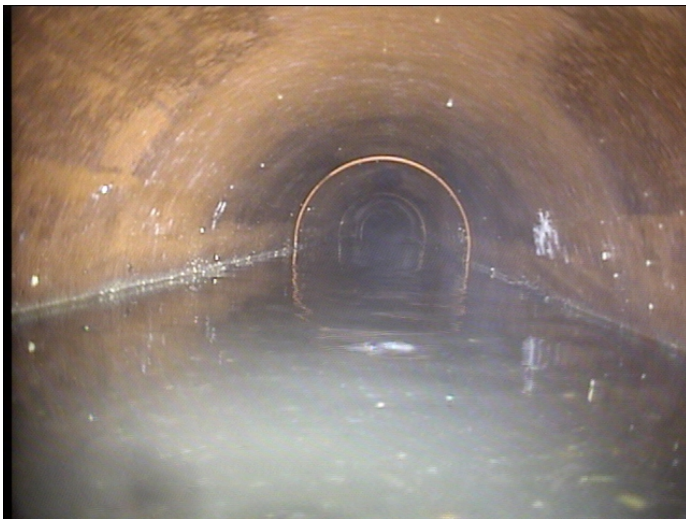
Code: **DSF**  
Description: **Deposits Settled Fine**

Distance (ft): **3.5**  
Structural Grade: **0**  
O&M Grade: **3**  
Clock Start/From: **4**  
Clock To: **8**  
1st Value:  
2nd Value:  
Value Percent: **15.000**  
Continuous Index: **S01**  
Within 8" of Joint: **NO**  
Remarks:

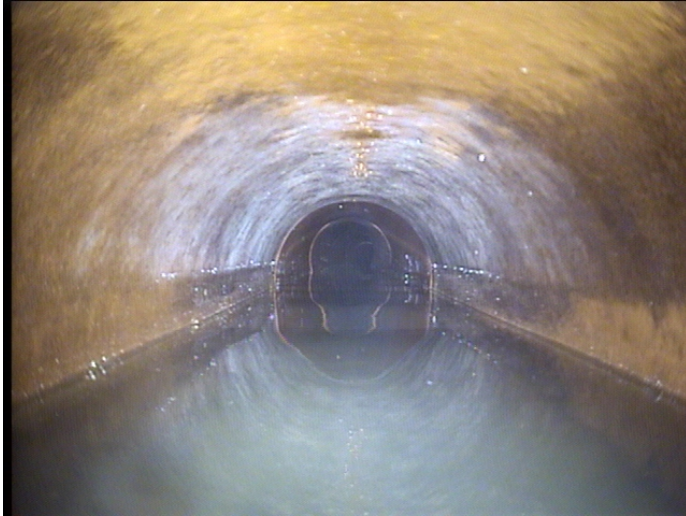
Code: **DSF**  
Description: **Deposits Settled Fine**

Distance (ft): **26.8**  
Structural Grade: **0**  
O&M Grade: **3**  
Clock Start/From: **4**  
Clock To: **8**  
1st Value:  
2nd Value:  
Value Percent: **15.000**  
Continuous Index: **F01**  
Within 8" of Joint: **NO**  
Remarks:

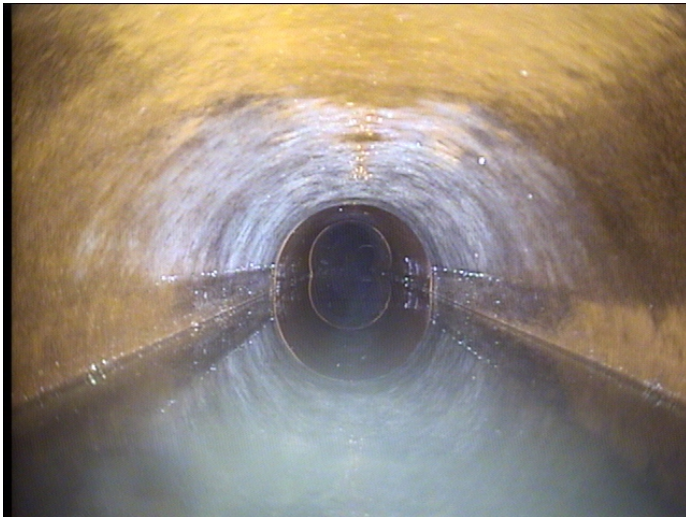
Code: **MSA**  
Description: **Abandoned Survey**

Distance (ft): **26.8**  
Structural Grade: **0**  
O&M Grade: **0**  
Clock Start/From:  
Clock To:  
1st Value:  
2nd Value:  
Value Percent:  
Continuous Index:  
Within 8" of Joint: **NO**  
Remarks: **Heavy sediment**
