Profile/Photo Observation Report

| Street: | N ASH ST | Flow Control: | Not Controlled |
| Use: | Sanitary | Material: | PVC |

| US MH: | M-604-050 | DS MH: | M-604-042 |

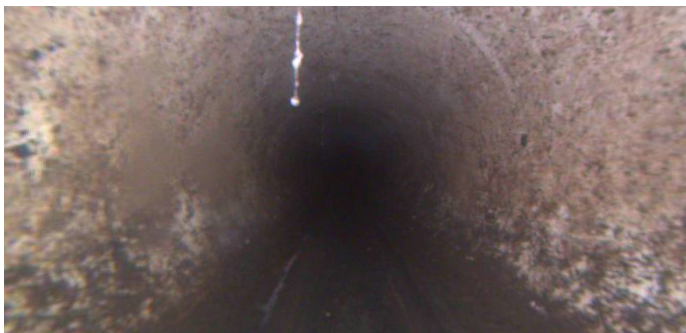
Code: **AMH**
Description: **Manhole**

Distance (ft): **.0**
Structural Grade: **0**
O&M Grade: **0**
Clock Start/From:
Clock To:
1st Value:
2nd Value:
Value Percent:
Continuous Index:
Within 8" of Joint: **NO**
Remarks: **M-604-050**

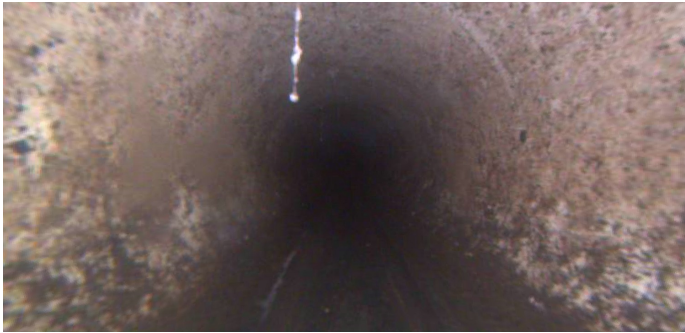
| Code: | MWL |
| Description: | Water Level |

| Value Percent: | 5.000 |

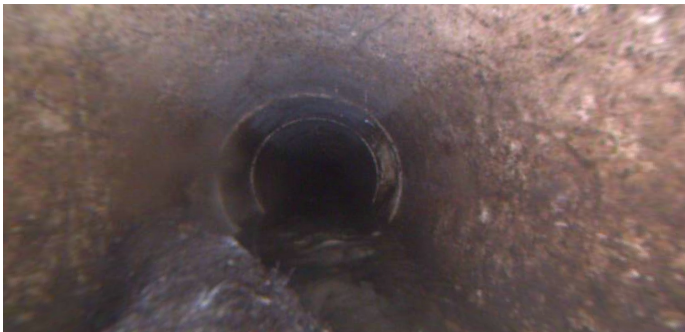
| Code: | OBZ |
| Description: | Obstacle Other |

| Distance (ft): | 32.8 |
| O&M Grade: | 2 |
| Clock Start/From: | 6 |
| Clock To: | 8 |
| Value Percent: | 10.000 |
| Remarks: | misc |

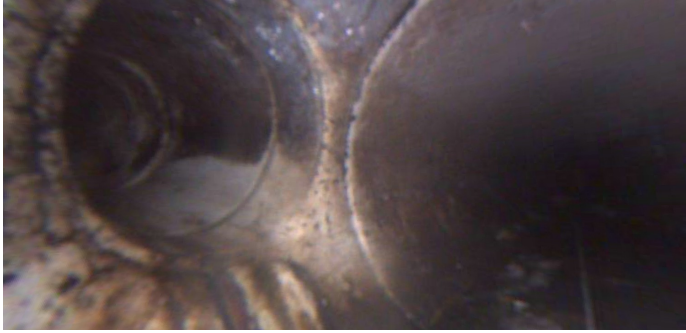
Code: **TFA**
Description: **Tap Factory Active**

Distance (ft): **35.1**
Structural Grade: **0**
O&M Grade: **0**
Clock Start/From: **3**
Clock To:
1st Value: **4.000**
2nd Value:
Value Percent:
Continuous Index:
Within 8" of Joint:
Remarks:

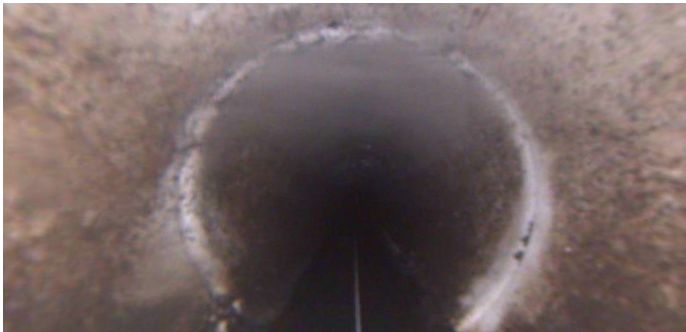
Code: **MGO**
Description: **General Observation**

Distance (ft): **48.9**
Structural Grade: **0**
O&M Grade: **0**
Clock Start/From:
Clock To:
1st Value:
2nd Value:
Value Percent:
Continuous Index:
Within 8" of Joint: **NO**
Remarks: **rear camera**

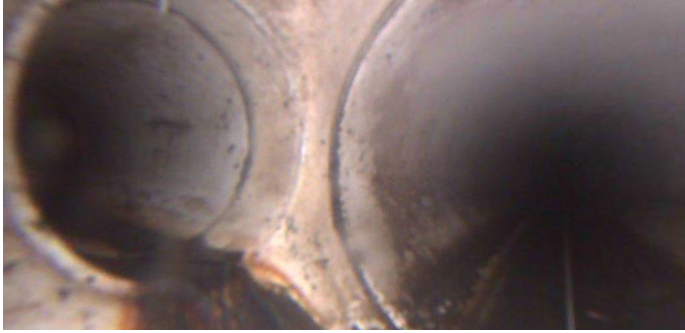
Code: **TFA**
Description: **Tap Factory Active**

Distance (ft): **84.5**
Structural Grade: **0**
O&M Grade: **0**
Clock Start/From: **3**
Clock To:
1st Value: **4.000**
2nd Value:
Value Percent:
Continuous Index:
Within 8" of Joint:
Remarks:

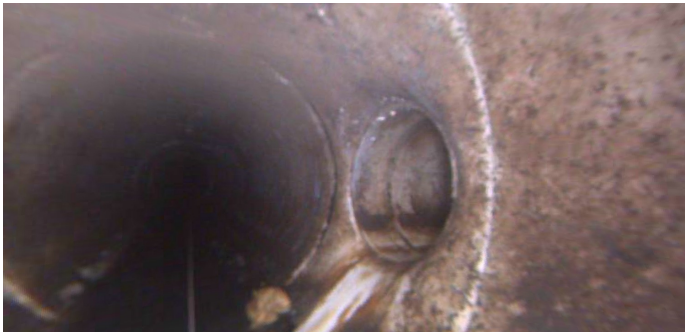
Code: **TFA**
Description: **Tap Factory Active**

Distance (ft): **90.7**
Structural Grade: **0**
O&M Grade: **0**
Clock Start/From: **9**
Clock To:
1st Value: **4.000**
2nd Value:
Value Percent:
Continuous Index:
Within 8" of Joint:
Remarks:

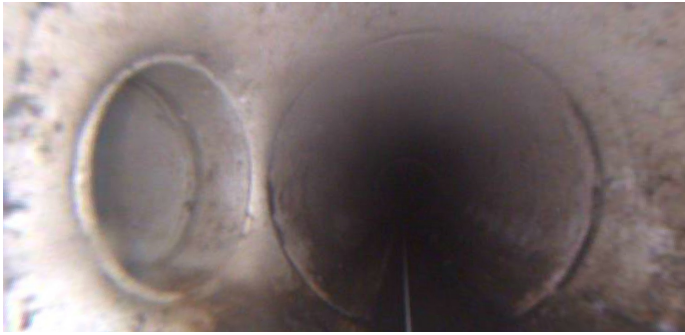
Code: **TF**
Description: **Tap Factory**

Distance (ft): **134.2**
Structural Grade: **0**
O&M Grade: **0**
Clock Start/From: **3**
Clock To:
1st Value: **4.000**
2nd Value:
Value Percent:
Continuous Index:
Within 8" of Joint:
Remarks:

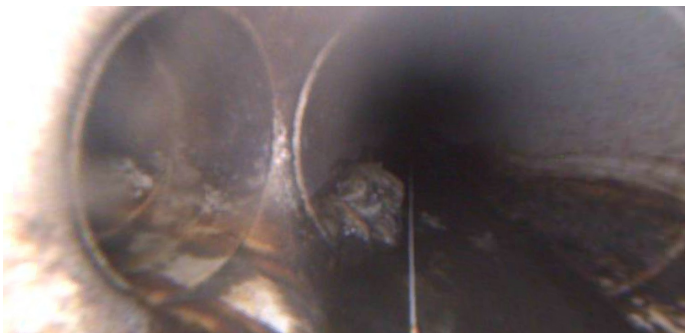
Code: **TF**
Description: **Tap Factory**

Distance (ft): **171.3**
Structural Grade: **0**
O&M Grade: **0**
Clock Start/From: **3**
Clock To:
1st Value: **4.000**
2nd Value:
Value Percent:
Continuous Index:
Within 8" of Joint:
Remarks:

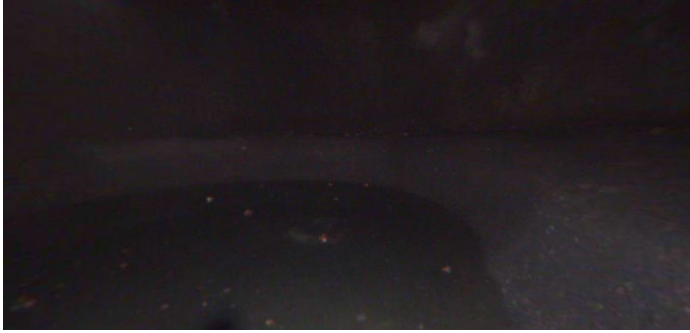
| Code: | AMH |
| Description: | Manhole |
| Distance (ft): | 173.4 |
| Remarks: | M-604-042 |
