Profile/Photo Observation Report

Street:	ALLEY BETWEEN N CONNECTICUT ST	Flow Control:	Not Controlled
City:	Hobart, IN	Year Renewed:	
Location:	Light Highway	Tape/Media #:	
Purpose:	Not Known	Dia/Height:	12"
Use:	Sanitary	Material:	PVC
Drain Area:	NA	Lining:	
Category:	NA		
Comment:

Location Details:		Direction of Survey:	Downstream
US MH:	M-604-050	DS MH:	M-604-051
		Total Length Surveyed (ft):	221.9

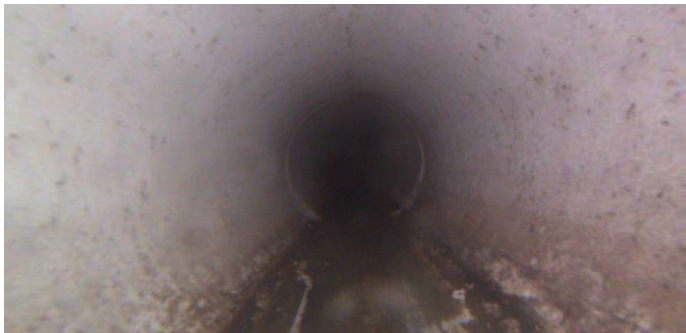
The diagram shows a vertical pipe section with a table of observations and a camera direction indicator.

Camera Direction: Indicated by a red arrow pointing downwards, labeled "Camera Direction".

Position	Code	Observation	Video (sec)	Grade
M-604-050				
.0	AMH	Manhole	10	NA
.0	MWL	Water Level	21	NA
16.5	TF	Tap Factory	68	NA
57.5	TF	Tap Factory	163	NA
60.4	TFA	Tap Factory Active	181	NA
109.2	TFA	Tap Factory Active	291	NA
158.9	TFA	Tap Factory Active	402	NA
221.9	AMH	Manhole	540	NA
M-604-051

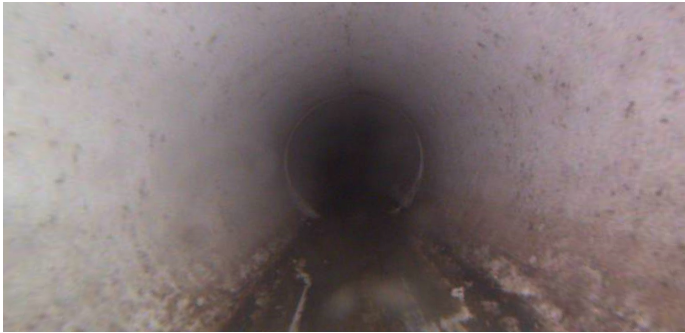
Code:	MWL
Description:	Water Level

Distance (ft):	.0
Structural Grade:	0
O&M Grade:	0
Clock Start/From:	
Clock To:	
1st Value:	
2nd Value:	
Value Percent:	5.000
Continuous Index:	
Within 8" of Joint:	NO
Remarks:

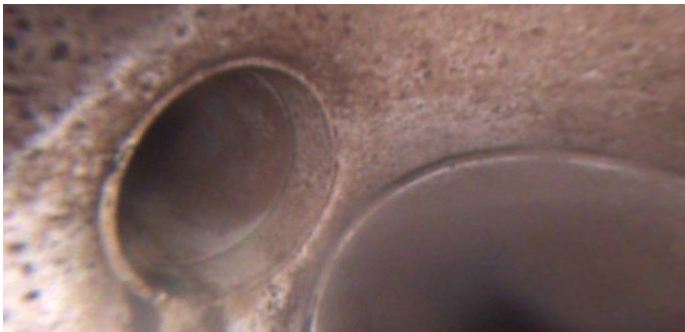
Code:	TF
Description:	Tap Factory

Distance (ft):	16.5
Structural Grade:	0
O&M Grade:	0
Clock Start/From:	2
Clock To:	
1st Value:	4.000
2nd Value:	
Value Percent:	
Continuous Index:	
Within 8" of Joint:	
Remarks:

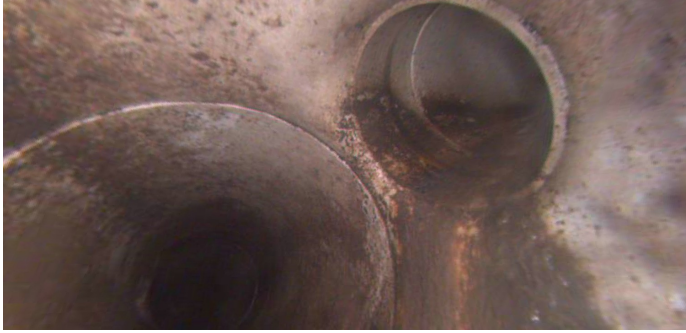
Code: **TF**
Description: **Tap Factory**

Distance (ft): **57.5**
Structural Grade: **0**
O&M Grade: **0**
Clock Start/From: **2**
Clock To:
1st Value: **4.000**
2nd Value:
Value Percent:
Continuous Index:
Within 8" of Joint:
Remarks:

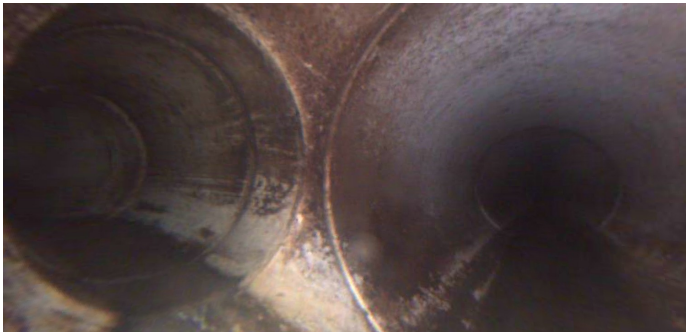
Code: **TFA**
Description: **Tap Factory Active**

Distance (ft): **60.4**
Structural Grade: **0**
O&M Grade: **0**
Clock Start/From: **9**
Clock To:
1st Value: **4.000**
2nd Value:
Value Percent:
Continuous Index:
Within 8" of Joint:
Remarks:

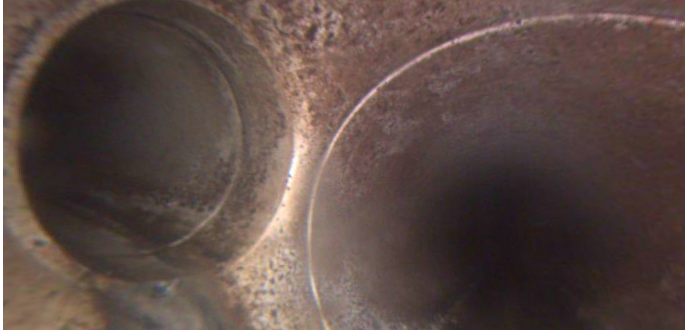
Code: **TFA**
Description: **Tap Factory Active**

Distance (ft): **109.2**
Structural Grade: **0**
O&M Grade: **0**
Clock Start/From: **9**
Clock To:
1st Value: **4.000**
2nd Value:
Value Percent:
Continuous Index:
Within 8" of Joint:
Remarks:

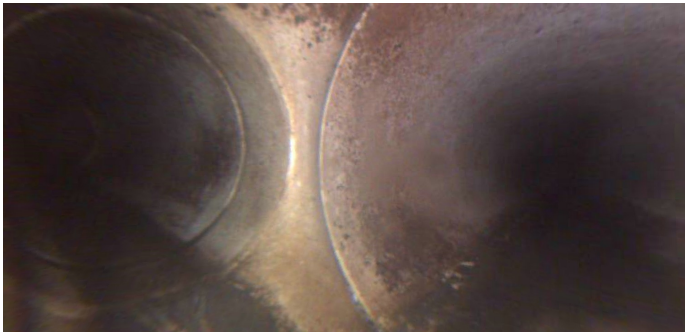
Code: **TFA**
Description: **Tap Factory Active**

Distance (ft): **158.9**
Structural Grade: **0**
O&M Grade: **0**
Clock Start/From: **9**
Clock To:
1st Value: **4.000**
2nd Value:
Value Percent:
Continuous Index:
Within 8" of Joint:
Remarks:

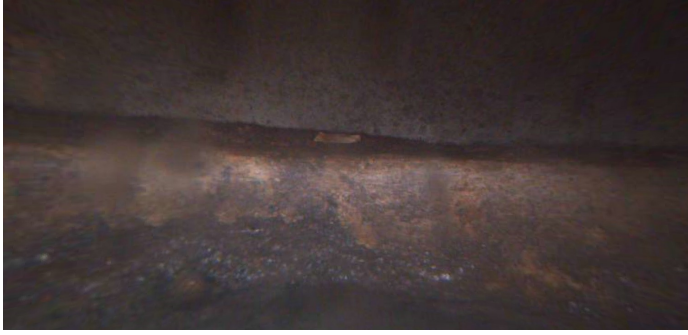
Code:	AMH
Description:	Manhole
Distance (ft):	221.9
Structural Grade:	0
O&M Grade:	0
Clock Start/From:	
Clock To:	
1st Value:	
2nd Value:	
Value Percent:	
Continuous Index:	
Within 8" of Joint:	NO
Remarks:	M-604-051
