Profile/Photo Observation Report

Street:	Summerlin	Flow Control:	Not Controlled
City:	Hobart, IN	Year Renewed:	
Location:	Light Highway	Tape/Media #:	
Purpose:	Not Known	Dia/Height:	12"
Use:	Sanitary	Material:	PVC
Drain Area:	NA	Lining:	
Category:	NA		
Comment:

Location Details:		Direction of Survey:	Downstream
US MH:	M-604-050	DS MH:	M-604-051
		Total Length Surveyed (ft):	221.9

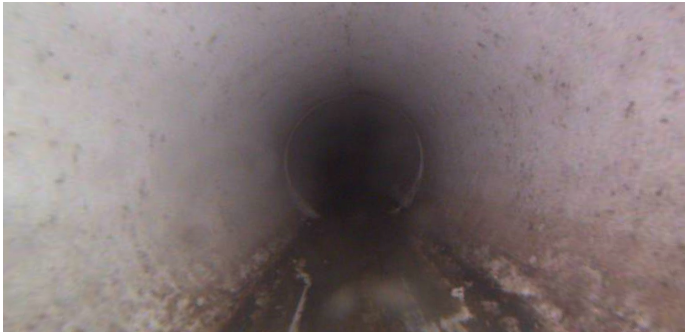
Code:	MWL
Description:	Water Level

Distance (ft):	.0
Structural Grade:	0
O&M Grade:	0
Clock Start/From:	
Clock To:	
1st Value:	
2nd Value:	
Value Percent:	5.000
Continuous Index:	
Within 8" of Joint:	NO
Remarks:

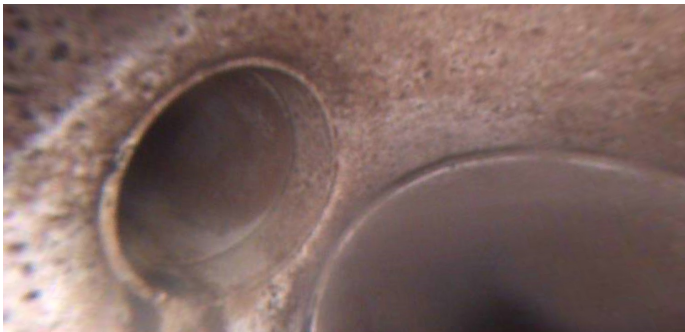
Code:	TF
Description:	Tap Factory

Distance (ft):	16.5
Structural Grade:	0
O&M Grade:	0
Clock Start/From:	2
Clock To:	
1st Value:	4.000
2nd Value:	
Value Percent:	
Continuous Index:	
Within 8" of Joint:	
Remarks:

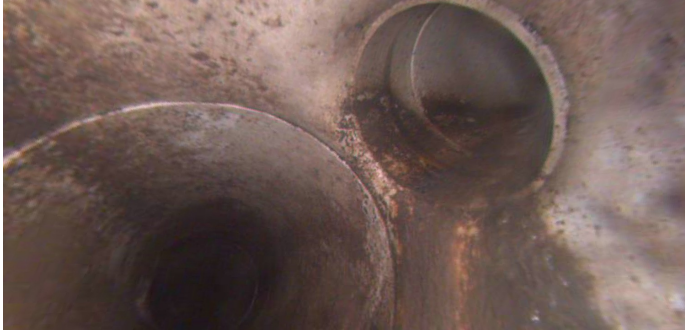
Code: **TF**
Description: **Tap Factory**

Distance (ft): **57.5**
Structural Grade: **0**
O&M Grade: **0**
Clock Start/From: **2**
Clock To:
1st Value: **4.000**
2nd Value:
Value Percent:
Continuous Index:
Within 8" of Joint:
Remarks:

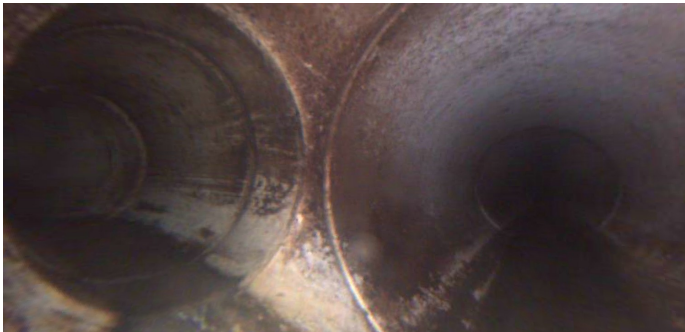
Code: **TFA**
Description: **Tap Factory Active**

Distance (ft): **60.4**
Structural Grade: **0**
O&M Grade: **0**
Clock Start/From: **9**
Clock To:
1st Value: **4.000**
2nd Value:
Value Percent:
Continuous Index:
Within 8" of Joint:
Remarks:

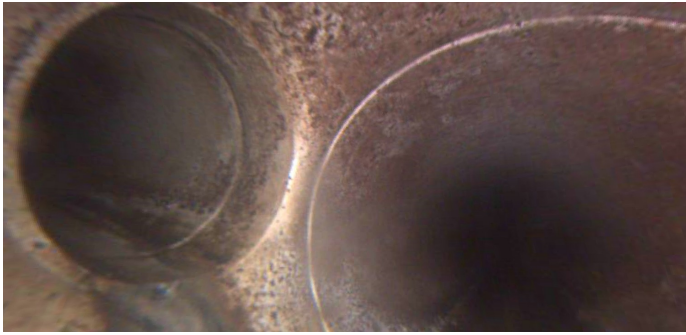
Code: **TFA**
Description: **Tap Factory Active**

Distance (ft): **109.2**
Structural Grade: **0**
O&M Grade: **0**
Clock Start/From: **9**
Clock To:
1st Value: **4.000**
2nd Value:
Value Percent:
Continuous Index:
Within 8" of Joint:
Remarks:

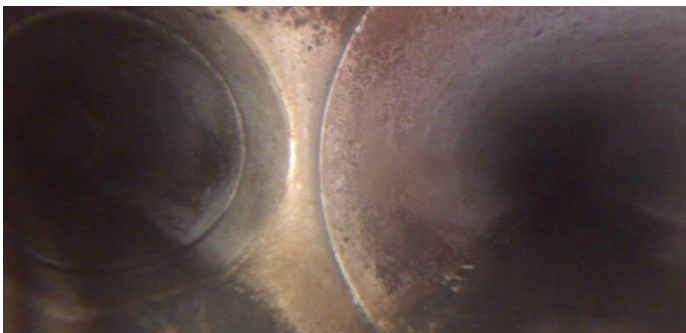
Code: **TFA**
Description: **Tap Factory Active**

Distance (ft): **158.9**
Structural Grade: **0**
O&M Grade: **0**
Clock Start/From: **9**
Clock To:
1st Value: **4.000**
2nd Value:
Value Percent:
Continuous Index:
Within 8" of Joint:
Remarks:

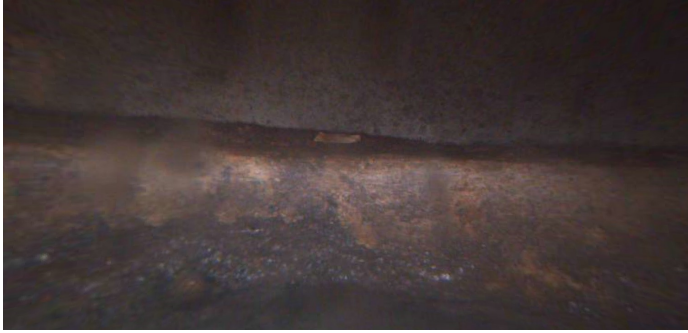
Code:	AMH
Description:	Manhole
Distance (ft):	221.9
Structural Grade:	0
O&M Grade:	0
Clock Start/From:	
Clock To:	
1st Value:	
2nd Value:	
Value Percent:	
Continuous Index:	
Within 8" of Joint:	NO
Remarks:	M-604-051
