Profile/Photo Observation Report

Date:	04/23/2018	Weather:		Coding:	PACP 6.0
Pipe Length (ft):	65.5	Owner:	NA	Pre Clean:	Not Known
P.O.#:		Surveyor:	Jen Costello	PSR:	P-604-052-051
Customer:		Clean Date:	01/01/1900	Shape:	C

Street:	ALLEY BETWEEN N CONNECTICUT ST	Flow Control:	Not Controlled
City:	Hobart, IN	Year Renewed:	
Location:	Light Highway	Tape/Media #:	
Purpose:	Not Known	Dia/Height:	12"
Use:	Sanitary	Material:	PVC
Drain Area:	NA	Lining:	
Category:	NA		
Comment:

Location Details:		Direction of Survey:	Downstream
US MH:	M-604-051	DS MH:	M-604-052
		Total Length Surveyed (ft):	222.0

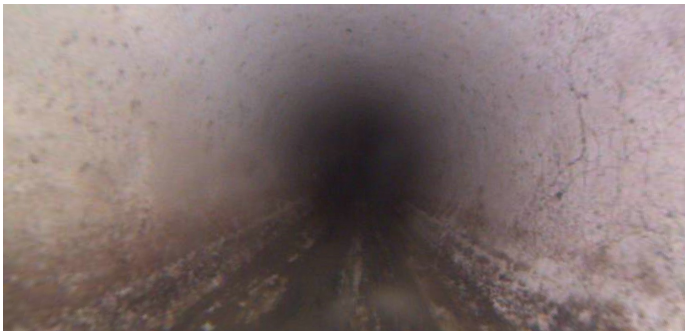
Code: **AMH**
Description: **Manhole**

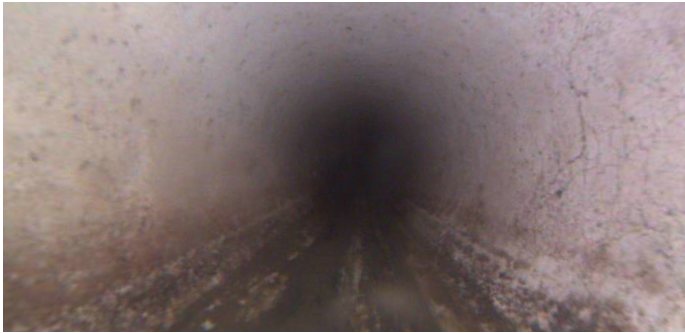
Code:	MWL
Description:	Water Level

Distance (ft):	.0
Structural Grade:	0
O&M Grade:	0
Clock Start/From:	
Clock To:	
1st Value:	
2nd Value:	
Value Percent:	5.000
Continuous Index:	
Within 8" of Joint:	NO
Remarks:

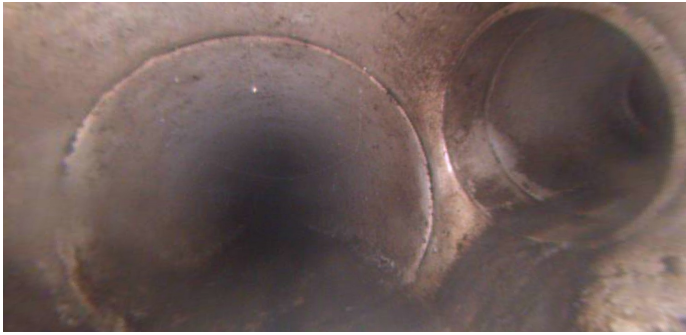
Code: **TFA**
Description: **Tap Factory Active**

Distance (ft): **42.9**
Structural Grade: **0**
O&M Grade: **0**
Clock Start/From: **3**
Clock To:
1st Value: **4.000**
2nd Value:
Value Percent:
Continuous Index:
Within 8" of Joint:
Remarks:

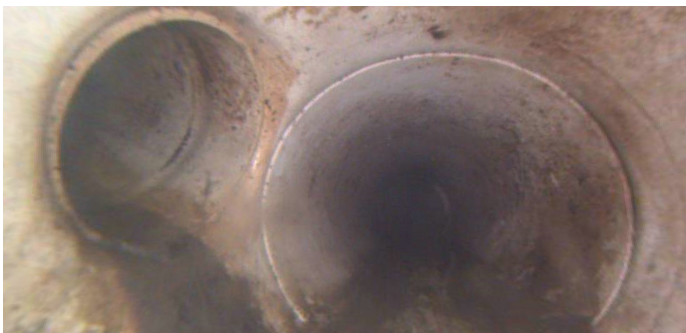
Code: **TF**
Description: **Tap Factory**

Distance (ft): **73.2**
Structural Grade: **0**
O&M Grade: **0**
Clock Start/From: **10**
Clock To:
1st Value: **4.000**
2nd Value:
Value Percent:
Continuous Index:
Within 8" of Joint:
Remarks:

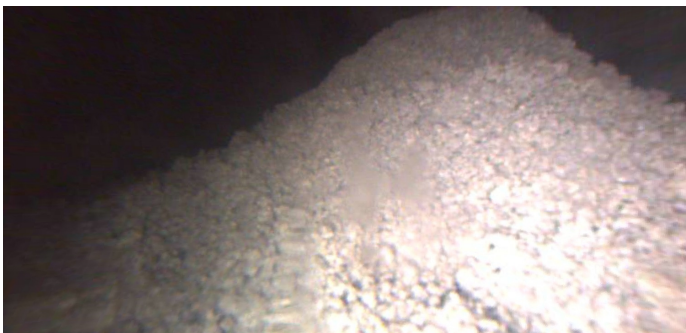
Code: **AMH**
Description: **Manhole**

Distance (ft): **222.0**
Structural Grade: **0**
O&M Grade: **0**
Clock Start/From:
Clock To:
1st Value:
2nd Value:
Value Percent:
Continuous Index:
Within 8" of Joint: **NO**
Remarks: **M-604-052**
