Profile/Photo Observation Report

Date:	04/23/2018	Weather:		Coding:	PACP 6.0
Pipe Length (ft):	65.5	Owner:	NA	Pre Clean:	Not Known
P.O.#:		Surveyor:	Jen Costello	PSR:	P-604-052-051
Customer:		Clean Date:	01/01/1900	Shape:	C

Street:	Summerlin	Flow Control:	Not Controlled
City:	Hobart, IN	Year Renewed:	
Location:	Light Highway	Tape/Media #:	
Purpose:	Not Known	Dia/Height:	12"
Use:	Sanitary	Material:	PVC
Drain Area:	NA	Lining:	
Category:	NA		
Comment:

Location Details:		Direction of Survey:	Downstream
US MH:	M-604-051	DS MH:	M-604-052
		Total Length Surveyed (ft):	222.0

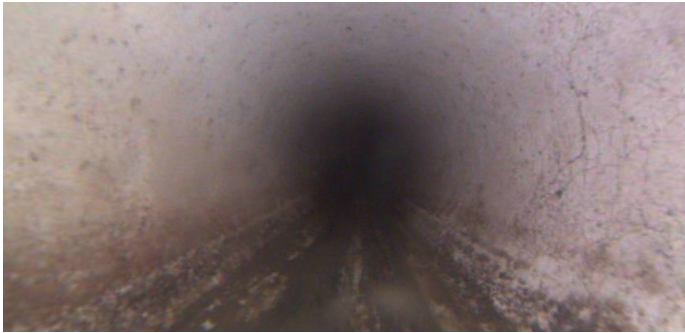
Code:	MWL
Description:	Water Level

Distance (ft):	.0
Structural Grade:	0
O&M Grade:	0
Clock Start/From:	
Clock To:	
1st Value:	
2nd Value:	
Value Percent:	5.000
Continuous Index:	
Within 8" of Joint:	NO
Remarks:

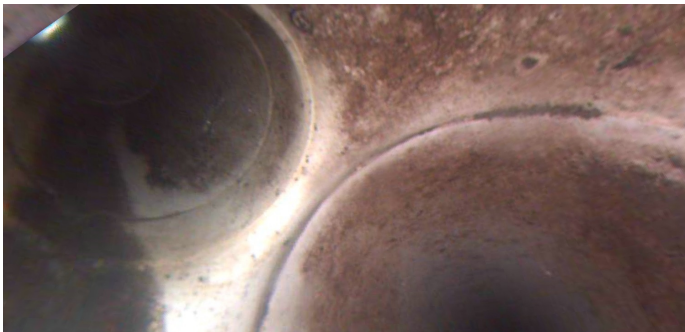
Code:	TF
Description:	Tap Factory

Distance (ft):	20.0
Structural Grade:	0
O&M Grade:	0
Clock Start/From:	10
Clock To:	
1st Value:	4.000
2nd Value:	
Value Percent:	
Continuous Index:	
Within 8" of Joint:	
Remarks:

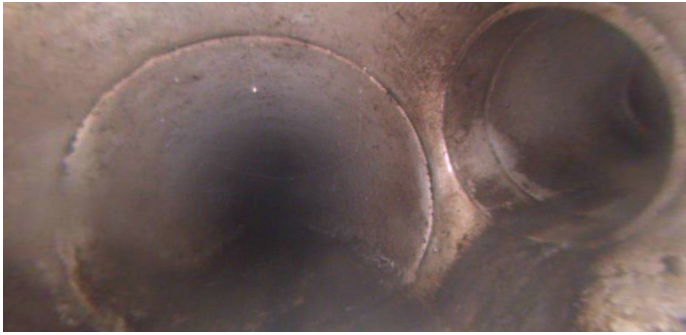
Code: **TFA**
Description: **Tap Factory Active**

Distance (ft): **42.9**
Structural Grade: **0**
O&M Grade: **0**
Clock Start/From: **3**
Clock To:
1st Value: **4.000**
2nd Value:
Value Percent:
Continuous Index:
Within 8" of Joint:
Remarks:

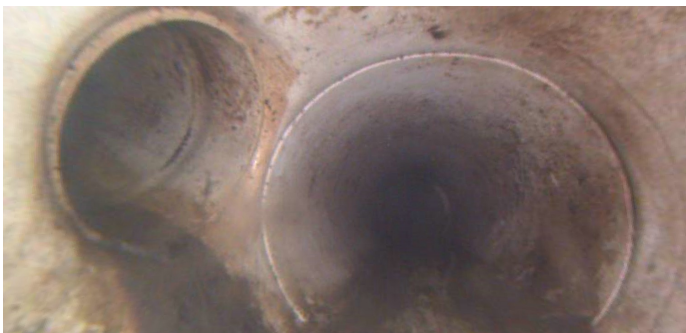
Code: **TF**
Description: **Tap Factory**

Distance (ft): **73.2**
Structural Grade: **0**
O&M Grade: **0**
Clock Start/From: **10**
Clock To:
1st Value: **4.000**
2nd Value:
Value Percent:
Continuous Index:
Within 8" of Joint:
Remarks:

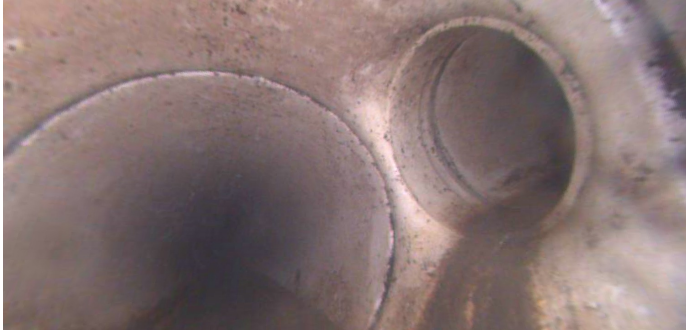
Code: **TFA**
Description: **Tap Factory Active**

Distance (ft): **77.0**
Structural Grade: **0**
O&M Grade: **0**
Clock Start/From: **2**
Clock To:
1st Value: **4.000**
2nd Value:
Value Percent:
Continuous Index:
Within 8" of Joint:
Remarks:

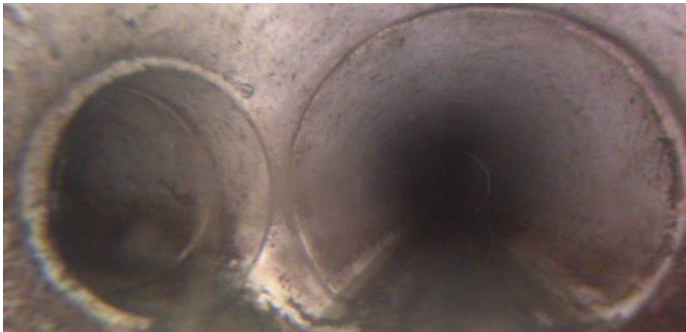
Code: **TFA**
Description: **Tap Factory Active**

Distance (ft): **201.1**
Structural Grade: **0**
O&M Grade: **0**
Clock Start/From: **9**
Clock To:
1st Value: **4.000**
2nd Value:
Value Percent:
Continuous Index:
Within 8" of Joint:
Remarks:

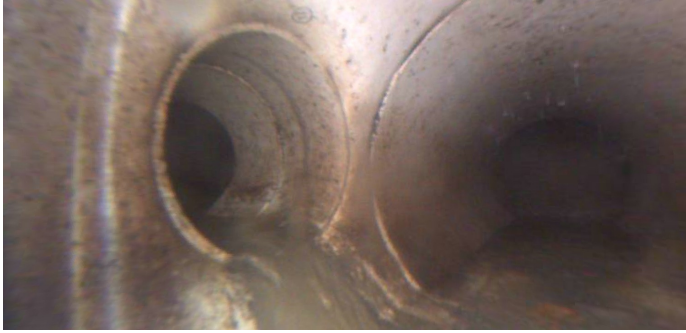
Code: **TFA**
Description: **Tap Factory Active**

Distance (ft): **217.8**
Structural Grade: **0**
O&M Grade: **0**
Clock Start/From: **9**
Clock To:
1st Value: **4.000**
2nd Value:
Value Percent:
Continuous Index:
Within 8" of Joint:
Remarks:

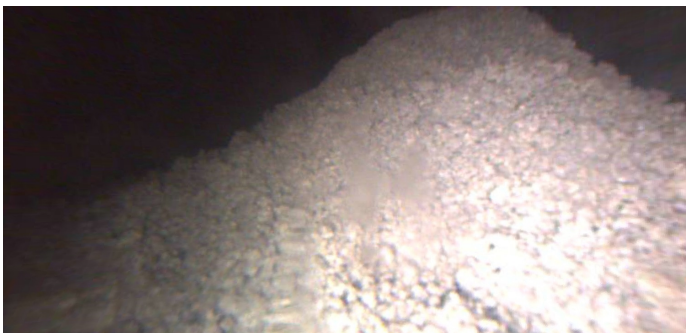
Code: **AMH**
Description: **Manhole**

Distance (ft): **222.0**
Structural Grade: **0**
O&M Grade: **0**
Clock Start/From:
Clock To:
1st Value:
2nd Value:
Value Percent:
Continuous Index:
Within 8" of Joint: **NO**
Remarks: **M-604-052**
