Profile/Photo Observation Report

Street:	Off 41st Avenue	Flow Control:	
City:	Hobart, IN	Year Renewed:	
Location:	Alley	Tape/Media #:	893
Purpose:	Routine Assessment	Dia/Height:	12"
Use:	Sanitary	Material:	PVC
Drain Area:		Lining:	
Category:	NA		
Comment:

Location Details:		Direction of Survey:	Downstream
US MH:	M-604-52	DS MH:	M-604-53
		Total Length Surveyed (ft):	223.8

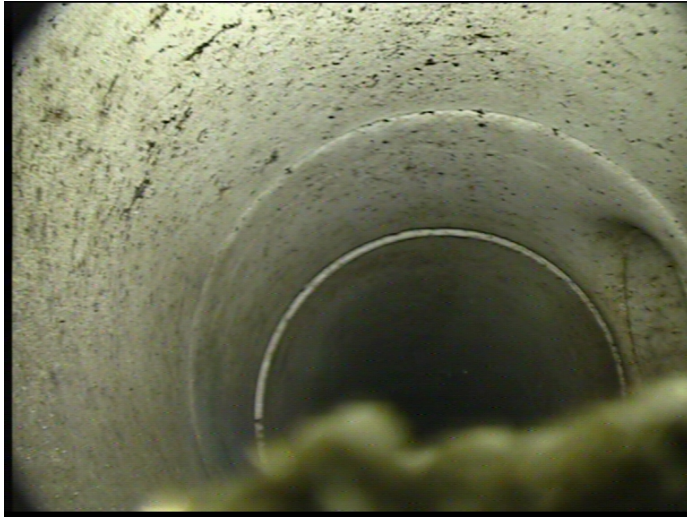
Code: **MWL**
Description: **Water Level**

Distance (ft): **.0**
Structural Grade: **0**
O&M Grade: **0**
Clock Start/From:
Clock To:
1st Value:
2nd Value:
Value Percent: **5.000**
Continuous Index:
Within 8" of Joint: **NO**
Remarks:

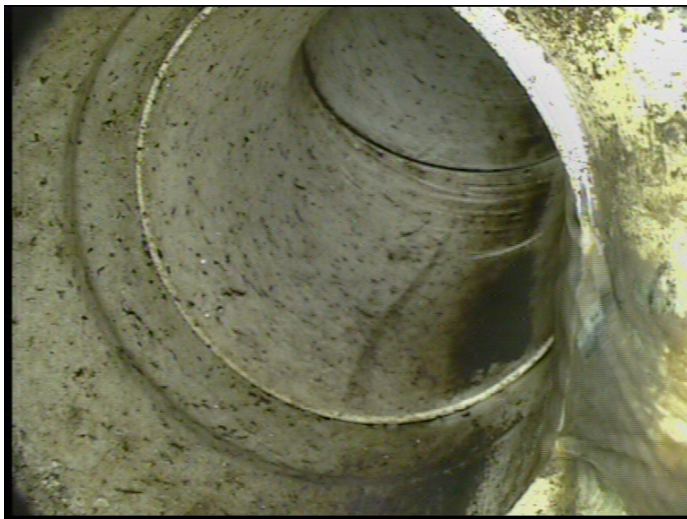
Code: **TFA**
Description: **Tap Factory Active**

Distance (ft): **1.8**
Structural Grade: **0**
O&M Grade: **0**
Clock Start/From: **3**
Clock To:
1st Value: **4.000**
2nd Value:
Value Percent:
Continuous Index:
Within 8" of Joint: **NO**
Remarks:

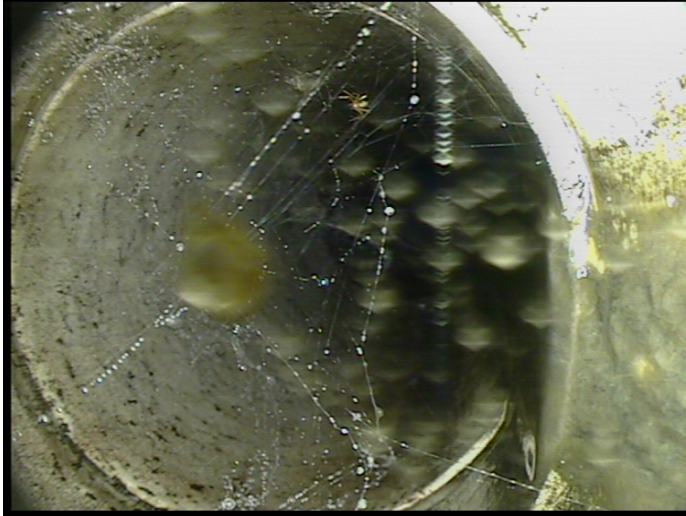
Code:	TFA
Description:	Tap Factory Active
Distance (ft):	20.2
Structural Grade:	0
O&M Grade:	0
Clock Start/From:	3
Clock To:	
1st Value:	4.000
2nd Value:	
Value Percent:	
Continuous Index:	
Within 8" of Joint:	NO
Remarks:

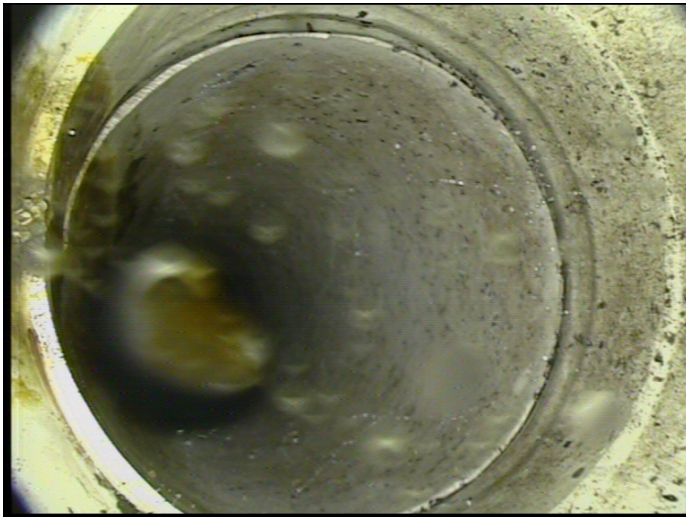
Code:	TFA
Description:	Tap Factory Active
Distance (ft):	144.7
Structural Grade:	0
O&M Grade:	0
Clock Start/From:	9
Clock To:	
1st Value:	4.000
2nd Value:	
Value Percent:	
Continuous Index:	
Within 8" of Joint:	NO
Remarks:

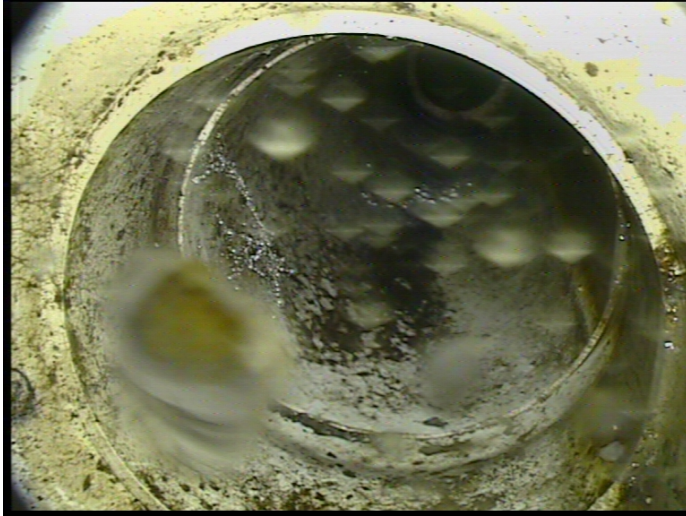
Code: **TFA**
Description: **Tap Factory Active**

Distance (ft): **148.5**
Structural Grade: **0**
O&M Grade: **0**
Clock Start/From: **3**
Clock To:
1st Value: **4.000**
2nd Value:
Value Percent:
Continuous Index:
Within 8" of Joint: **NO**
Remarks:

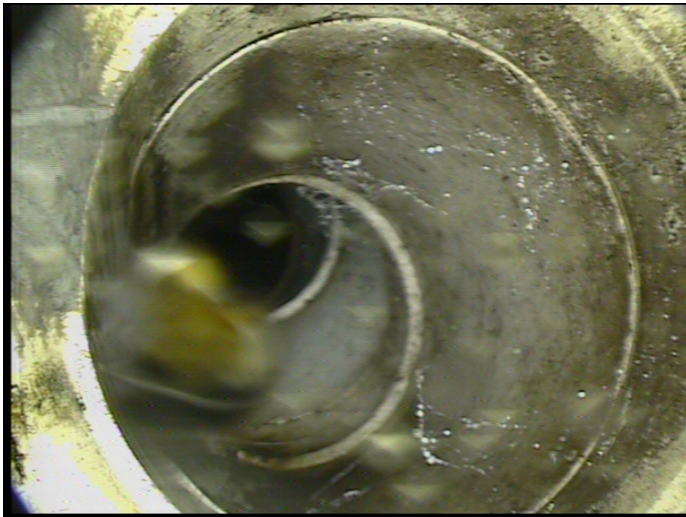
Code: **TFA**
Description: **Tap Factory Active**

Distance (ft): **179.4**
Structural Grade: **0**
O&M Grade: **0**
Clock Start/From: **9**
Clock To:
1st Value: **4.000**
2nd Value:
Value Percent:
Continuous Index:
Within 8" of Joint: **NO**
Remarks:

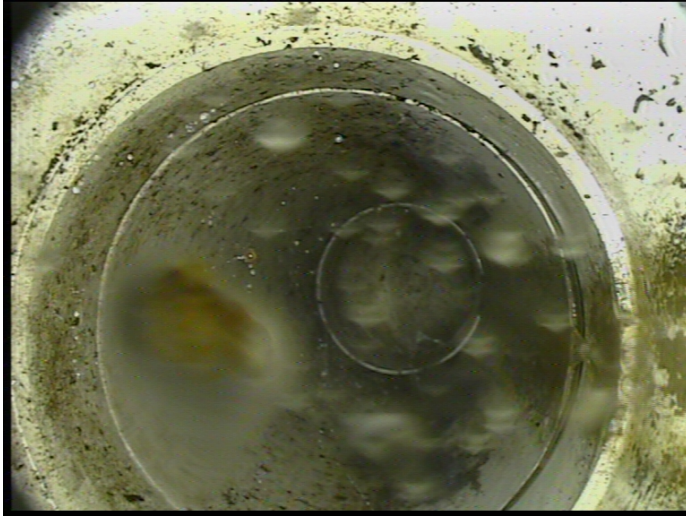
Code: **TFA**
Description: **Tap Factory Active**

Distance (ft): **200.9**
Structural Grade: **0**
O&M Grade: **0**
Clock Start/From: **3**
Clock To:
1st Value: **4.000**
2nd Value:
Value Percent:
Continuous Index:
Within 8" of Joint: **NO**
Remarks:

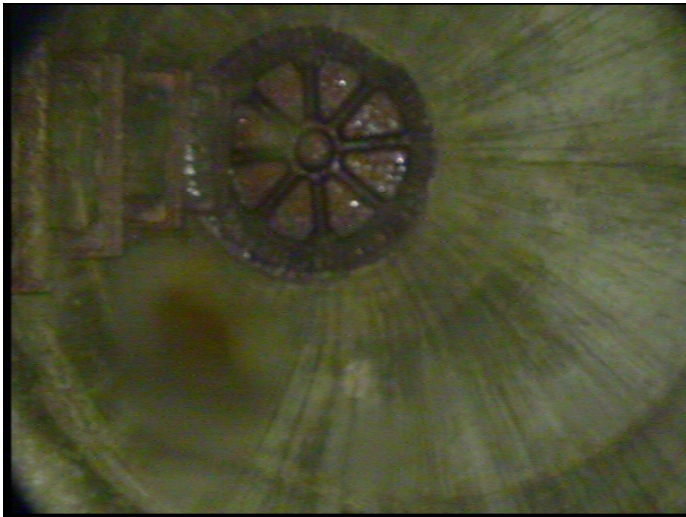
Code: **AMH**
Description: **Manhole**

Distance (ft): **223.8**
Structural Grade: **0**
O&M Grade: **0**
Clock Start/From:
Clock To:
1st Value:
2nd Value:
Value Percent:
Continuous Index:
Within 8" of Joint: **NO**
Remarks: **M-604-53**
