Profile/Photo Observation Report

Date:	04/22/2018	Weather:		Coding:	PACP 6.0
Pipe Length (ft):	193.0	Owner:	NA	Pre Clean:	Not Known
P.O.#:		Surveyor:	Mark Ruby	PSR:	P-604-050-054
Customer:		Clean Date:	01/01/1900	Shape:	C

Street:	N CONNECTICUT ST	Flow Control:	Not Controlled
City:	Hobart, IN	Year Renewed:	
Location:	Light Highway	Tape/Media #:	
Purpose:	Not Known	Dia/Height:	12"
Use:	Sanitary	Material:	PVC
Drain Area:	NA	Lining:	
Category:	NA		
Comment:

Location Details:		Direction of Survey:	Downstream
US MH:	M-604-054	DS MH:	M-604-050
		Total Length Surveyed (ft):	190.9

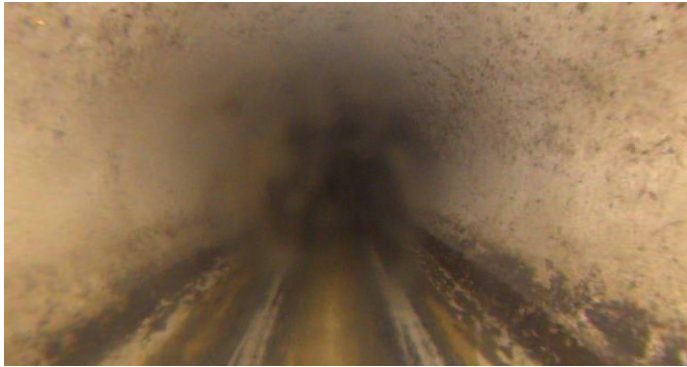
Code:	MWL
Description:	Water Level
Distance (ft):	.0
Structural Grade:	0
O&M Grade:	0
Clock Start/From:	
Clock To:	
1st Value:	
2nd Value:	
Value Percent:	10.000
Continuous Index:	
Within 8" of Joint:	NO
Remarks:

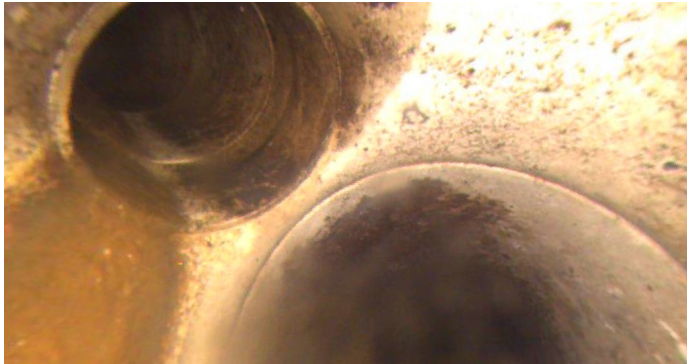
Code:	TF
Description:	Tap Factory
Distance (ft):	69.5
Structural Grade:	0
O&M Grade:	0
Clock Start/From:	10
Clock To:	
1st Value:	4.000
2nd Value:	
Value Percent:	
Continuous Index:	
Within 8" of Joint:	
Remarks:

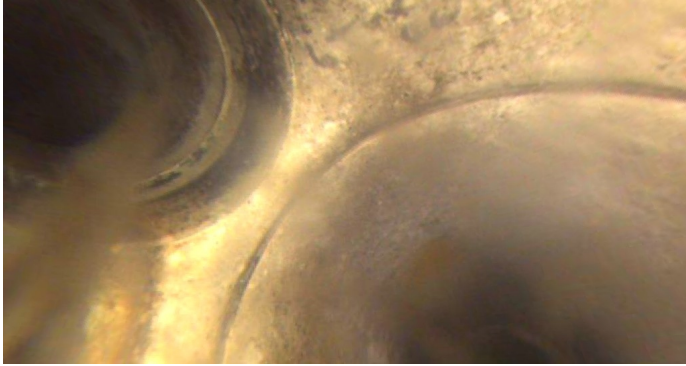
Code: **TF**
Description: **Tap Factory**

Distance (ft): **74.2**
Structural Grade: **0**
O&M Grade: **0**
Clock Start/From: **2**
Clock To:
1st Value: **4.000**
2nd Value:
Value Percent:
Continuous Index:
Within 8" of Joint:
Remarks:

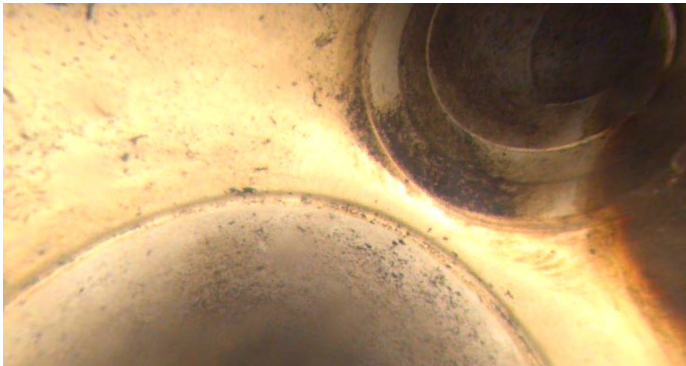
Code: **TF**
Description: **Tap Factory**

Distance (ft): **128.5**
Structural Grade: **0**
O&M Grade: **0**
Clock Start/From: **2**
Clock To:
1st Value: **4.000**
2nd Value:
Value Percent:
Continuous Index:
Within 8" of Joint:
Remarks:

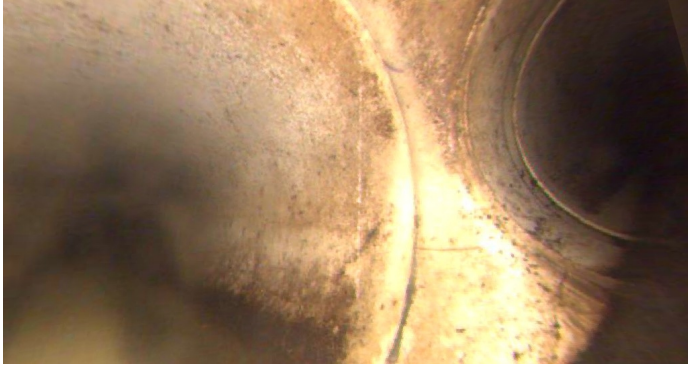
Code: **TF**
Description: **Tap Factory**

Distance (ft): **176.9**
Structural Grade: **0**
O&M Grade: **0**
Clock Start/From: **3**
Clock To:
1st Value: **4.000**
2nd Value:
Value Percent:
Continuous Index:
Within 8" of Joint:
Remarks:

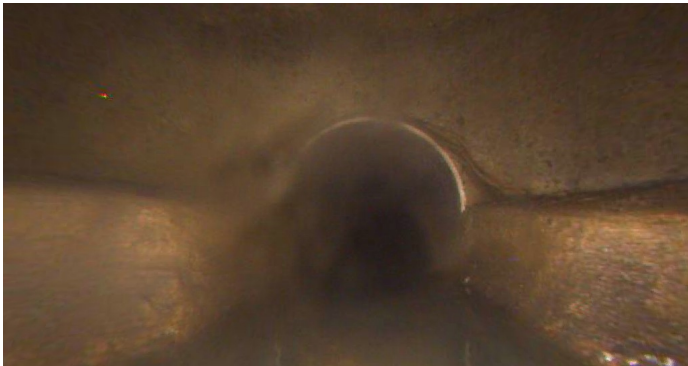
Code: **AMH**
Description: **Manhole**

Distance (ft): **190.9**
Structural Grade: **0**
O&M Grade: **0**
Clock Start/From:
Clock To:
1st Value:
2nd Value:
Value Percent:
Continuous Index:
Within 8" of Joint: **NO**
Remarks: **M-604-050**
