Profile/Photo Observation Report

Street:	Summerlin	Flow Control:	Not Controlled
City:	Hobart, IN	Year Renewed:	
Location:	Light Highway	Tape/Media #:	
Purpose:	Not Known	Dia/Height:	12"
Use:	Sanitary	Material:	PVC
Drain Area:	NA	Lining:	
Category:	NA		
Comment:

Location Details:		Direction of Survey:	Downstream
US MH:	M-604-054	DS MH:	M-604-050
		Total Length Surveyed (ft):	190.9

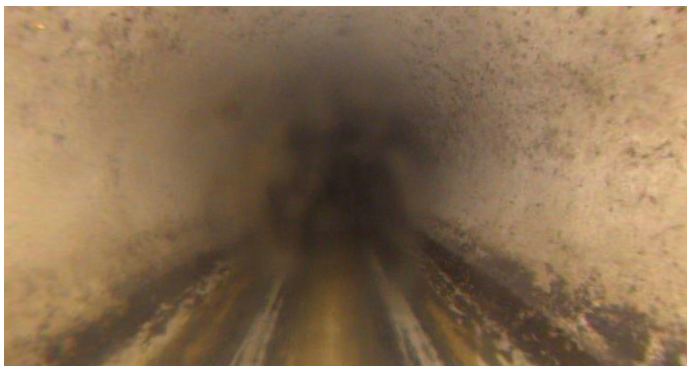
Code: **AMH**
 Description: **Manhole**

Distance (ft): **.0**
 Structural Grade: **0**
 O&M Grade: **0**
 Clock Start/From:
 Clock To:
 1st Value:
 2nd Value:
 Value Percent:
 Continuous Index:
 Within 8" of Joint: **NO**
 Remarks: **M-604-054**

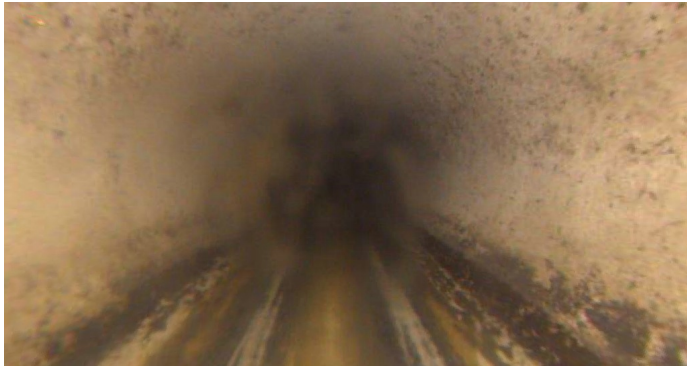
Code:	MWL
Description:	Water Level
Distance (ft):	.0
Structural Grade:	0
O&M Grade:	0
Clock Start/From:	
Clock To:	
1st Value:	
2nd Value:	
Value Percent:	10.000
Continuous Index:	
Within 8" of Joint:	NO
Remarks:

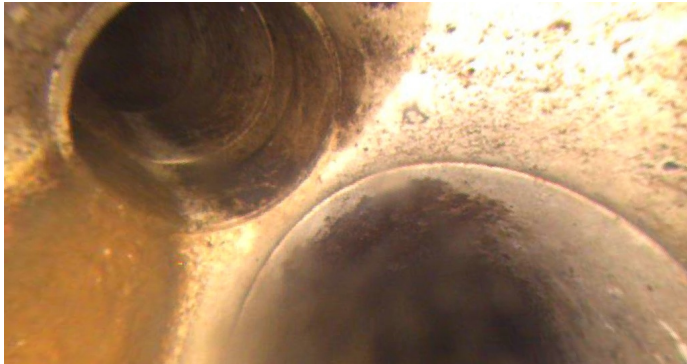
Code:	TF
Description:	Tap Factory
Distance (ft):	69.5
Structural Grade:	0
O&M Grade:	0
Clock Start/From:	10
Clock To:	
1st Value:	4.000
2nd Value:	
Value Percent:	
Continuous Index:	
Within 8" of Joint:	
Remarks:

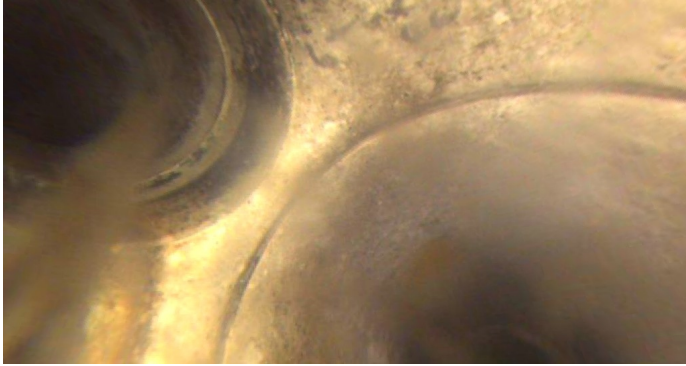
Code: **TF**
Description: **Tap Factory**

Distance (ft): **74.2**
Structural Grade: **0**
O&M Grade: **0**
Clock Start/From: **2**
Clock To:
1st Value: **4.000**
2nd Value:
Value Percent:
Continuous Index:
Within 8" of Joint:
Remarks:

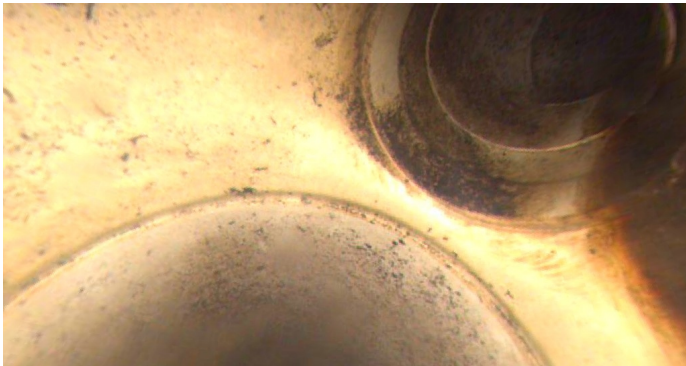
Code: **TF**
Description: **Tap Factory**

Distance (ft): **128.5**
Structural Grade: **0**
O&M Grade: **0**
Clock Start/From: **2**
Clock To:
1st Value: **4.000**
2nd Value:
Value Percent:
Continuous Index:
Within 8" of Joint:
Remarks:

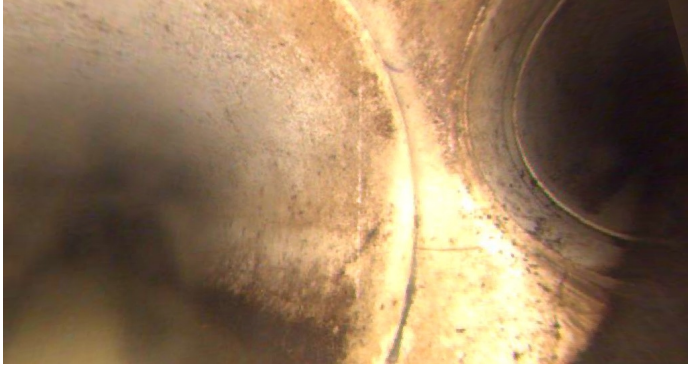
Code: **TF**
Description: **Tap Factory**

Distance (ft): **176.9**
Structural Grade: **0**
O&M Grade: **0**
Clock Start/From: **3**
Clock To:
1st Value: **4.000**
2nd Value:
Value Percent:
Continuous Index:
Within 8" of Joint:
Remarks:

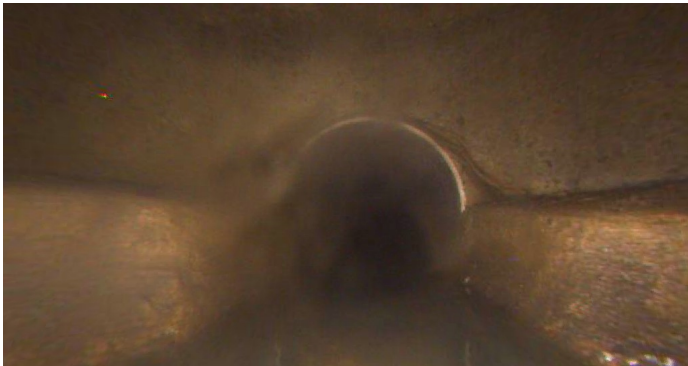
Code: **AMH**
Description: **Manhole**

Distance (ft): **190.9**
Structural Grade: **0**
O&M Grade: **0**
Clock Start/From:
Clock To:
1st Value:
2nd Value:
Value Percent:
Continuous Index:
Within 8" of Joint: **NO**
Remarks: **M-604-050**
