Profile/Photo Observation Report

Date:	04/12/2018	Weather:		Coding:	PACP 6.0
Pipe Length (ft):		Owner:	City of Hobart	Pre Clean:	Not Known
P.O.#:	243	Surveyor:	B. Helbling	PSR:	P-604-057-058
Customer:	City of Hobart	Clean Date:		Shape:	C

Street:	North Conneticut Street	Flow Control:	Not Controlled
City:	Hobart, IN	Year Renewed:	
Location:	Light Highway	Tape/Media #:	DEP243
Purpose:	Routine Assessment	Dia/Height:	15"
Use:	Sanitary	Material:	VCP
Drain Area:		Lining:	
Category:	NA		
Comment:	YES501824 Submital 2		
Location Details:		Direction of Survey:	Upstream
US MH:	M-604-057	DS MH:	M-604-058
		Total Length Surveyed (ft):	146.5

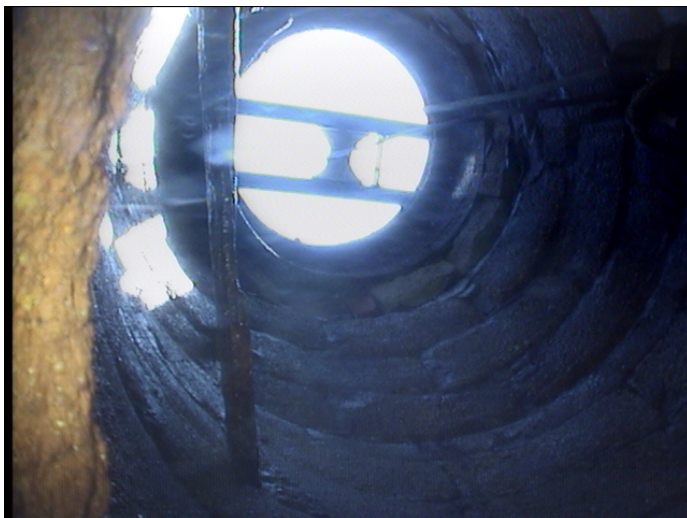
Code: **AMH**
Description: **Manhole**

Distance (ft): **.0**
Structural Grade: **0**
O&M Grade: **0**
Clock Start/From:
Clock To:
1st Value:
2nd Value:
Value Percent:
Continuous Index:
Within 8" of Joint: **NO**
Remarks: **M-604-058**

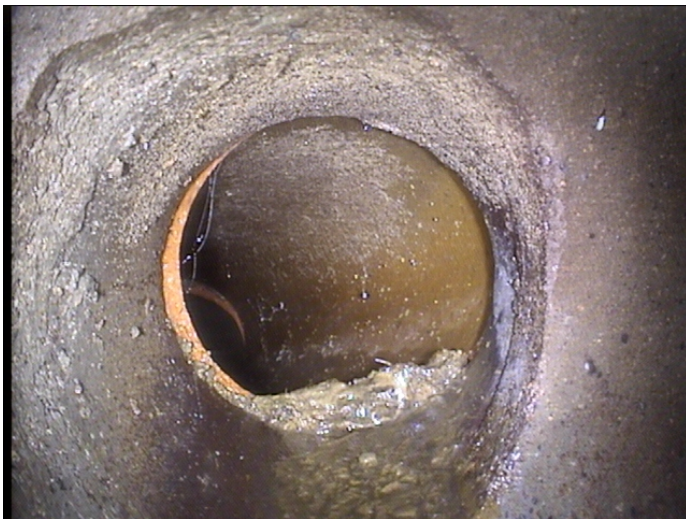
Code: **TB**
Description: **Tap Break-in**

Distance (ft): **46.9**
Structural Grade: **0**
O&M Grade: **0**
Clock Start/From: **10**
Clock To:
1st Value: **4.000**
2nd Value:
Value Percent:
Continuous Index:
Within 8" of Joint: **NO**
Remarks:

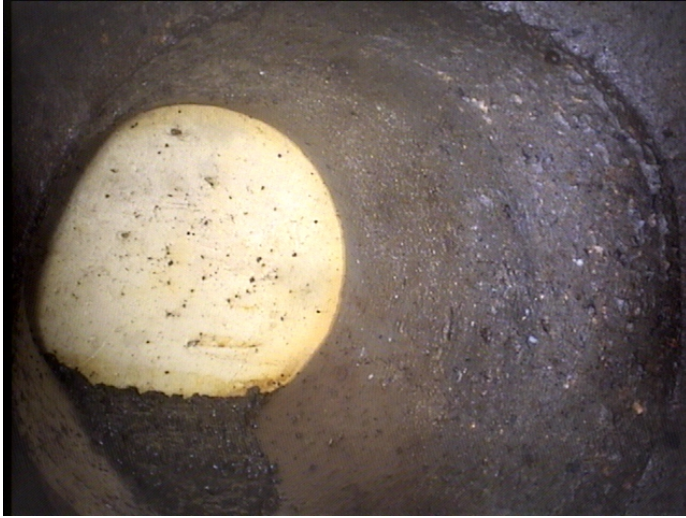
Code: **TFC**
Description: **Tap Factory Capped**

Distance (ft): **49.2**
Structural Grade: **0**
O&M Grade: **0**
Clock Start/From: **2**
Clock To:
1st Value: **4.000**
2nd Value:
Value Percent:
Continuous Index:
Within 8" of Joint: **NO**
Remarks:

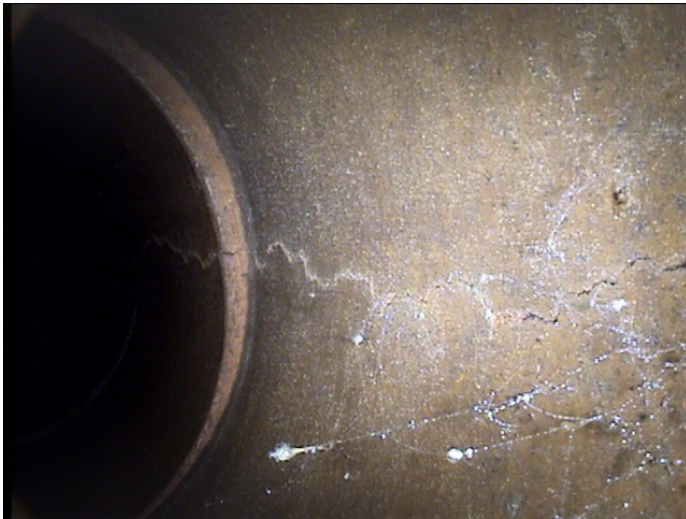
Code: **FL**
Description: **Fracture Longitudinal**

Distance (ft): **52.0**
Structural Grade: **3**
O&M Grade: **0**
Clock Start/From: **12**
Clock To:
1st Value:
2nd Value:
Value Percent:
Continuous Index: **S01**
Within 8" of Joint: **NO**
Remarks:

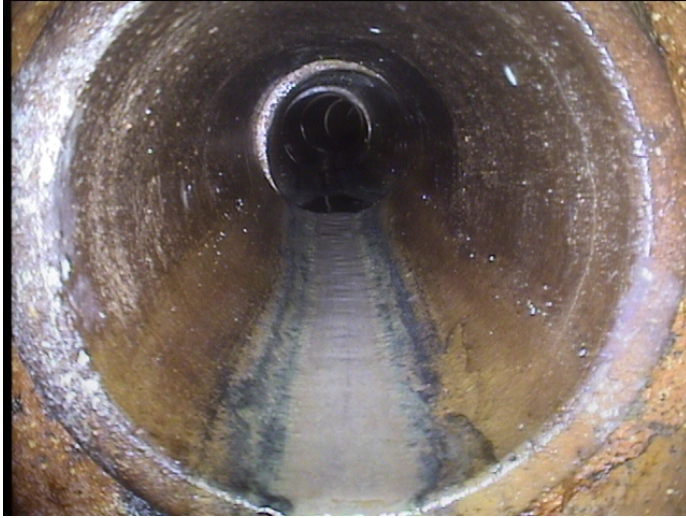
Code: **TBA**
Description: **Tap Break-in Active**

Distance (ft): **59.7**
Structural Grade: **0**
O&M Grade: **0**
Clock Start/From: **3**
Clock To:
1st Value: **4.000**
2nd Value:
Value Percent:
Continuous Index:
Within 8" of Joint: **NO**
Remarks:

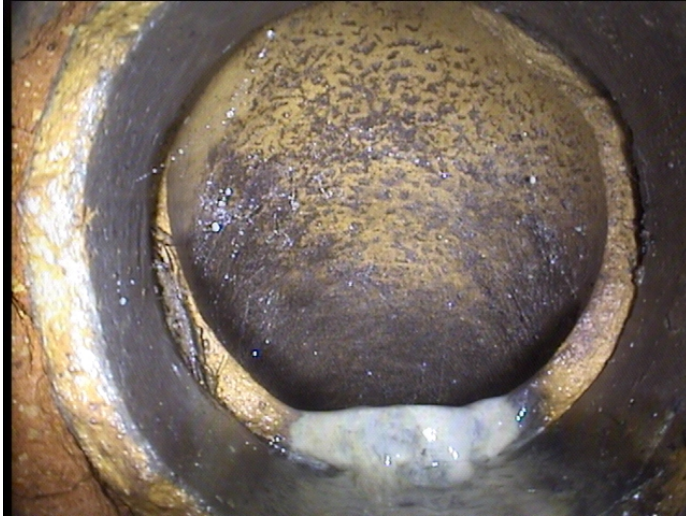
Code: **TB**
Description: **Tap Break-in**

Distance (ft): **63.7**
Structural Grade: **0**
O&M Grade: **0**
Clock Start/From: **10**
Clock To:
1st Value: **4.000**
2nd Value:
Value Percent:
Continuous Index:
Within 8" of Joint: **NO**
Remarks:

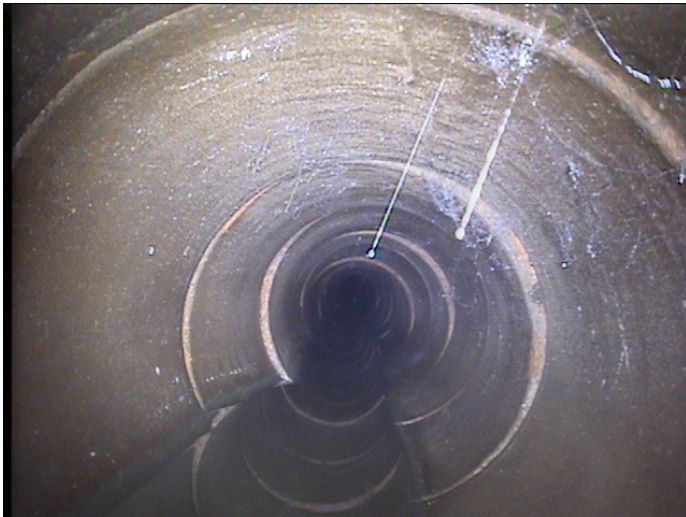
Code: **FL**
Description: **Fracture Longitudinal**

Distance (ft): **65.7**
Structural Grade: **3**
O&M Grade: **0**
Clock Start/From: **12**
Clock To:
1st Value:
2nd Value:
Value Percent:
Continuous Index: **S02**
Within 8" of Joint: **NO**
Remarks:

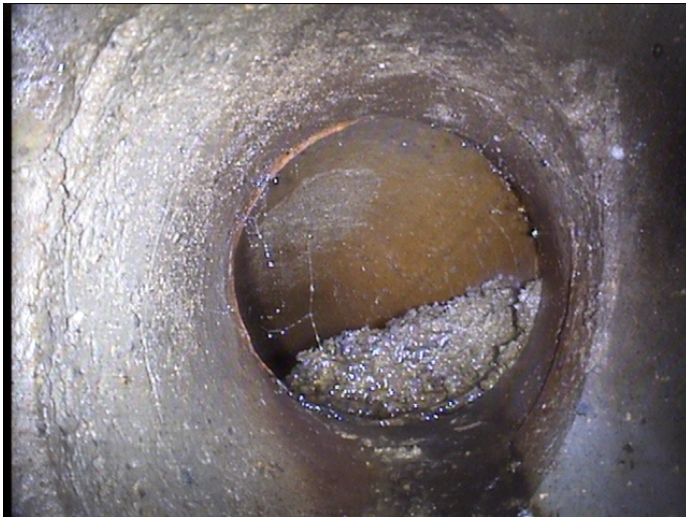
Code: **TFC**
Description: **Tap Factory Capped**

Distance (ft): **86.6**
Structural Grade: **0**
O&M Grade: **0**
Clock Start/From: **10**
Clock To:
1st Value: **4.000**
2nd Value:
Value Percent:
Continuous Index:
Within 8" of Joint: **NO**
Remarks:

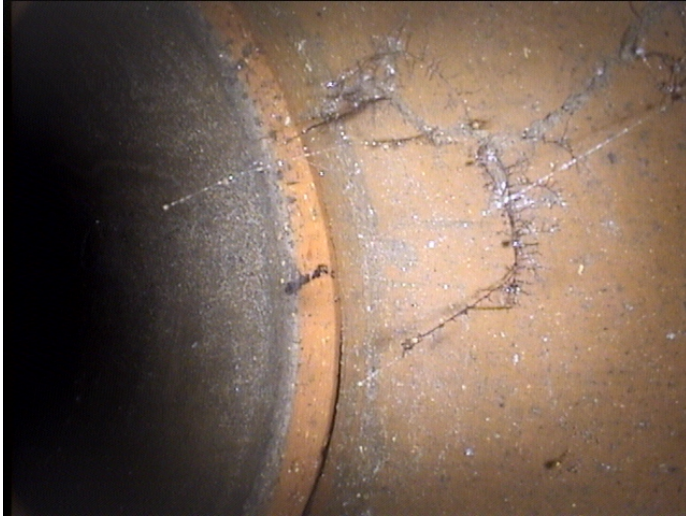
Code: **CL**
Description: **Crack Longitudinal**

Distance (ft): **111.4**
Structural Grade: **2**
O&M Grade: **0**
Clock Start/From: **12**
Clock To:
1st Value:
2nd Value:
Value Percent:
Continuous Index:
Within 8" of Joint: **NO**
Remarks:

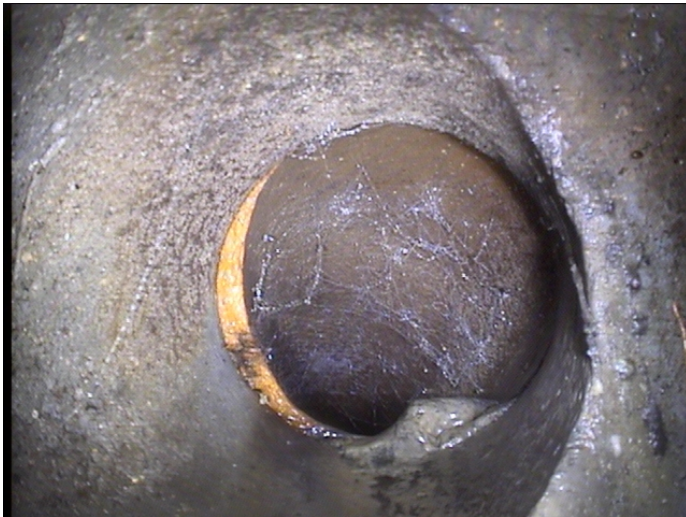
Code: **TF**
Description: **Tap Factory**

Distance (ft): **126.5**
Structural Grade: **0**
O&M Grade: **0**
Clock Start/From: **10**
Clock To:
1st Value: **4.000**
2nd Value:
Value Percent:
Continuous Index:
Within 8" of Joint: **NO**
Remarks:

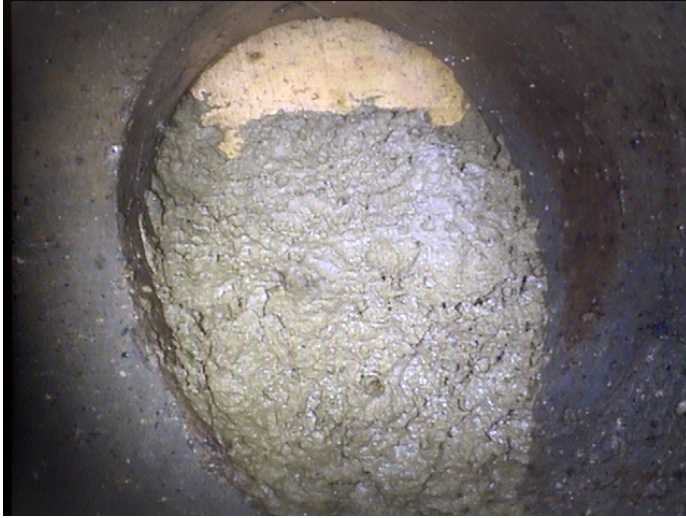
Code:	TFC
Description:	Tap Factory Capped
Distance (ft):	128.6
Structural Grade:	0
O&M Grade:	0
Clock Start/From:	2
Clock To:	
1st Value:	4.000
2nd Value:	
Value Percent:	
Continuous Index:	
Within 8" of Joint:	NO
Remarks:

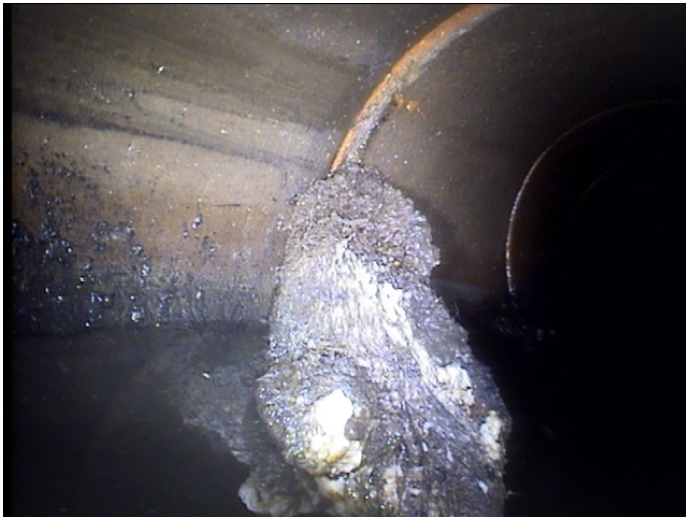
Code:	DSF
Description:	Deposits Settled Fine
Distance (ft):	146.5
Structural Grade:	0
O&M Grade:	2
Clock Start/From:	5
Clock To:	7
1st Value:	
2nd Value:	
Value Percent:	5.000
Continuous Index:	F03
Within 8" of Joint:	NO
Remarks:

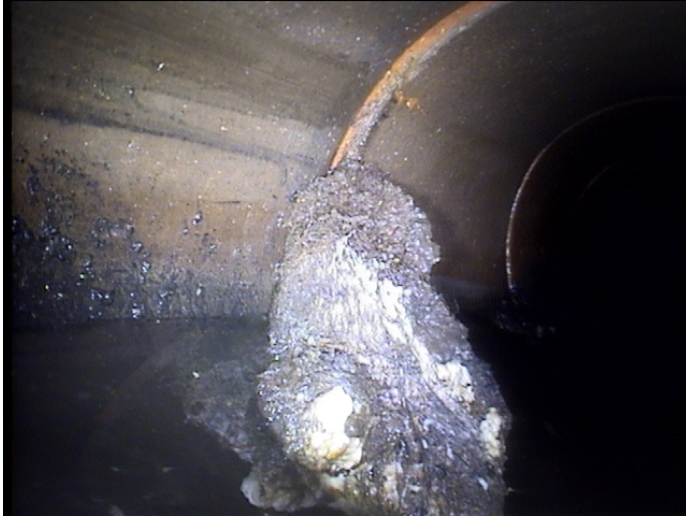
Code:	MSA
Description:	Abandoned Survey
Distance (ft):	146.5
Structural Grade:	0
O&M Grade:	0
Clock Start/From:	
Clock To:	
1st Value:	
2nd Value:	
Value Percent:	
Continuous Index:	
Within 8" of Joint:	NO
Remarks:	Same roots. Complete
