## Profile/Photo Observation Report

| Street: | <b>North Conneticut Street</b> | Flow Control: | <b>Not Controlled</b> |
| Use: | <b>Sanitary</b> | Material: | <b>VCP</b> |
| US MH: | <b>M-604-057</b> | DS MH: | <b>M-604-058</b> |

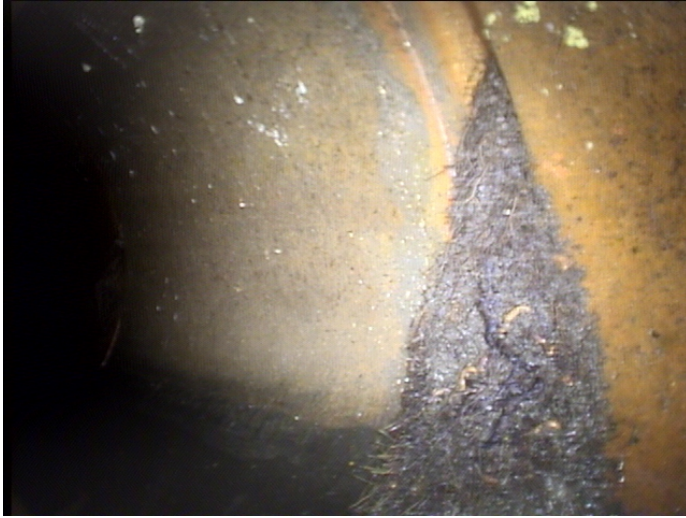
Code: **RFJ**  
Description: **Roots Fine Joint**

Distance (ft): **4.8**  
Structural Grade: **0**  
O&M Grade: **1**  
Clock Start/From: **3**  
Clock To: **5**  
1st Value:  
2nd Value:  
Value Percent:  
Continuous Index:  
Within 8" of Joint: **YES**  
Remarks:

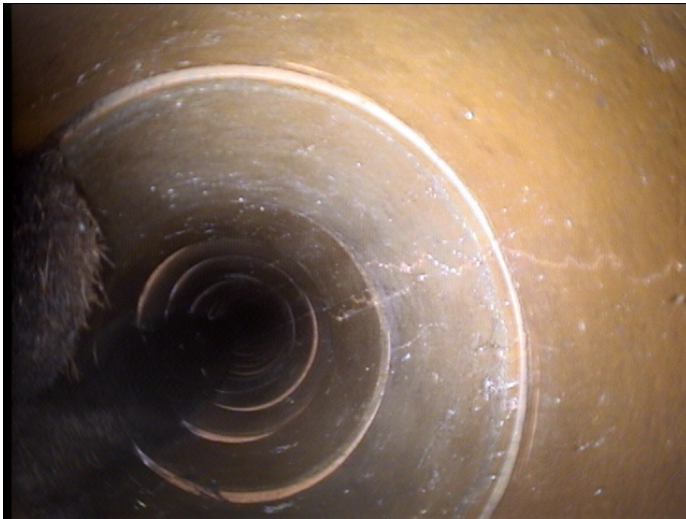
Code: **CL**  
Description: **Crack Longitudinal**

Distance (ft): **7.8**  
Structural Grade: **2**  
O&M Grade: **0**  
Clock Start/From: **12**  
Clock To:  
1st Value:  
2nd Value:  
Value Percent:  
Continuous Index: **S01**  
Within 8" of Joint: **NO**  
Remarks:

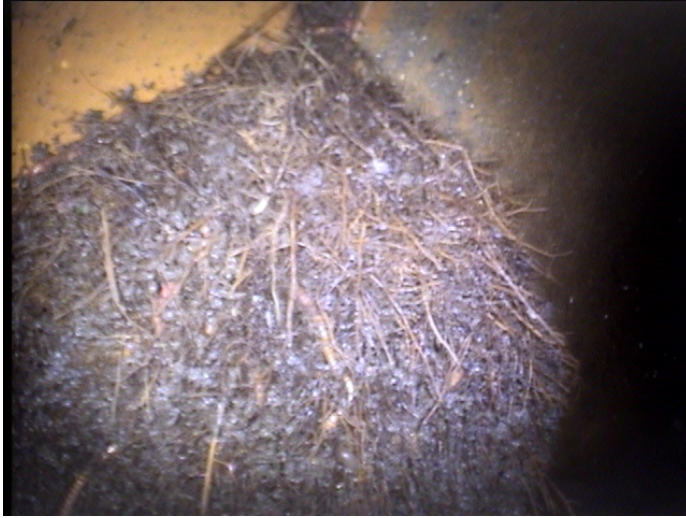
| Code: | <b>RFJ</b> |
| Description: | <b>Roots Fine Joint</b> |
| Distance (ft): | <b>9.2</b> |
| O&M Grade: | <b>1</b> |
| Clock Start/From: | <b>4</b> |
| Clock To: | <b>8</b> |
| Within 8" of Joint: | <b>YES</b> |

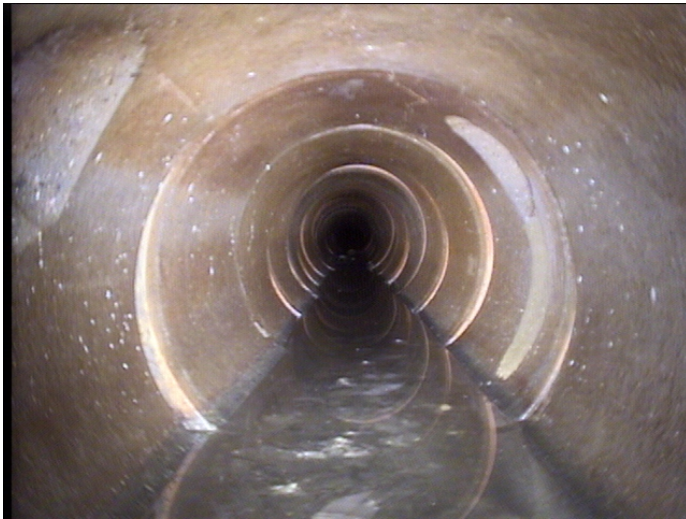
| Code: | <b>CL</b> |
| Description: | <b>Crack Longitudinal</b> |
| Distance (ft): | <b>17.5</b> |
| Structural Grade: | <b>2</b> |
| Clock Start/From: | <b>12</b> |
| Continuous Index: | <b>F01</b> |

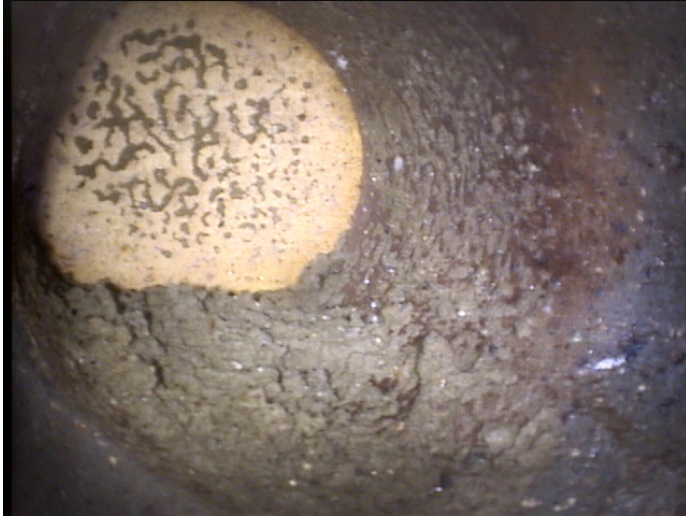
| Code: | <b>TFC</b> |
| Description: | <b>Tap Factory Capped</b> |
| Distance (ft): | <b>19.3</b> |
| Clock Start/From: | <b>10</b> |
| 1st Value: | <b>4.000</b> |

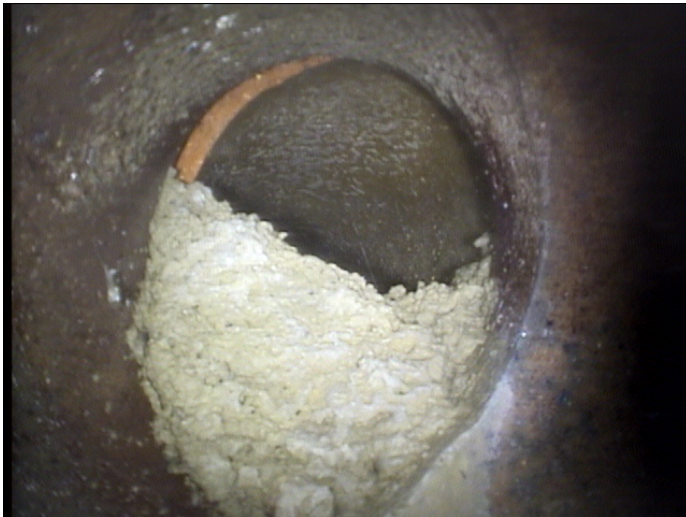
| Code: | <b>TF</b> |
| Description: | <b>Tap Factory</b> |
| Distance (ft): | <b>21.3</b> |
| Clock Start/From: | <b>2</b> |
| 1st Value: | <b>4.000</b> |

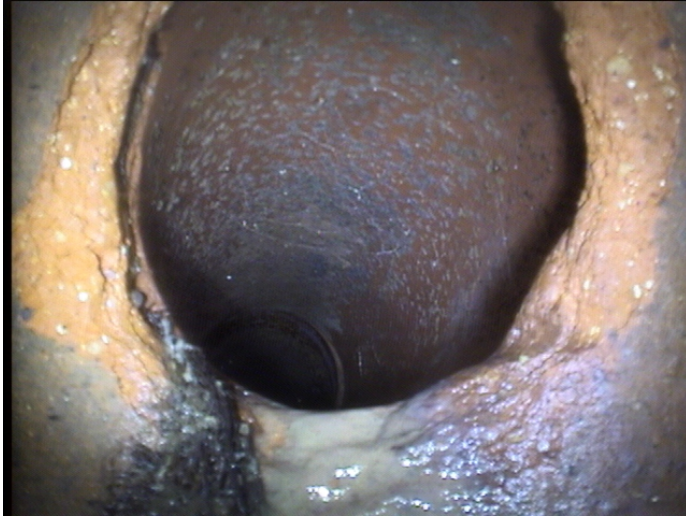
Code: **TBD**  
Description: **Tap Break-in Defective**

Distance (ft): **49.9**  
Structural Grade: **0**  
O&M Grade: **3**  
Clock Start/From: **10**  
Clock To:  
1st Value: **4.000**  
2nd Value:  
Value Percent:  
Continuous Index:  
Within 8" of Joint: **NO**  
Remarks: **Defective**

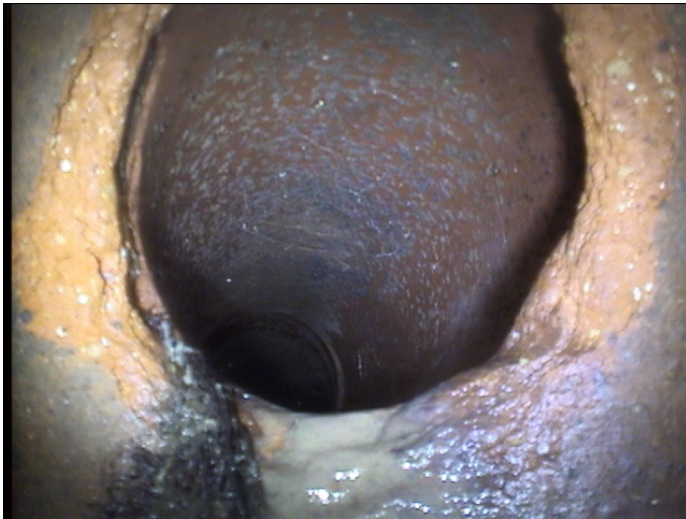
Code: **RFL**  
Description: **Roots Fine Lateral**

Distance (ft): **49.9**  
Structural Grade: **0**  
O&M Grade: **1**  
Clock Start/From: **10**  
Clock To:  
1st Value:  
2nd Value:  
Value Percent:  
Continuous Index:  
Within 8" of Joint: **NO**  
Remarks:

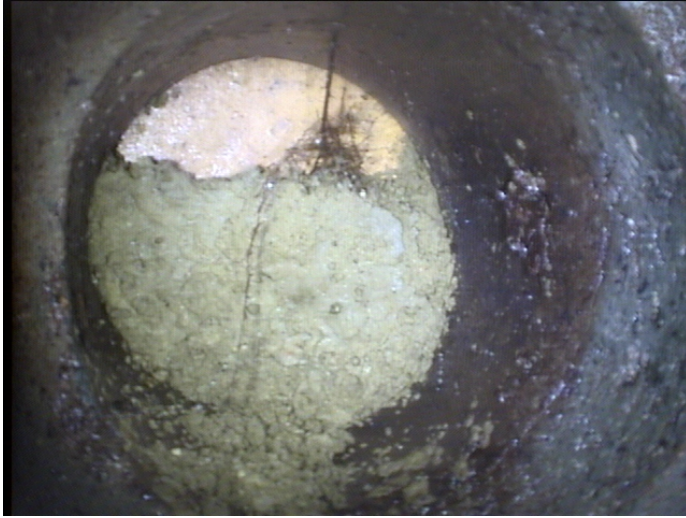
| Code: | <b>TFC</b> |
| Description: | <b>Tap Factory Capped</b> |
| Distance (ft): | <b>58.7</b> |
| Clock Start/From: | <b>10</b> |
| 1st Value: | <b>4.000</b> |

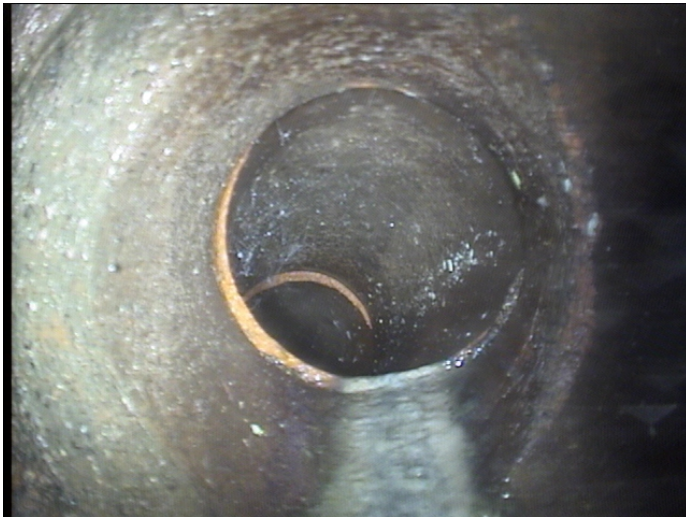
| Code: | <b>TF</b> |
| Description: | <b>Tap Factory</b> |
| Distance (ft): | <b>60.9</b> |
| Clock Start/From: | <b>2</b> |
| 1st Value: | <b>4.000</b> |

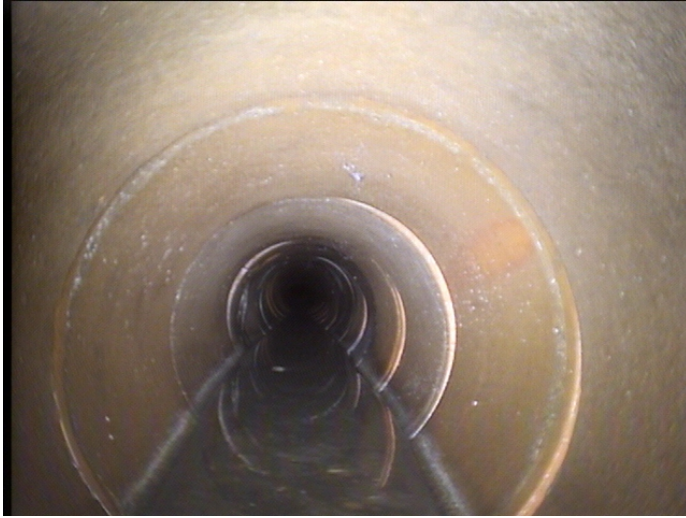
Code: **DSF**  
Description: **Deposits Settled Fine**

Distance (ft): **82.5**  
Structural Grade: **0**  
O&M Grade: **2**  
Clock Start/From: **5**  
Clock To: **7**  
1st Value:  
2nd Value:  
Value Percent: **5.000**  
Continuous Index: **S02**  
Within 8" of Joint: **NO**  
Remarks:

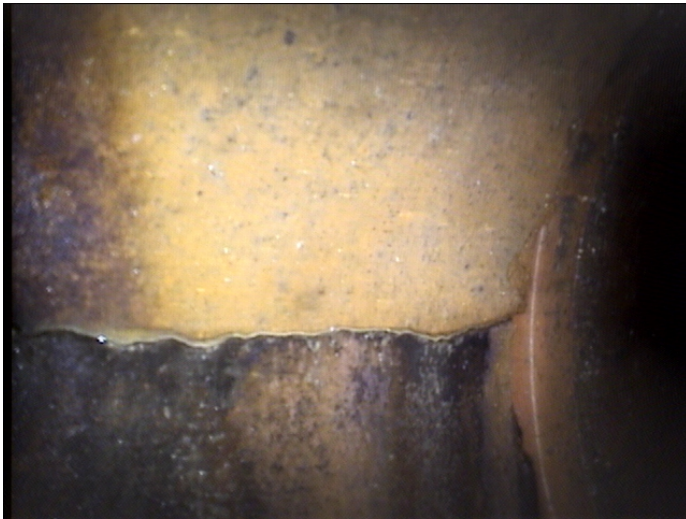
| Code: | <b>CL</b> |
| Description: | <b>Crack Longitudinal</b> |
| Distance (ft): | <b>92.2</b> |
| Structural Grade: | <b>2</b> |
| Clock Start/From: | <b>9</b> |

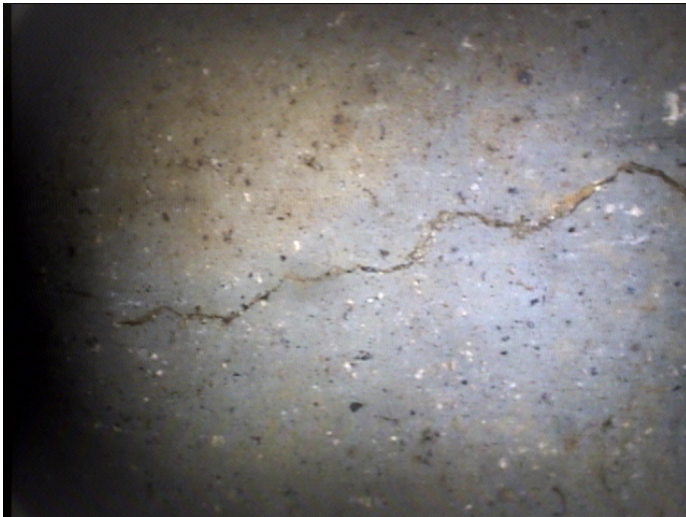
| Code: | <b>FL</b> |
| Description: | <b>Fracture Longitudinal</b> |
| Distance (ft): | <b>95.5</b> |
| Structural Grade: | <b>3</b> |
| Clock Start/From: | <b>12</b> |

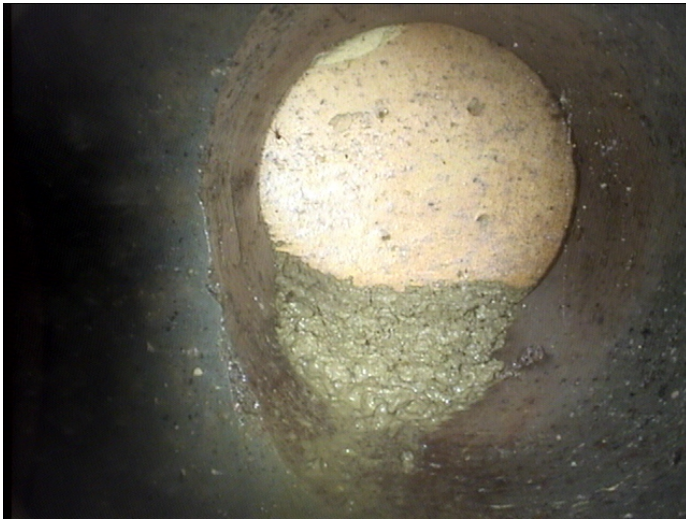
Code: **TFC**  
Description: **Tap Factory Capped**

Distance (ft): **96.3**  
Structural Grade: **0**  
O&M Grade: **0**  
Clock Start/From: **10**  
Clock To:  
1st Value: **4.000**  
2nd Value:  
Value Percent:  
Continuous Index:  
Within 8" of Joint: **NO**  
Remarks:

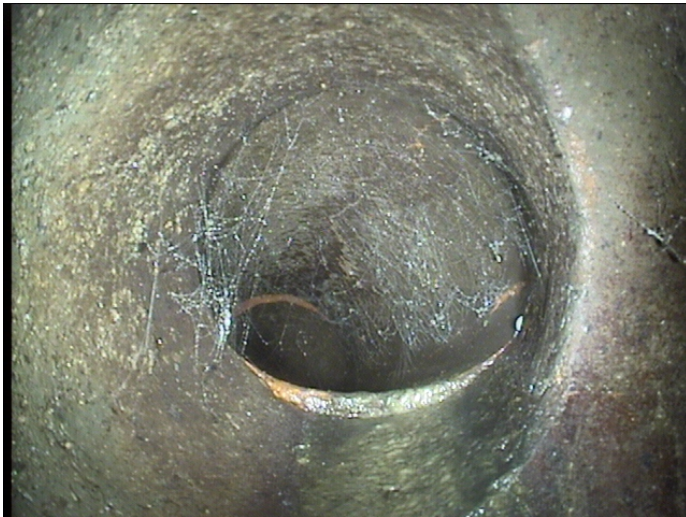
Code: **TF**  
Description: **Tap Factory**

Distance (ft): **98.6**  
Structural Grade: **0**  
O&M Grade: **0**  
Clock Start/From: **2**  
Clock To:  
1st Value: **4.000**  
2nd Value:  
Value Percent:  
Continuous Index:  
Within 8" of Joint: **NO**  
Remarks:

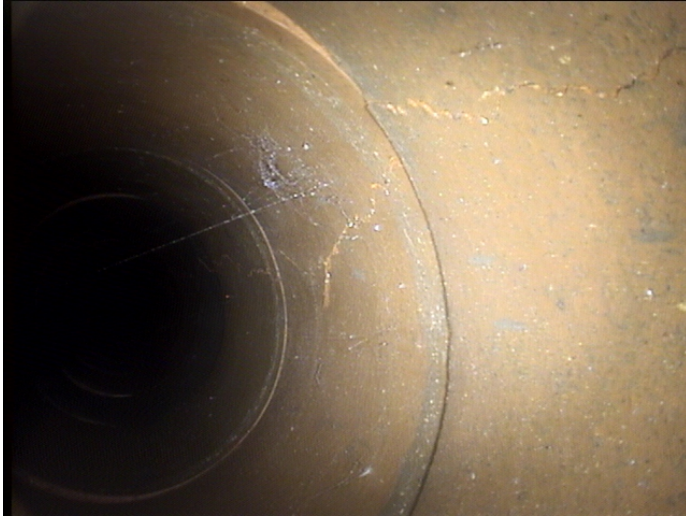
Code: **FL**  
Description: **Fracture Longitudinal**

Distance (ft): **101.8**  
Structural Grade: **3**  
O&M Grade: **0**  
Clock Start/From: **12**  
Clock To:  
1st Value:  
2nd Value:  
Value Percent:  
Continuous Index: **S03**  
Within 8" of Joint: **NO**  
Remarks:

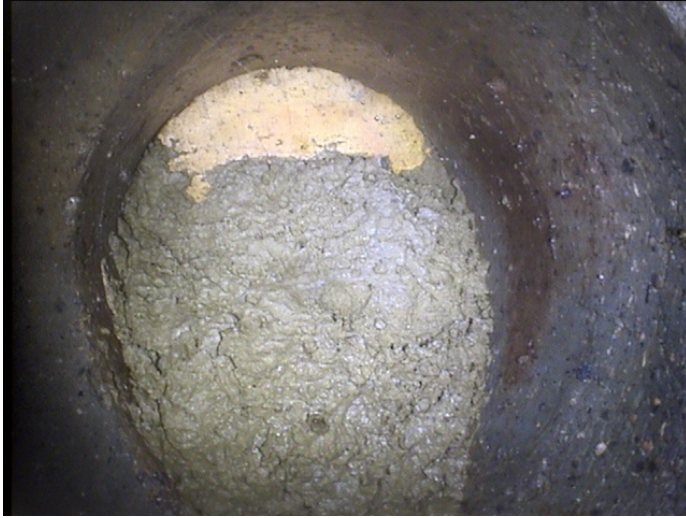
Code: **TFC**  
Description: **Tap Factory Capped**

Distance (ft): **137.8**  
Structural Grade: **0**  
O&M Grade: **0**  
Clock Start/From: **10**  
Clock To:  
1st Value: **4.000**  
2nd Value:  
Value Percent:  
Continuous Index:  
Within 8" of Joint: **NO**  
Remarks:

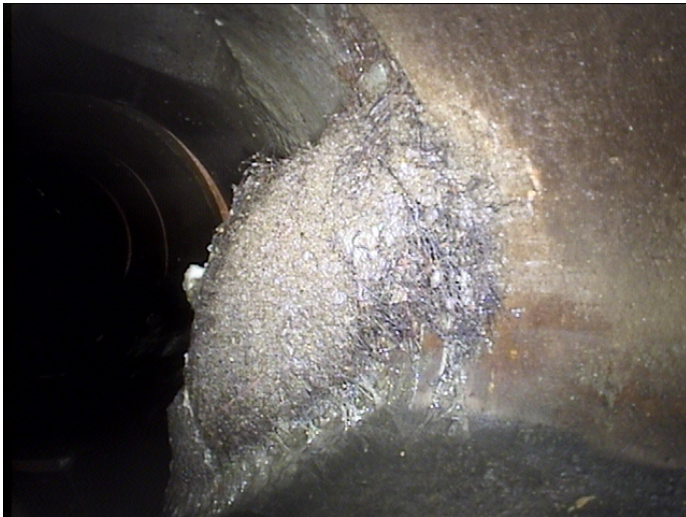
Code: **RMJ**  
Description: **Roots Medium Joint**

Distance (ft): **138.9**  
Structural Grade: **0**  
O&M Grade: **3**  
Clock Start/From: **3**  
Clock To: **5**  
1st Value:  
2nd Value:  
Value Percent: **5.000**  
Continuous Index:  
Within 8" of Joint: **YES**  
Remarks:

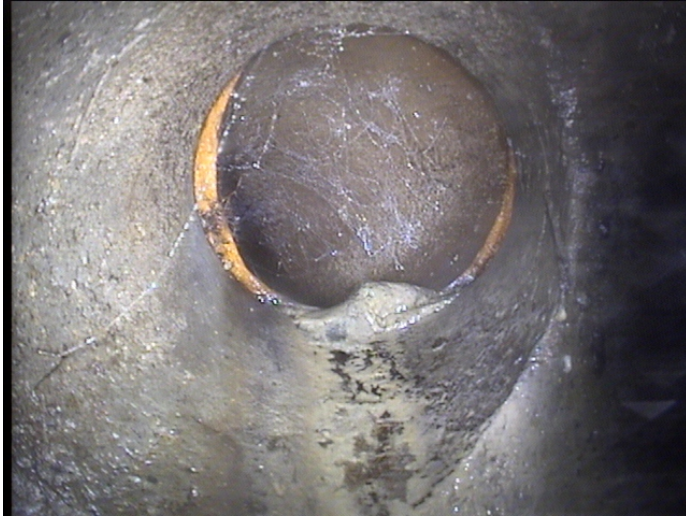
Code: **TF**  
Description: **Tap Factory**

Distance (ft): **142.3**  
Structural Grade: **0**  
O&M Grade: **0**  
Clock Start/From: **2**  
Clock To:  
1st Value: **4.000**  
2nd Value:  
Value Percent:  
Continuous Index:  
Within 8" of Joint: **NO**  
Remarks:
