Profile/Photo Observation Report

Date:	04/16/2018	Weather:		Coding:	PACP 6.0
Pipe Length (ft):		Owner:	City of Hobart	Pre Clean:	No Pre-Cleaning
P.O.#:	62-1	Surveyor:	M. Pielacha	PSR:	M-604-058-M-604-059
Customer:	City of Hobart	Clean Date:		Shape:	C

Street:	1st Street	Flow Control:	Not Controlled
City:	Hobart, IN	Year Renewed:	
Location:	Light Highway	Tape/Media #:	DEP 62
Purpose:	Routine Assessment	Dia/Height:	18"
Use:	Sanitary	Material:	VCP
Drain Area:		Lining:	
Category:	NA		
Comment:			
Location Details:		Direction of Survey:	Downstream
US MH:	M-604-058	DS MH:	M-604-059
		Total Length Surveyed (ft):	212.8

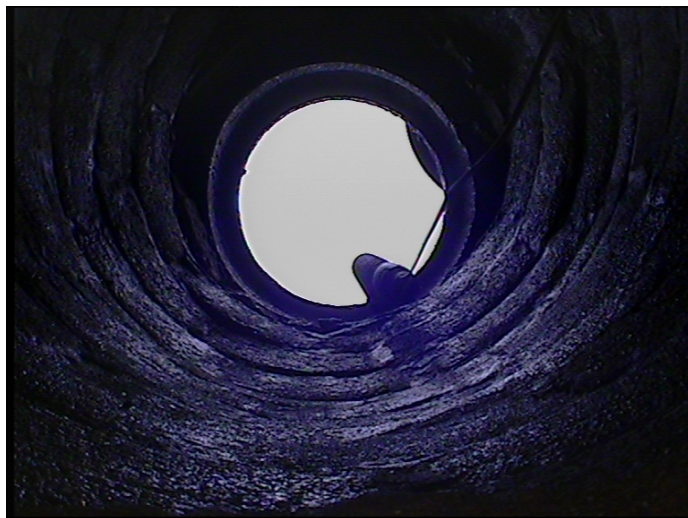
Code: **AMH**
Description: **Manhole**

Distance (ft): **.0**
Structural Grade: **0**
O&M Grade: **0**
Clock Start/From:
Clock To:
1st Value:
2nd Value:
Value Percent:
Continuous Index:
Within 8" of Joint: **NO**
Remarks: **M-604-058**

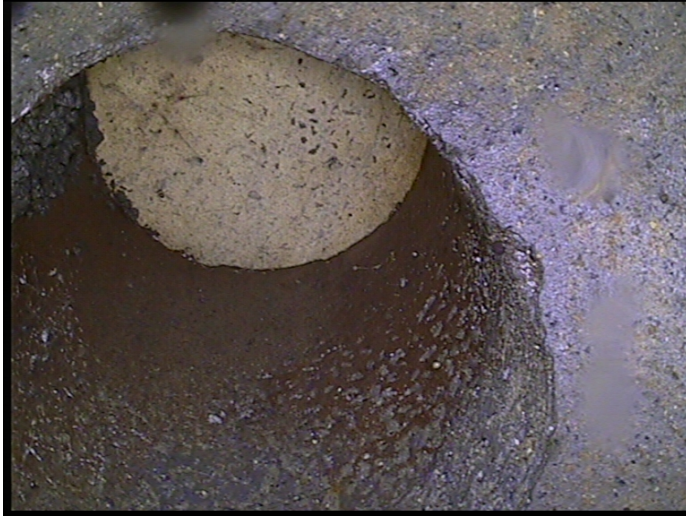
Code:	TFC
Description:	Tap Factory Capped
Distance (ft):	95.6
Structural Grade:	0
O&M Grade:	0
Clock Start/From:	9
Clock To:	
1st Value:	4.000
2nd Value:	
Value Percent:	
Continuous Index:	
Within 8" of Joint:	NO
Remarks:

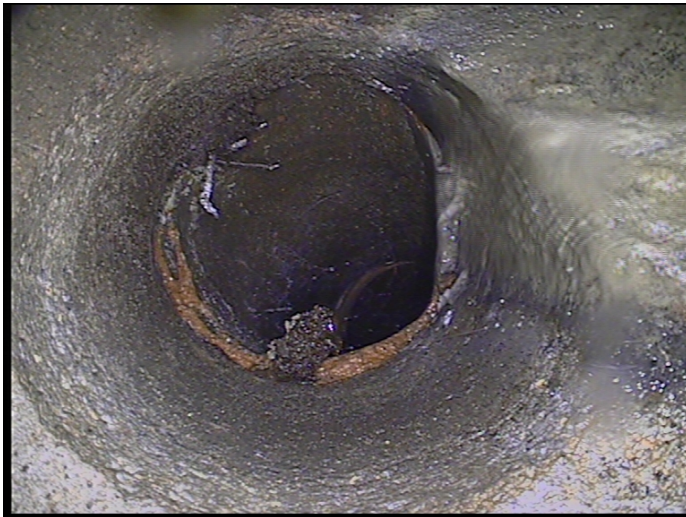
Code:	TFA
Description:	Tap Factory Active
Distance (ft):	98.0
Structural Grade:	0
O&M Grade:	0
Clock Start/From:	2
Clock To:	
1st Value:	4.000
2nd Value:	
Value Percent:	
Continuous Index:	
Within 8" of Joint:	NO
Remarks:

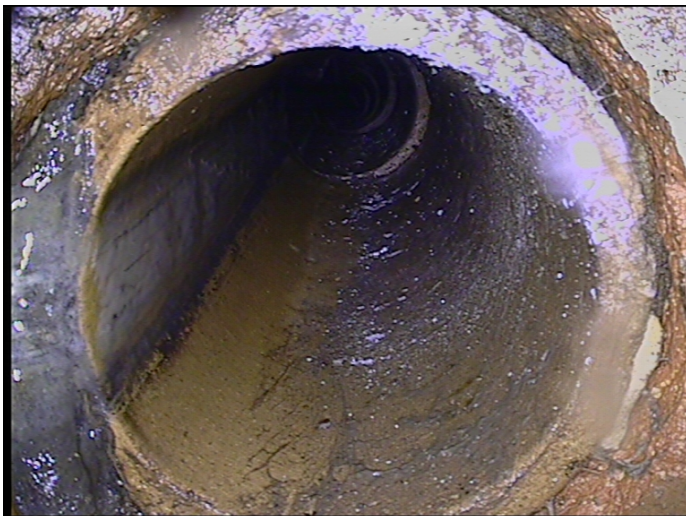
Code: **TB**
Description: **Tap Break-in**

Distance (ft): **153.3**
Structural Grade: **0**
O&M Grade: **0**
Clock Start/From: **9**
Clock To:
1st Value: **4.000**
2nd Value:
Value Percent:
Continuous Index:
Within 8" of Joint: **YES**
Remarks:
