Profile/Photo Observation Report

Street:	N CONNECTICUT ST & W HOME AVE	Flow Control:	Not Controlled
City:	Hobart, IN	Year Renewed:	
Location:	Other	Tape/Media #:	
Purpose:	Not Known	Dia/Height:	12"
Use:	Sanitary	Material:	VCP
Drain Area:	NA	Lining:	
Category:	NA		
Comment:

Location Details:		Direction of Survey:	Downstream
US MH:	M-604-058	DS MH:	M-604-107
		Total Length Surveyed (ft):	162.9

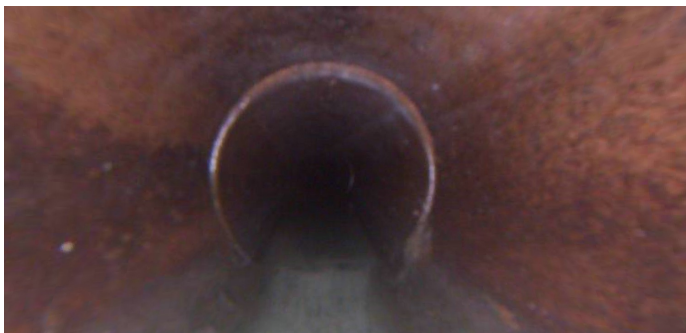
Code: **AMH**
Description: **Manhole**

Distance (ft): **.0**
Structural Grade: **0**
O&M Grade: **0**
Clock Start/From:
Clock To:
1st Value:
2nd Value:
Value Percent:
Continuous Index:
Within 8" of Joint: **NO**
Remarks: **M-604-058**

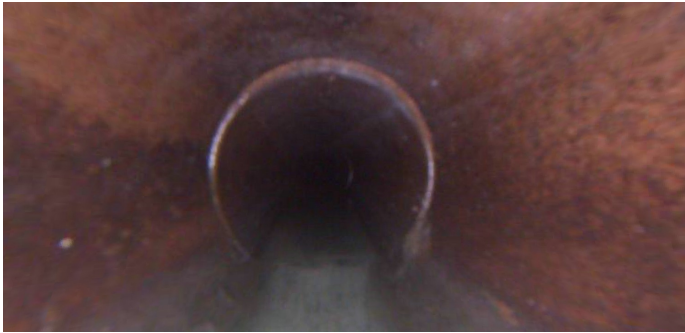
Code:	MWL
Description:	Water Level

Distance (ft):	.0
Structural Grade:	0
O&M Grade:	0
Clock Start/From:	
Clock To:	
1st Value:	
2nd Value:	
Value Percent:	5.000
Continuous Index:	
Within 8" of Joint:	NO
Remarks:

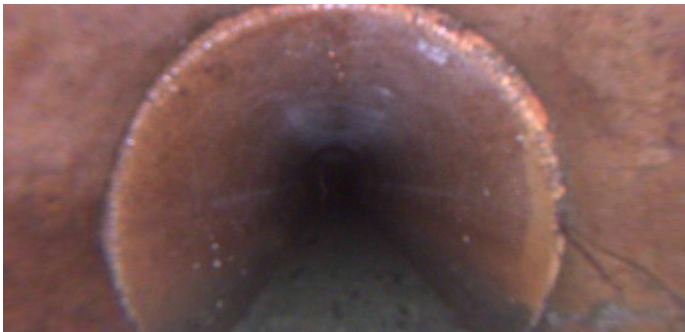
Code:	RFJ
Description:	Roots Fine Joint

Distance (ft):	7.3
Structural Grade:	0
O&M Grade:	1
Clock Start/From:	3
Clock To:	
1st Value:	
2nd Value:	
Value Percent:	
Continuous Index:	
Within 8" of Joint:	YES
Remarks:

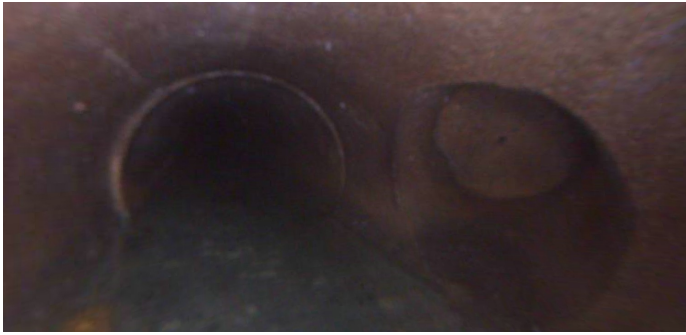
Code: **TFC**
Description: **Tap Factory Capped**

Distance (ft): **71.7**
Structural Grade: **0**
O&M Grade: **0**
Clock Start/From: **3**
Clock To:
1st Value: **4.000**
2nd Value:
Value Percent:
Continuous Index:
Within 8" of Joint:
Remarks:

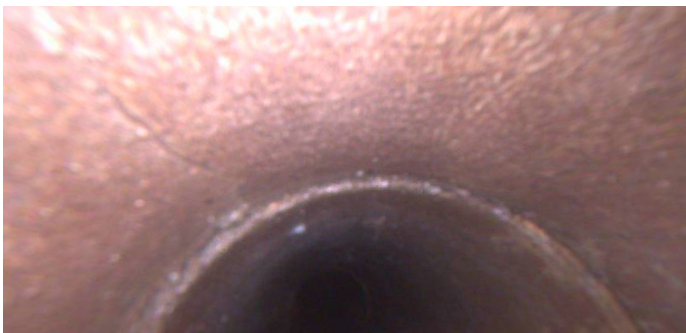
Code: **FL**
Description: **Fracture Longitudinal**

Distance (ft): **72.4**
Structural Grade: **3**
O&M Grade: **0**
Clock Start/From: **10**
Clock To:
1st Value:
2nd Value:
Value Percent:
Continuous Index:
Within 8" of Joint: **YES**
Remarks:

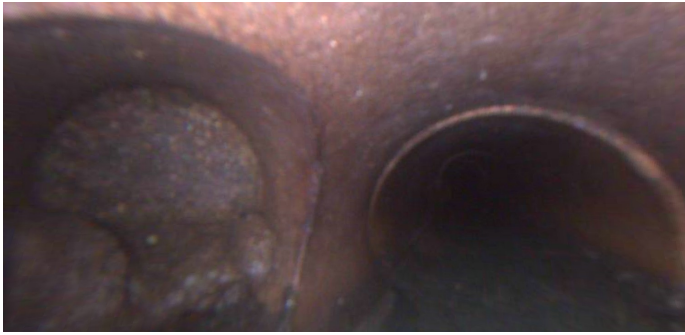
Code: **TFC**
Description: **Tap Factory Capped**

Distance (ft): **74.9**
Structural Grade: **0**
O&M Grade: **0**
Clock Start/From: **9**
Clock To:
1st Value: **4.000**
2nd Value:
Value Percent:
Continuous Index:
Within 8" of Joint:
Remarks:

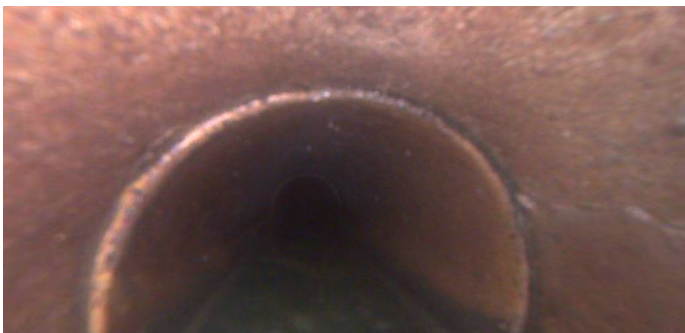
Code: **FL**
Description: **Fracture Longitudinal**

Distance (ft): **96.2**
Structural Grade: **3**
O&M Grade: **0**
Clock Start/From: **3**
Clock To:
1st Value:
2nd Value:
Value Percent:
Continuous Index:
Within 8" of Joint: **YES**
Remarks:

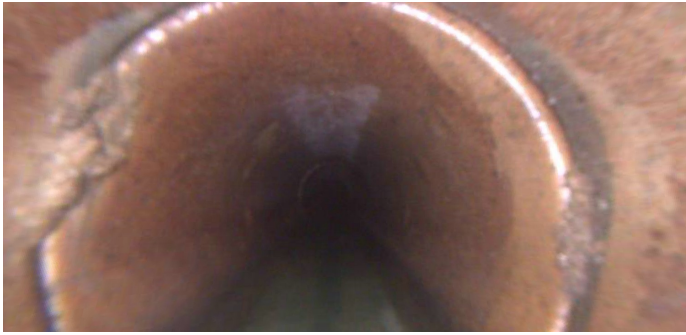
Code: **DAGS**
Description: **Deposits Attached Grease**

Distance (ft): **111.1**
Structural Grade: **0**
O&M Grade: **2**
Clock Start/From: **9**
Clock To:
1st Value:
2nd Value:
Value Percent: **5.000**
Continuous Index:
Within 8" of Joint: **YES**
Remarks:

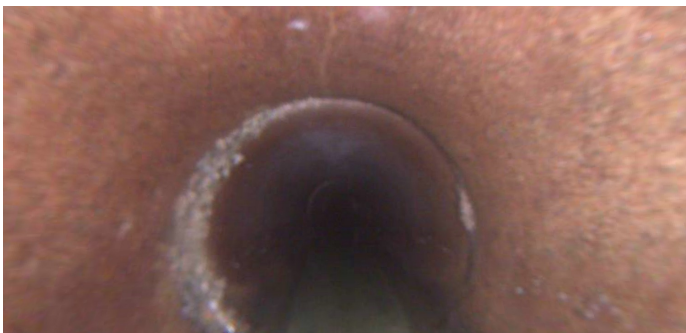
Code: **CL**
Description: **Crack Longitudinal**

Distance (ft): **125.5**
Structural Grade: **2**
O&M Grade: **0**
Clock Start/From: **12**
Clock To:
1st Value:
2nd Value:
Value Percent:
Continuous Index:
Within 8" of Joint: **YES**
Remarks:

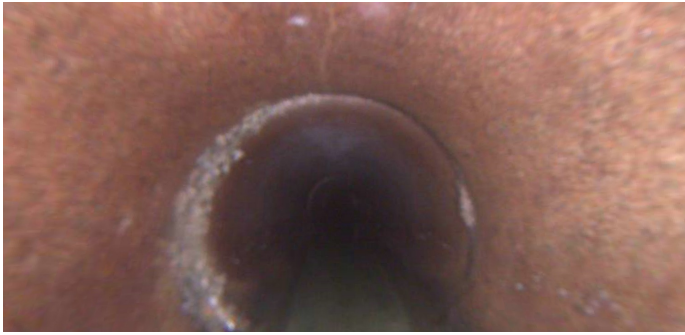
Code: **DAGS**
Description: **Deposits Attached Grease**

Distance (ft): **125.5**
Structural Grade: **0**
O&M Grade: **2**
Clock Start/From: **8**
Clock To: **4**
1st Value:
2nd Value:
Value Percent: **5.000**
Continuous Index: **S01**
Within 8" of Joint: **YES**
Remarks:

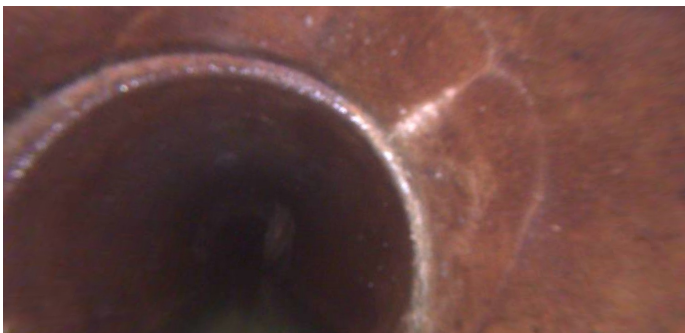
Code: **FM**
Description: **Fracture Multiple**

Distance (ft): **158.4**
Structural Grade: **4**
O&M Grade: **0**
Clock Start/From: **12**
Clock To: **4**
1st Value:
2nd Value:
Value Percent:
Continuous Index:
Within 8" of Joint: **YES**
Remarks:

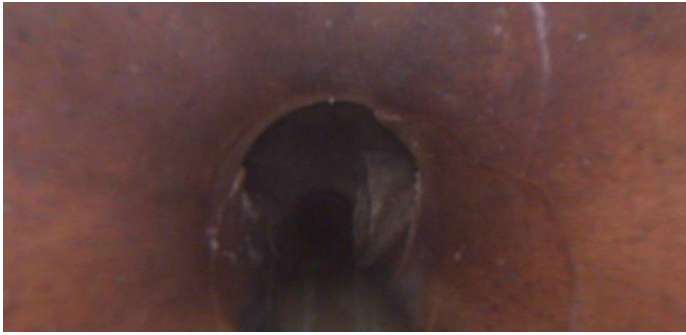
Code: **FM**
Description: **Fracture Multiple**

Distance (ft): **160.0**
Structural Grade: **4**
O&M Grade: **0**
Clock Start/From: **12**
Clock To: **12**
1st Value:
2nd Value:
Value Percent:
Continuous Index:
Within 8" of Joint:
Remarks:

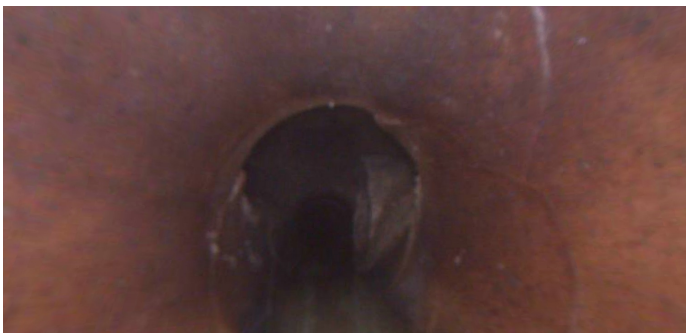
Code: **DAGS**
Description: **Deposits Attached Grease**

Distance (ft): **160.0**
Structural Grade: **0**
O&M Grade: **2**
Clock Start/From: **8**
Clock To: **4**
1st Value:
2nd Value:
Value Percent: **5.000**
Continuous Index: **F01**
Within 8" of Joint: **YES**
Remarks:

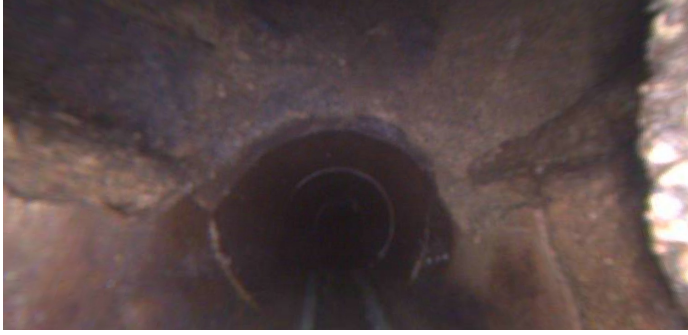
Code:	AMH
Description:	Manhole
Distance (ft):	162.9
Structural Grade:	0
O&M Grade:	0
Clock Start/From:	
Clock To:	
1st Value:	
2nd Value:	
Value Percent:	
Continuous Index:	
Within 8" of Joint:	NO
Remarks:	M-604-107
