Profile/Photo Observation Report

Street:	W Home Ave.	Flow Control:	Not Controlled
City:	Hobart, IN	Year Renewed:	
Location:	Other	Tape/Media #:	
Purpose:	Not Known	Dia/Height:	12"
Use:	Sanitary	Material:	VCP
Drain Area:	NA	Lining:	
Category:	NA		
Comment:

Location Details:		Direction of Survey:	Downstream
US MH:	M-604-058	DS MH:	M-604-107
		Total Length Surveyed (ft):	162.9

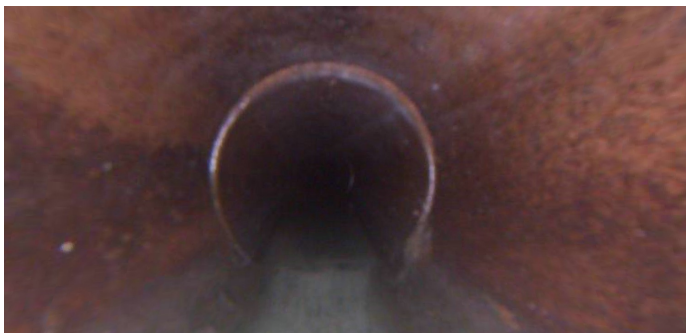
Code: **AMH**
Description: **Manhole**

Distance (ft): **.0**
Structural Grade: **0**
O&M Grade: **0**
Clock Start/From:
Clock To:
1st Value:
2nd Value:
Value Percent:
Continuous Index:
Within 8" of Joint: **NO**
Remarks: **M-604-058**

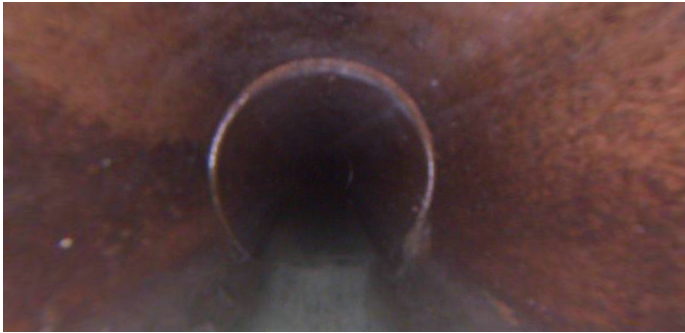
Code:	MWL
Description:	Water Level

Distance (ft):	.0
Structural Grade:	0
O&M Grade:	0
Clock Start/From:	
Clock To:	
1st Value:	
2nd Value:	
Value Percent:	5.000
Continuous Index:	
Within 8" of Joint:	NO
Remarks:

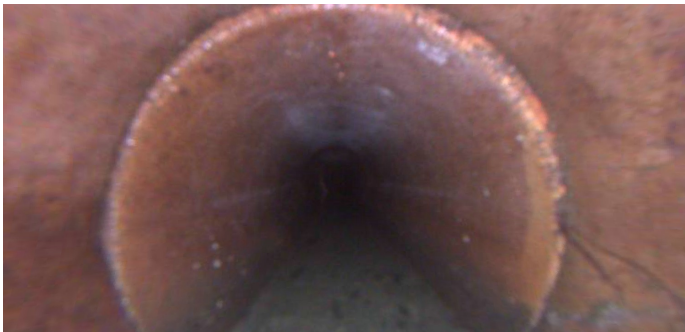
Code:	RFJ
Description:	Roots Fine Joint

Distance (ft):	7.3
Structural Grade:	0
O&M Grade:	1
Clock Start/From:	3
Clock To:	
1st Value:	
2nd Value:	
Value Percent:	
Continuous Index:	
Within 8" of Joint:	YES
Remarks:

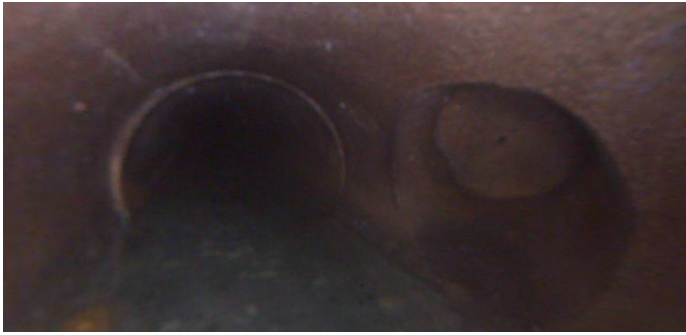
Code: **TFC**
Description: **Tap Factory Capped**

Distance (ft): **71.7**
Structural Grade: **0**
O&M Grade: **0**
Clock Start/From: **3**
Clock To:
1st Value: **4.000**
2nd Value:
Value Percent:
Continuous Index:
Within 8" of Joint:
Remarks:

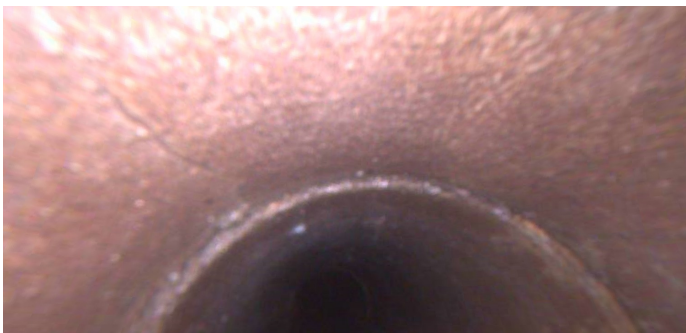
Code: **FL**
Description: **Fracture Longitudinal**

Distance (ft): **72.4**
Structural Grade: **3**
O&M Grade: **0**
Clock Start/From: **10**
Clock To:
1st Value:
2nd Value:
Value Percent:
Continuous Index:
Within 8" of Joint: **YES**
Remarks:

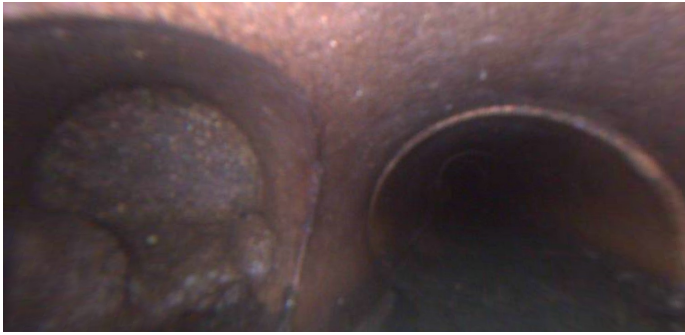
Code: **TFC**
Description: **Tap Factory Capped**

Distance (ft): **74.9**
Structural Grade: **0**
O&M Grade: **0**
Clock Start/From: **9**
Clock To:
1st Value: **4.000**
2nd Value:
Value Percent:
Continuous Index:
Within 8" of Joint:
Remarks:

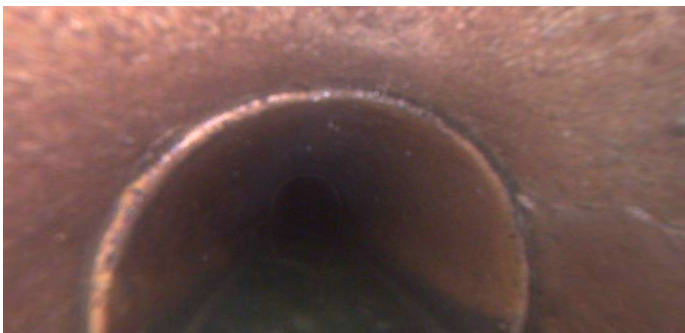
Code: **FL**
Description: **Fracture Longitudinal**

Distance (ft): **96.2**
Structural Grade: **3**
O&M Grade: **0**
Clock Start/From: **3**
Clock To:
1st Value:
2nd Value:
Value Percent:
Continuous Index:
Within 8" of Joint: **YES**
Remarks:

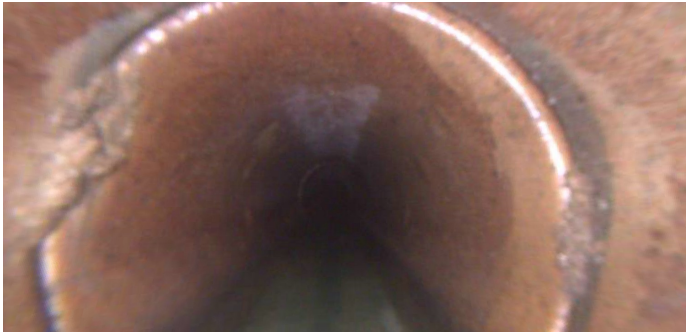
Code: **DAGS**
Description: **Deposits Attached Grease**

Distance (ft): **111.1**
Structural Grade: **0**
O&M Grade: **2**
Clock Start/From: **9**
Clock To:
1st Value:
2nd Value:
Value Percent: **5.000**
Continuous Index:
Within 8" of Joint: **YES**
Remarks:

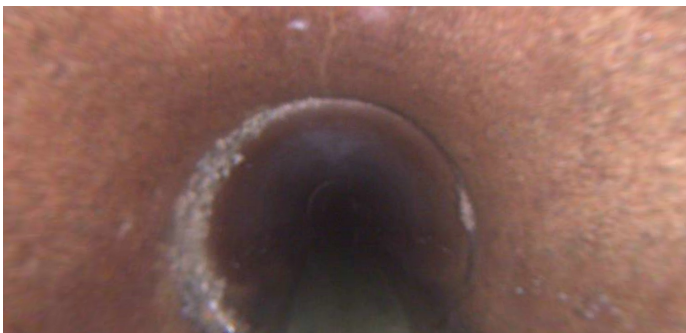
Code: **CL**
Description: **Crack Longitudinal**

Distance (ft): **125.5**
Structural Grade: **2**
O&M Grade: **0**
Clock Start/From: **12**
Clock To:
1st Value:
2nd Value:
Value Percent:
Continuous Index:
Within 8" of Joint: **YES**
Remarks:

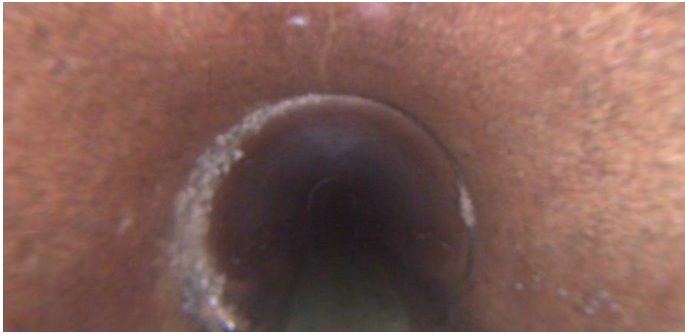
Code: **DAGS**
Description: **Deposits Attached Grease**

Distance (ft): **125.5**
Structural Grade: **0**
O&M Grade: **2**
Clock Start/From: **8**
Clock To: **4**
1st Value:
2nd Value:
Value Percent: **5.000**
Continuous Index: **S01**
Within 8" of Joint: **YES**
Remarks:

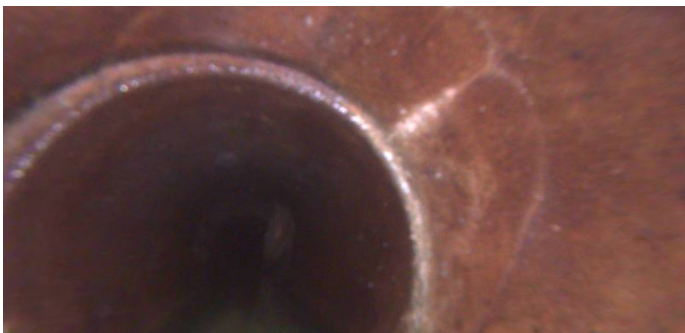
Code: **FM**
Description: **Fracture Multiple**

Distance (ft): **158.4**
Structural Grade: **4**
O&M Grade: **0**
Clock Start/From: **12**
Clock To: **4**
1st Value:
2nd Value:
Value Percent:
Continuous Index:
Within 8" of Joint: **YES**
Remarks:

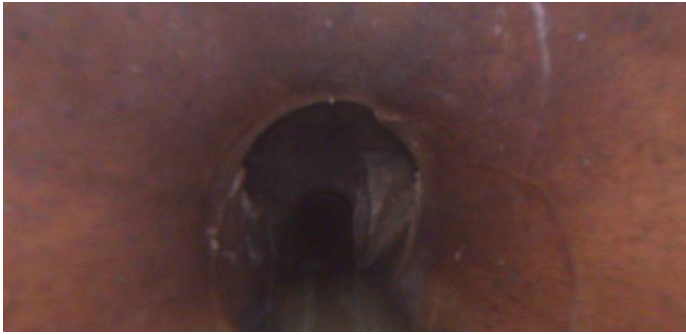
Code: **FM**
Description: **Fracture Multiple**

Distance (ft): **160.0**
Structural Grade: **4**
O&M Grade: **0**
Clock Start/From: **12**
Clock To: **12**
1st Value:
2nd Value:
Value Percent:
Continuous Index:
Within 8" of Joint:
Remarks:

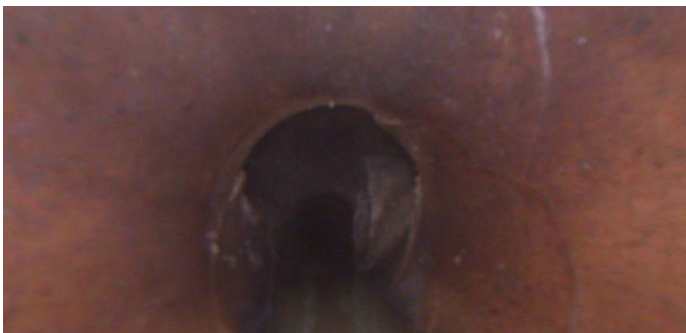
Code: **DAGS**
Description: **Deposits Attached Grease**

Distance (ft): **160.0**
Structural Grade: **0**
O&M Grade: **2**
Clock Start/From: **8**
Clock To: **4**
1st Value:
2nd Value:
Value Percent: **5.000**
Continuous Index: **F01**
Within 8" of Joint: **YES**
Remarks:

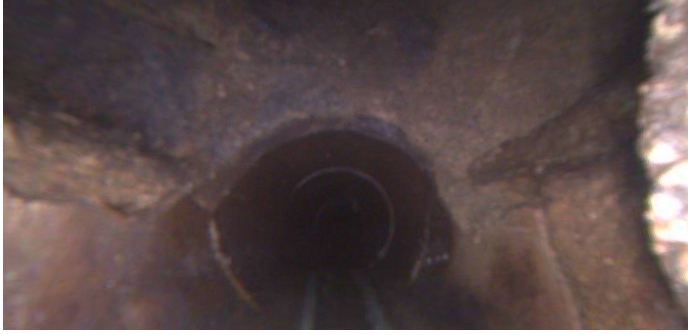
Code:	AMH
Description:	Manhole
Distance (ft):	162.9
Structural Grade:	0
O&M Grade:	0
Clock Start/From:	
Clock To:	
1st Value:	
2nd Value:	
Value Percent:	
Continuous Index:	
Within 8" of Joint:	NO
Remarks:	M-604-107
