Profile/Photo Observation Report

Date:	04/24/2018	Weather:		Coding:	PACP 6.0
Pipe Length (ft):	329.1	Owner:	NA	Pre Clean:	Not Known
P.O.#:		Surveyor:	Jen Costello	PSR:	P-604-107-058
Customer:		Clean Date:	01/01/1900	Shape:	C

Street:	W Home Ave.	Flow Control:	Not Controlled
City:	Hobart, IN	Year Renewed:	
Location:	Other	Tape/Media #:	
Purpose:	Not Known	Dia/Height:	12"
Use:	Sanitary	Material:	VCP
Drain Area:	NA	Lining:	
Category:	NA		
Comment:

Location Details:		Direction of Survey:	Upstream
US MH:	M-604-058	DS MH:	M-604-107
		Total Length Surveyed (ft):	11.8

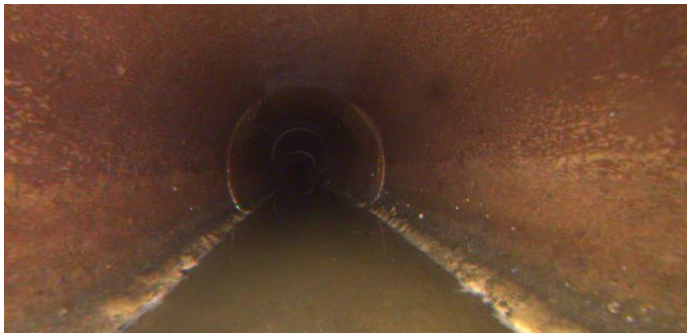
Code: **AMH**
Description: **Manhole**

Distance (ft): **.0**
Structural Grade: **0**
O&M Grade: **0**
Clock Start/From:
Clock To:
1st Value:
2nd Value:
Value Percent:
Continuous Index:
Within 8" of Joint: **NO**
Remarks: **M-604-107**

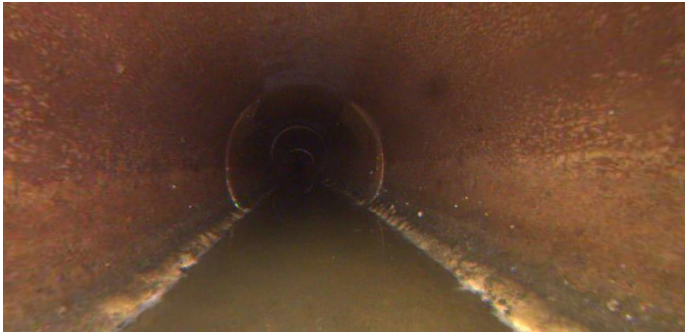
Code:	MWL
Description:	Water Level

Distance (ft):	.0
Structural Grade:	0
O&M Grade:	0
Clock Start/From:	
Clock To:	
1st Value:	
2nd Value:	
Value Percent:	10.000
Continuous Index:	
Within 8" of Joint:	NO
Remarks:

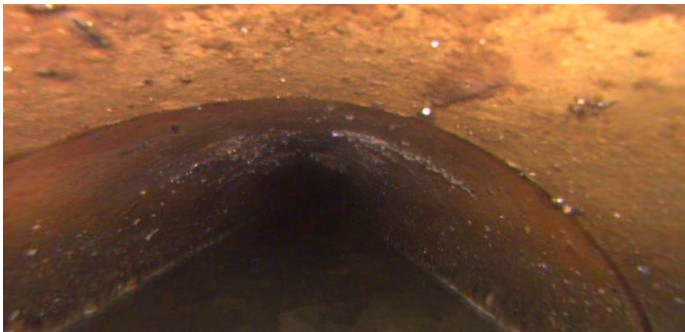
Code:	MSA
Description:	Abandoned Survey

Distance (ft):	11.8
Structural Grade:	0
O&M Grade:	0
Clock Start/From:	
Clock To:	
1st Value:	
2nd Value:	
Value Percent:	
Continuous Index:	
Within 8" of Joint:	NO
Remarks:	debris under water
