Profile/Photo Observation Report

Date:	04/16/2018	Weather:		Coding:	PACP 6.0
Pipe Length (ft):		Owner:	City of Hobart	Pre Clean:	No Pre-Cleaning
P.O.#:	62-2	Surveyor:	M. Pielacha	PSR:	M-604-059-M-604-060
Customer:	City of Hobart	Clean Date:		Shape:	C

Street:	1st Street	Flow Control:	Not Controlled
City:	Hobart, IN	Year Renewed:	
Location:	Light Highway	Tape/Media #:	DEP 62
Purpose:	Routine Assessment	Dia/Height:	18"
Use:	Sanitary	Material:	VCP
Drain Area:		Lining:	
Category:	NA		
Comment:			
Location Details:		Direction of Survey:	Downstream
US MH:	M-604-059	DS MH:	M-604-060
		Total Length Surveyed (ft):	221.1

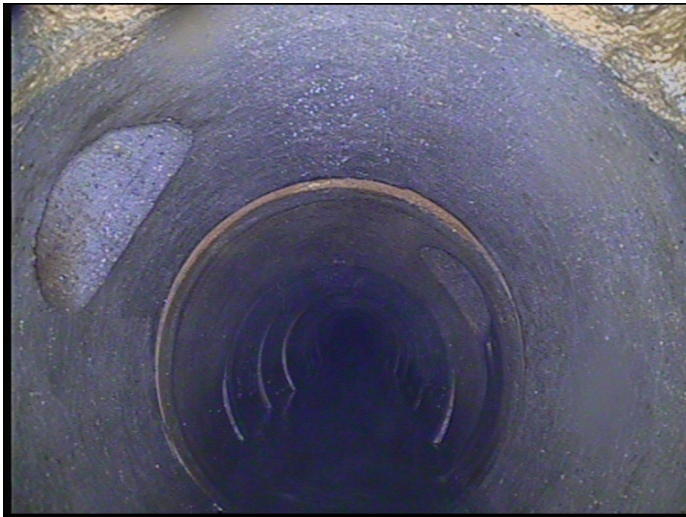
Code: **MWL**
Description: **Water Level**

Distance (ft): **.0**
Structural Grade: **0**
O&M Grade: **0**
Clock Start/From:
Clock To:
1st Value:
2nd Value:
Value Percent: **10.000**
Continuous Index:
Within 8" of Joint: **NO**
Remarks:

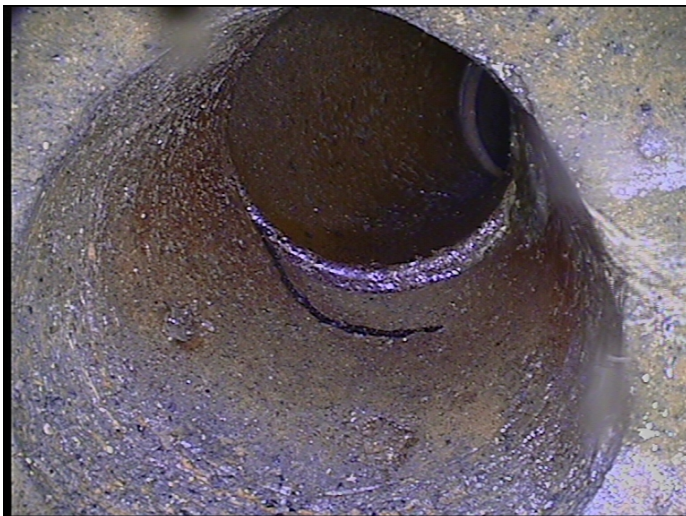
Code: **TFA**
Description: **Tap Factory Active**

Distance (ft): **4.0**
Structural Grade: **0**
O&M Grade: **0**
Clock Start/From: **2**
Clock To:
1st Value: **4.000**
2nd Value:
Value Percent:
Continuous Index:
Within 8" of Joint: **NO**
Remarks:

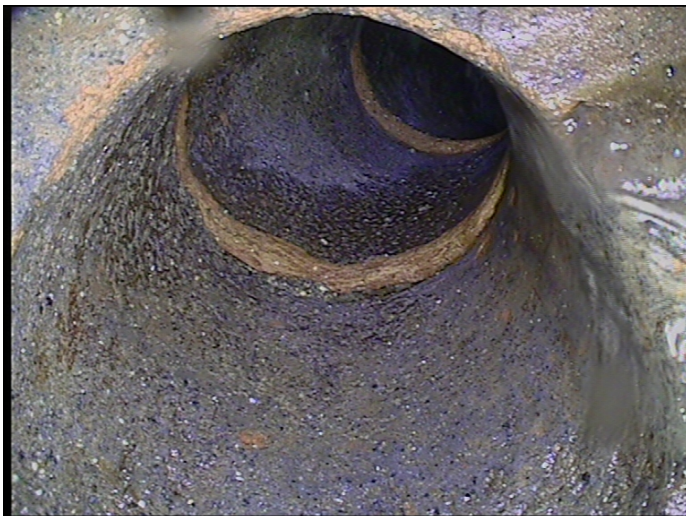
Code:	TFA
Description:	Tap Factory Active
Distance (ft):	42.1
Structural Grade:	0
O&M Grade:	0
Clock Start/From:	2
Clock To:	
1st Value:	4.000
2nd Value:	
Value Percent:	
Continuous Index:	
Within 8" of Joint:	NO
Remarks:

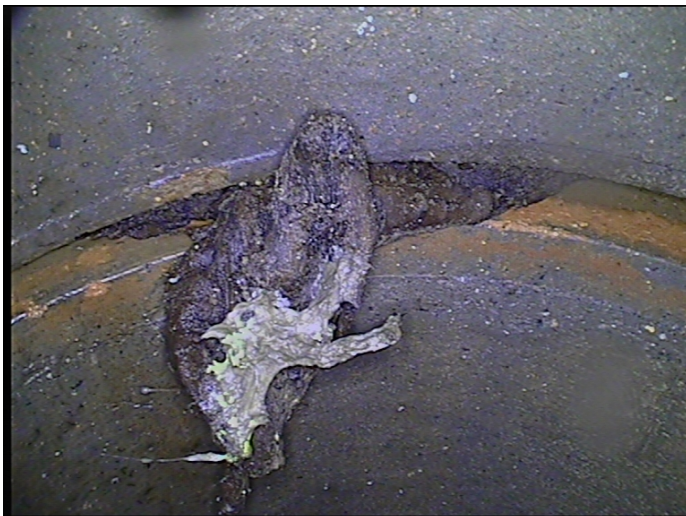
Code: **RTJ**
Description: **Roots Tap Joint**

Distance (ft): **46.8**
Structural Grade: **0**
O&M Grade: **2**
Clock Start/From: **9**
Clock To:
1st Value:
2nd Value:
Value Percent: **5.000**
Continuous Index:
Within 8" of Joint: **YES**
Remarks:

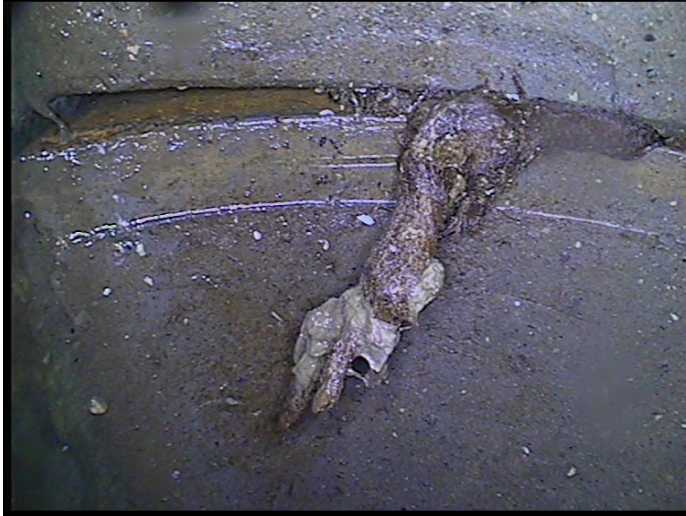
Code: **RTJ**
Description: **Roots Tap Joint**

Distance (ft): **53.1**
Structural Grade: **0**
O&M Grade: **2**
Clock Start/From: **9**
Clock To:
1st Value:
2nd Value:
Value Percent: **5.000**
Continuous Index:
Within 8" of Joint: **YES**
Remarks:

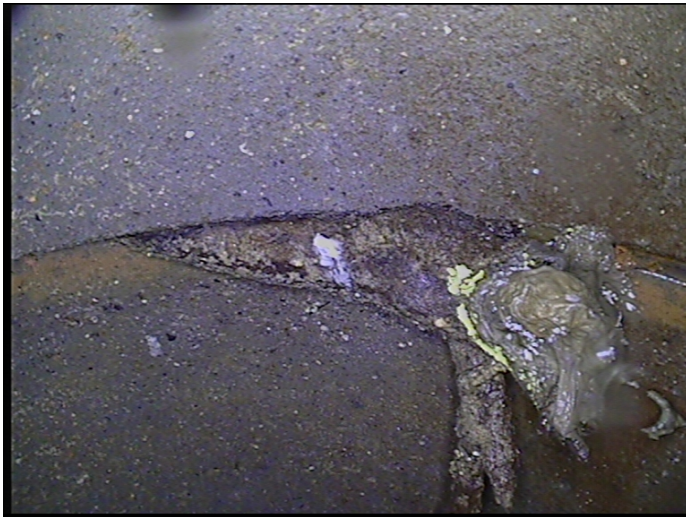
Code: **RTJ**
Description: **Roots Tap Joint**

Distance (ft): **55.0**
Structural Grade: **0**
O&M Grade: **2**
Clock Start/From: **8**
Clock To: **4**
1st Value:
2nd Value:
Value Percent: **5.000**
Continuous Index:
Within 8" of Joint: **YES**
Remarks:

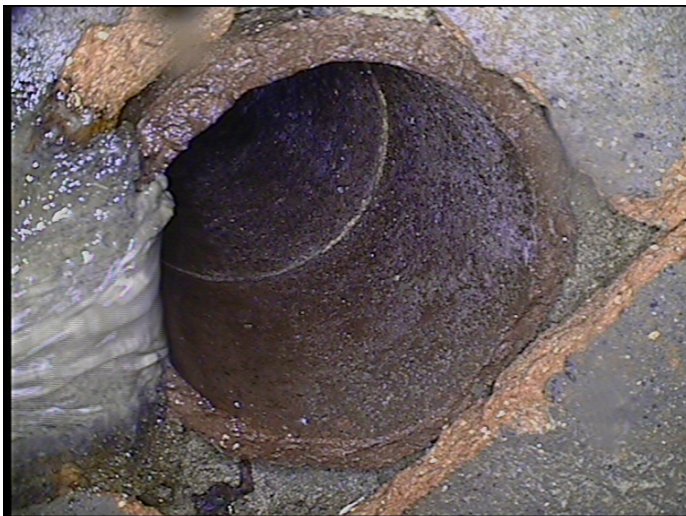
Code: **TBA**
Description: **Tap Break-in Active**

Distance (ft): **72.3**
Structural Grade: **0**
O&M Grade: **0**
Clock Start/From: **10**
Clock To:
1st Value: **4.000**
2nd Value:
Value Percent:
Continuous Index:
Within 8" of Joint: **NO**
Remarks:

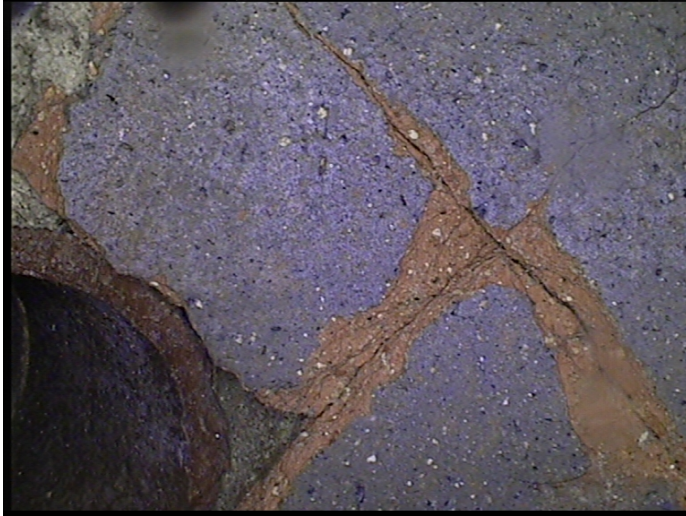
Code: **CM**
Description: **Crack Multiple**

Distance (ft): **72.3**
Structural Grade: **3**
O&M Grade: **0**
Clock Start/From: **10**
Clock To: **1**
1st Value:
2nd Value:
Value Percent:
Continuous Index:
Within 8" of Joint: **YES**
Remarks:

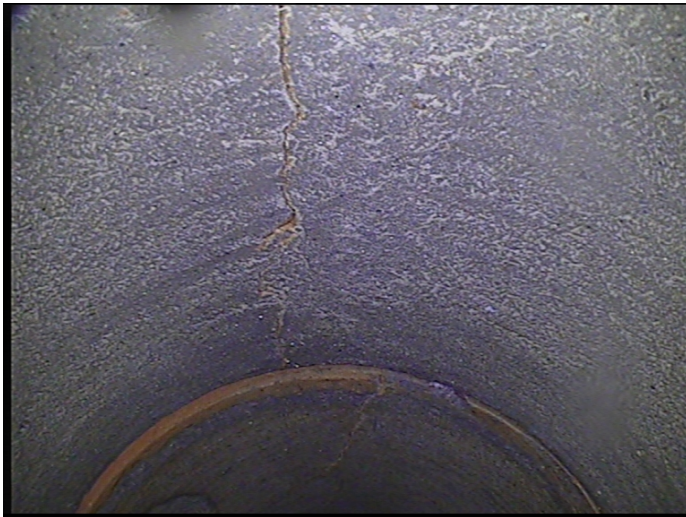
Code: **FL**
Description: **Fracture Longitudinal**

Distance (ft): **75.5**
Structural Grade: **3**
O&M Grade: **0**
Clock Start/From: **12**
Clock To:
1st Value:
2nd Value:
Value Percent:
Continuous Index: **S01**
Within 8" of Joint: **YES**
Remarks:

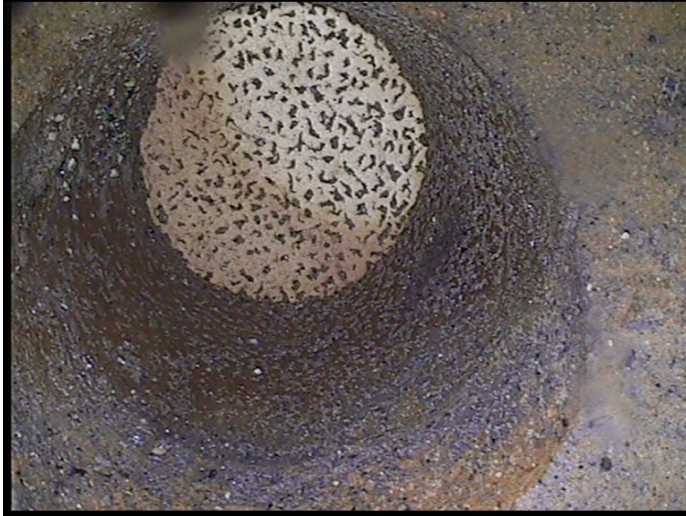
Code: **TFC**
Description: **Tap Factory Capped**

Distance (ft): **78.6**
Structural Grade: **0**
O&M Grade: **0**
Clock Start/From: **9**
Clock To:
1st Value: **4.000**
2nd Value:
Value Percent:
Continuous Index:
Within 8" of Joint: **NO**
Remarks:

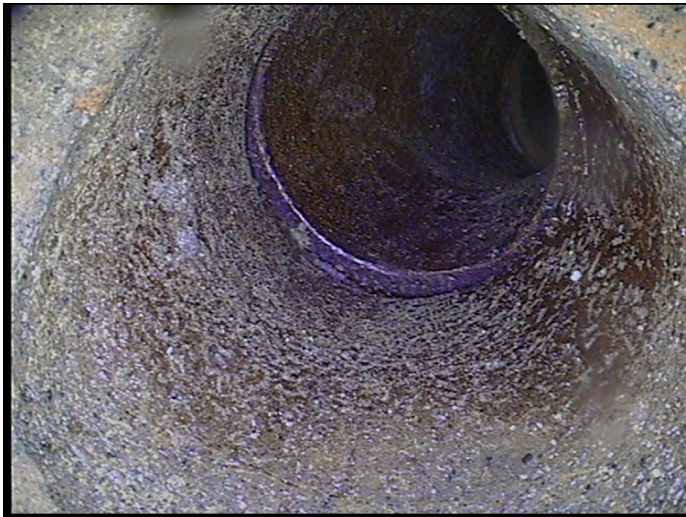
Code: **TF**
Description: **Tap Factory**

Distance (ft): **80.8**
Structural Grade: **0**
O&M Grade: **0**
Clock Start/From: **2**
Clock To:
1st Value: **4.000**
2nd Value:
Value Percent:
Continuous Index:
Within 8" of Joint: **NO**
Remarks:

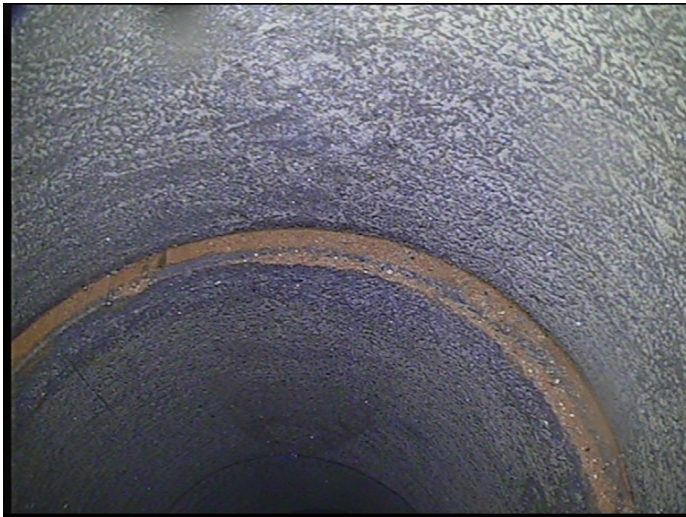
Code: **FL**
Description: **Fracture Longitudinal**

Distance (ft): **82.3**
Structural Grade: **3**
O&M Grade: **0**
Clock Start/From: **12**
Clock To:
1st Value:
2nd Value:
Value Percent:
Continuous Index: **F01**
Within 8" of Joint: **NO**
Remarks:

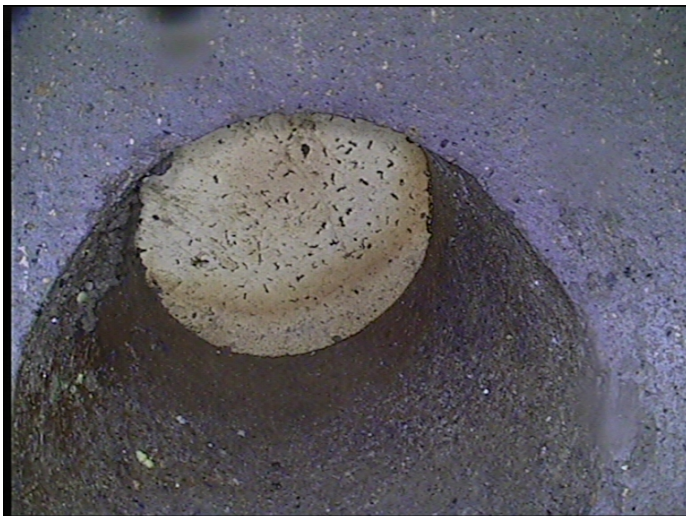
Code: **TFC**
Description: **Tap Factory Capped**

Distance (ft): **118.8**
Structural Grade: **0**
O&M Grade: **0**
Clock Start/From: **10**
Clock To:
1st Value: **4.000**
2nd Value:
Value Percent:
Continuous Index:
Within 8" of Joint: **NO**
Remarks:

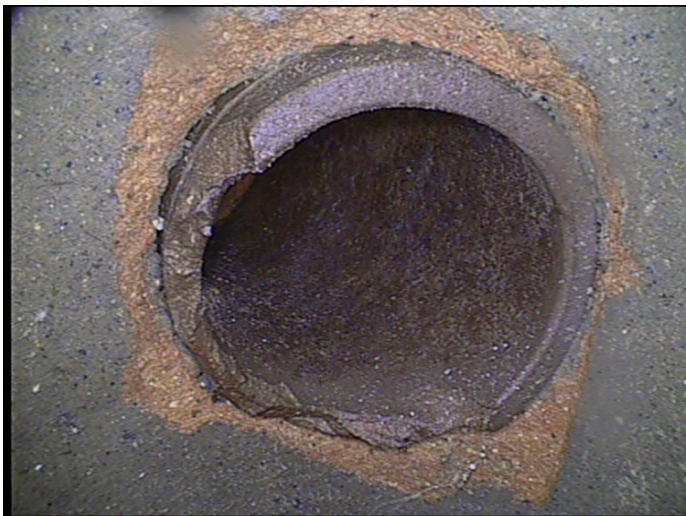
Code: **TB**
Description: **Tap Break-in**

Distance (ft): **128.6**
Structural Grade: **0**
O&M Grade: **0**
Clock Start/From: **10**
Clock To:
1st Value: **4.000**
2nd Value:
Value Percent:
Continuous Index:
Within 8" of Joint: **NO**
Remarks:

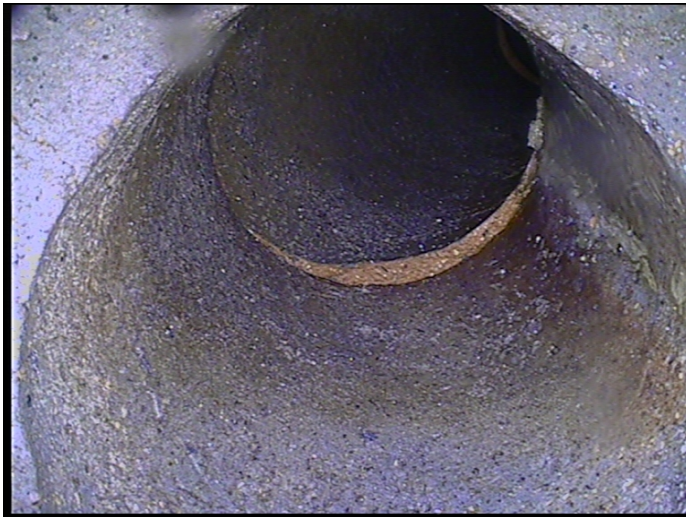
Code:	TFA
Description:	Tap Factory Active
Distance (ft):	159.5
Structural Grade:	0
O&M Grade:	0
Clock Start/From:	2
Clock To:	
1st Value:	4.000
2nd Value:	
Value Percent:	
Continuous Index:	
Within 8" of Joint:	NO
Remarks:

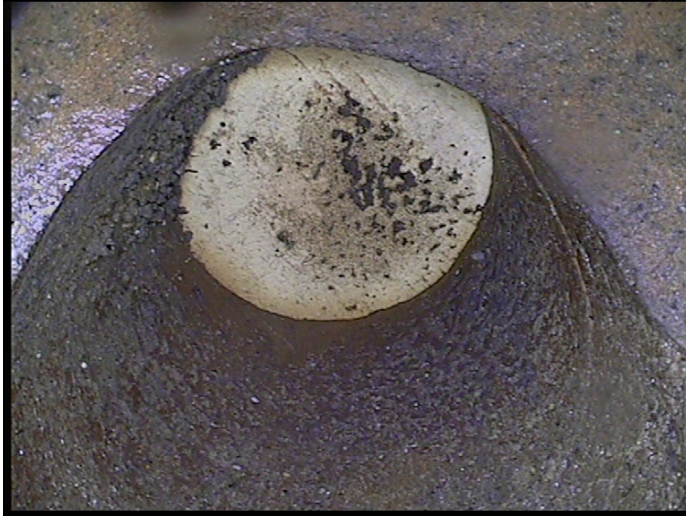
Code:	TFC
Description:	Tap Factory Capped
Distance (ft):	197.6
Structural Grade:	0
O&M Grade:	0
Clock Start/From:	10
Clock To:	
1st Value:	4.000
2nd Value:	
Value Percent:	
Continuous Index:	
Within 8" of Joint:	NO
Remarks:

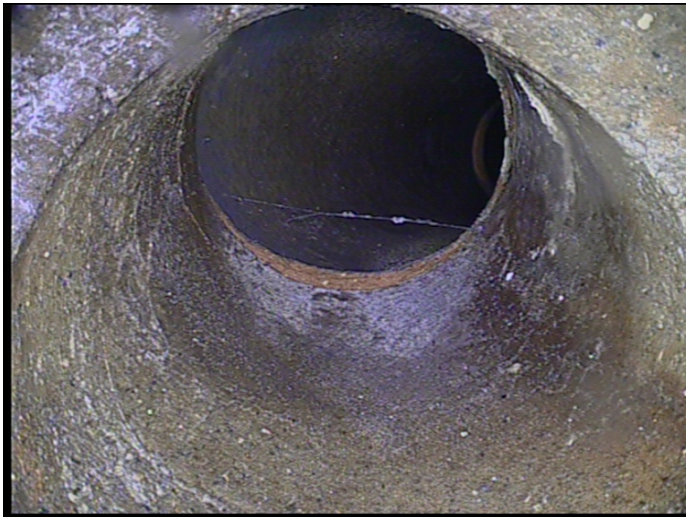
Code:	TF
Description:	Tap Factory
Distance (ft):	199.8
Structural Grade:	0
O&M Grade:	0
Clock Start/From:	2
Clock To:	
1st Value:	4.000
2nd Value:	
Value Percent:	
Continuous Index:	
Within 8" of Joint:	NO
Remarks:

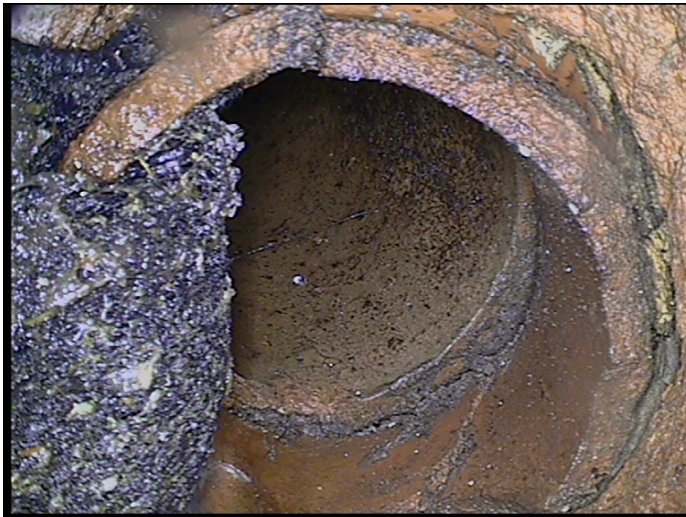
Code: **TBD**
Description: **Tap Break-in Defective**

Distance (ft): **207.8**
Structural Grade: **0**
O&M Grade: **3**
Clock Start/From: **10**
Clock To:
1st Value: **4.000**
2nd Value:
Value Percent:
Continuous Index:
Within 8" of Joint: **NO**
Remarks: **Defective**

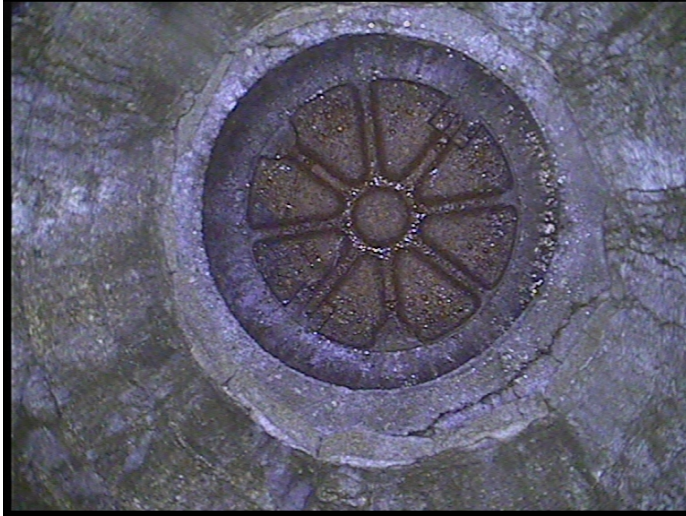
Code:	AMH
Description:	Manhole
Distance (ft):	221.1
Structural Grade:	0
O&M Grade:	0
Clock Start/From:	
Clock To:	
1st Value:	
2nd Value:	
Value Percent:	
Continuous Index:	
Within 8" of Joint:	NO
Remarks:	M-604-060
