Profile/Photo Observation Report

Date:	04/16/2018	Weather:		Coding:	PACP 6.0
Pipe Length (ft):		Owner:	City of Hobart	Pre Clean:	No Pre-Cleaning
P.O.#:	61-2	Surveyor:	M. Pielacha	PSR:	M-604-060-M-604-061
Customer:	City of Hobart	Clean Date:		Shape:	C

Street:	Connecticut Street	Flow Control:	Not Controlled
City:	Hobart, IN	Year Renewed:	
Location:	Light Highway	Tape/Media #:	DEP 61
Purpose:	Routine Assessment	Dia/Height:	18"
Use:	Sanitary	Material:	VCP
Drain Area:		Lining:	
Category:	NA		
Comment:			
Location Details:		Direction of Survey:	Upstream
US MH:	M-604-060	DS MH:	M-604-061
		Total Length Surveyed (ft):	222.7

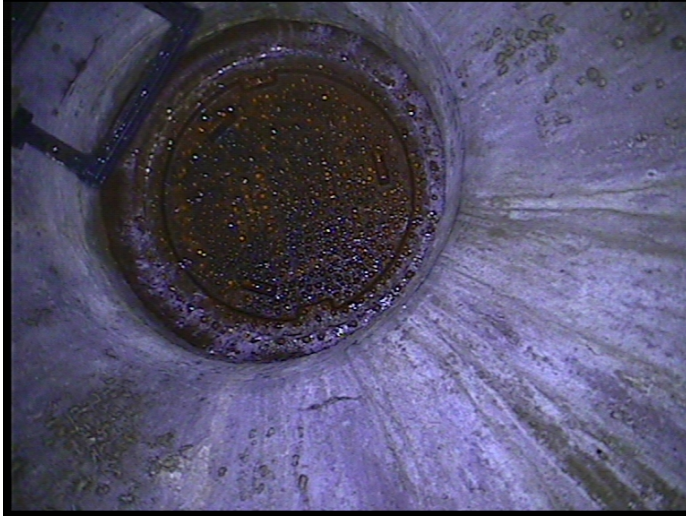
Code: **AMH**
Description: **Manhole**

Distance (ft): **.0**
Structural Grade: **0**
O&M Grade: **0**
Clock Start/From:
Clock To:
1st Value:
2nd Value:
Value Percent:
Continuous Index:
Within 8" of Joint: **NO**
Remarks: **M-604-061**

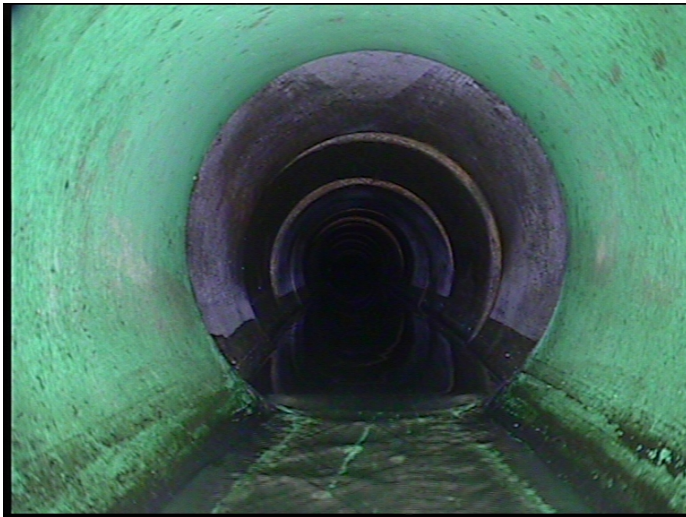
Code: **MWL**
Description: **Water Level**

Distance (ft): **.0**
Structural Grade: **0**
O&M Grade: **0**
Clock Start/From:
Clock To:
1st Value:
2nd Value:
Value Percent: **10.000**
Continuous Index:
Within 8" of Joint: **NO**
Remarks:

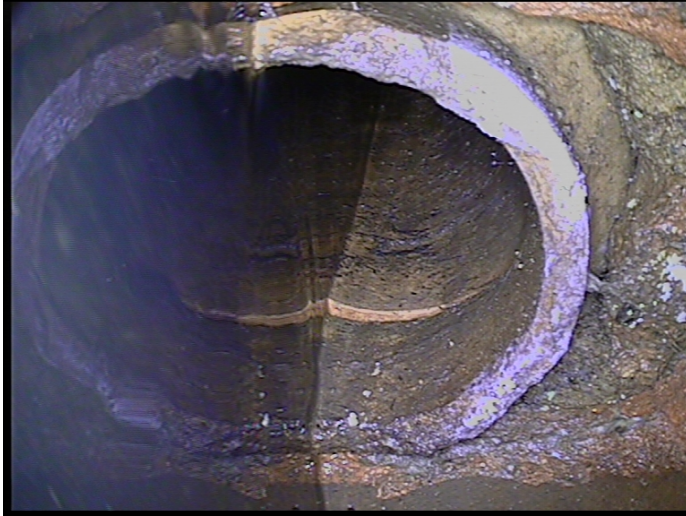
Code: **TB**
Description: **Tap Break-in**

Distance (ft): **26.2**
Structural Grade: **0**
O&M Grade: **0**
Clock Start/From: **9**
Clock To:
1st Value: **4.000**
2nd Value:
Value Percent:
Continuous Index:
Within 8" of Joint: **NO**
Remarks:

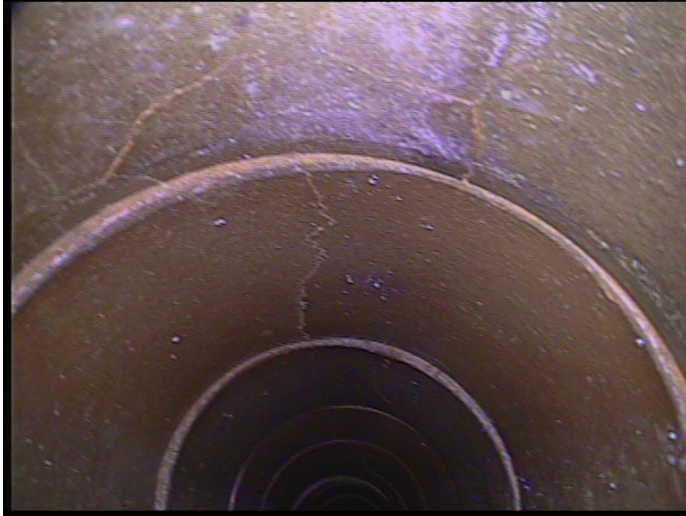
Code: **CL**
Description: **Crack Longitudinal**

Distance (ft): **30.2**
Structural Grade: **2**
O&M Grade: **0**
Clock Start/From: **12**
Clock To:
1st Value:
2nd Value:
Value Percent:
Continuous Index: **S01**
Within 8" of Joint: **YES**
Remarks:

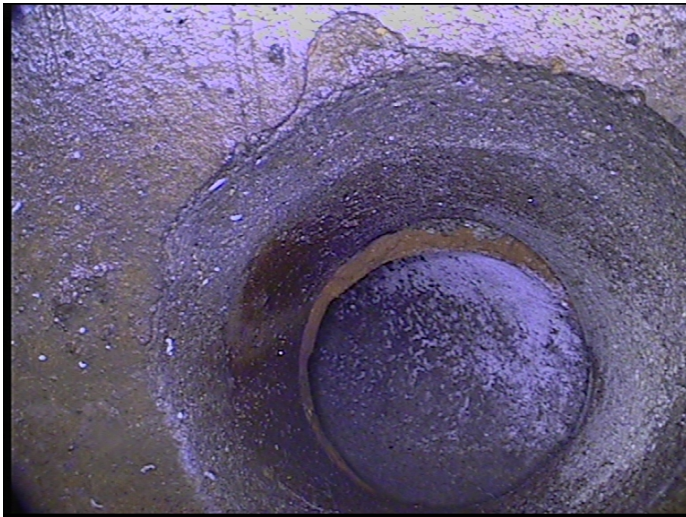
Code: **TF**
Description: **Tap Factory**

Distance (ft): **49.2**
Structural Grade: **0**
O&M Grade: **0**
Clock Start/From: **10**
Clock To:
1st Value: **4.000**
2nd Value:
Value Percent:
Continuous Index:
Within 8" of Joint: **NO**
Remarks:

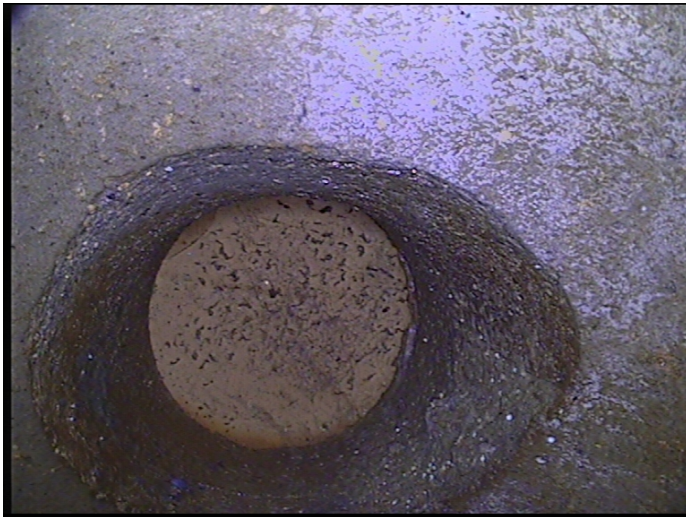
Code: **TFC**
Description: **Tap Factory Capped**

Distance (ft): **51.2**
Structural Grade: **0**
O&M Grade: **0**
Clock Start/From: **2**
Clock To:
1st Value: **4.000**
2nd Value:
Value Percent:
Continuous Index:
Within 8" of Joint: **NO**
Remarks:

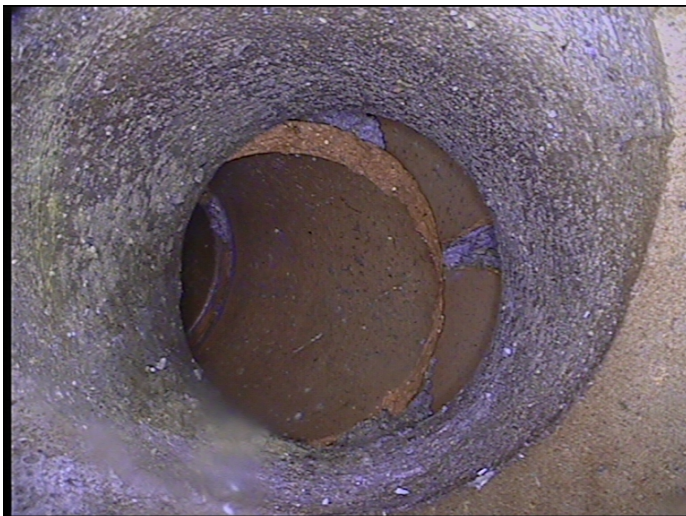
Code: **TF**
Description: **Tap Factory**

Distance (ft): **88.6**
Structural Grade: **0**
O&M Grade: **0**
Clock Start/From: **10**
Clock To:
1st Value: **4.000**
2nd Value:
Value Percent:
Continuous Index:
Within 8" of Joint: **NO**
Remarks:

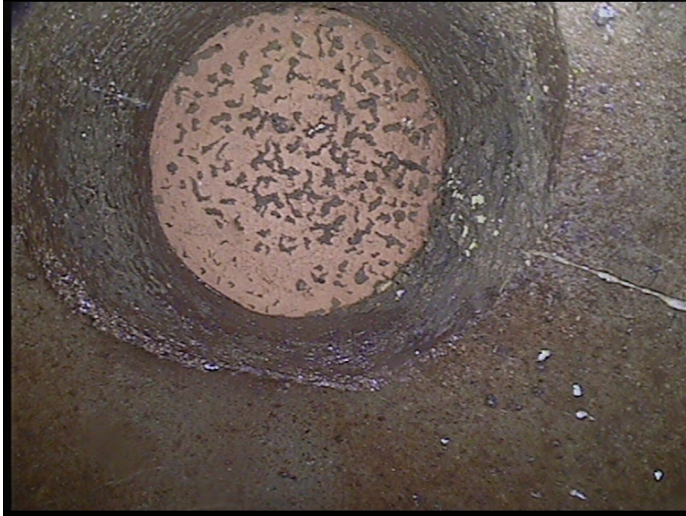
Code: **TFC**
Description: **Tap Factory Capped**

Distance (ft): **129.7**
Structural Grade: **0**
O&M Grade: **0**
Clock Start/From: **2**
Clock To:
1st Value: **4.000**
2nd Value:
Value Percent:
Continuous Index:
Within 8" of Joint: **NO**
Remarks:

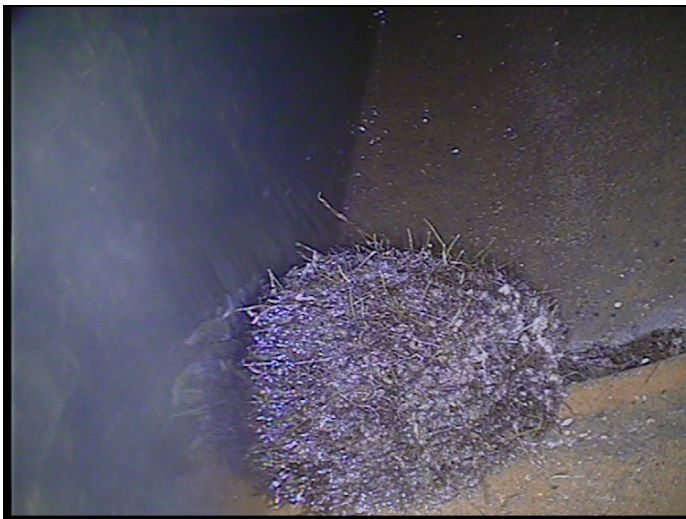
Code:	RMJ
Description:	Roots Medium Joint
Distance (ft):	148.6
Structural Grade:	0
O&M Grade:	3
Clock Start/From:	4
Clock To:	
1st Value:	
2nd Value:	
Value Percent:	5.000
Continuous Index:	
Within 8" of Joint:	YES
Remarks:

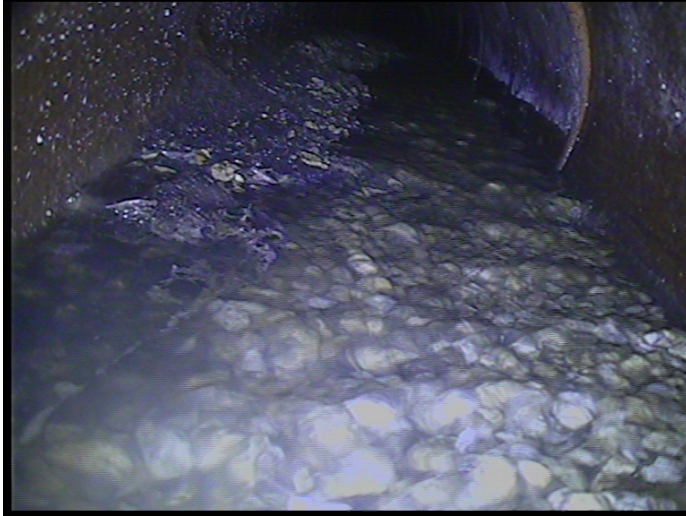
Code: **DSF**
Description: **Deposits Settled Fine**

Distance (ft): **156.3**
Structural Grade: **0**
O&M Grade: **3**
Clock Start/From: **5**
Clock To: **7**
1st Value:
2nd Value:
Value Percent: **15.000**
Continuous Index: **S02**
Within 8" of Joint: **YES**
Remarks:

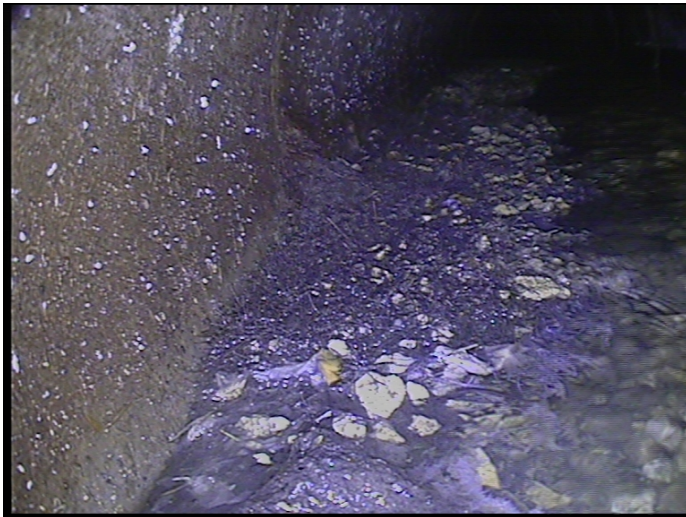
Code: **RMJ**
Description: **Roots Medium Joint**

Distance (ft): **157.6**
Structural Grade: **0**
O&M Grade: **3**
Clock Start/From: **8**
Clock To:
1st Value:
2nd Value:
Value Percent: **10.000**
Continuous Index: **S03**
Within 8" of Joint: **YES**
Remarks:

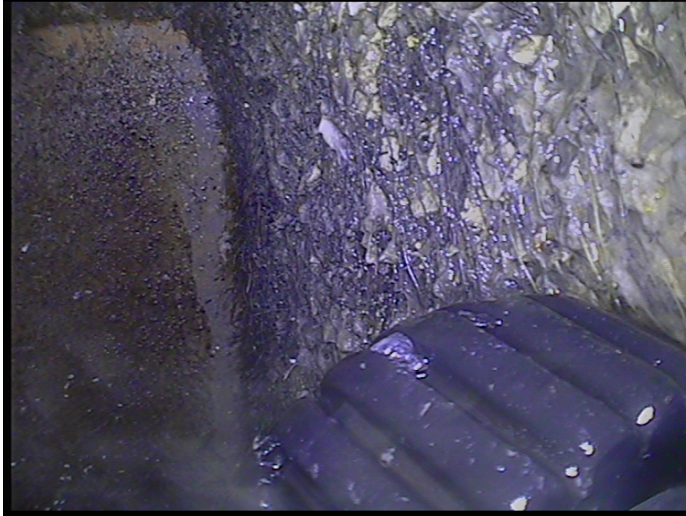
Code: **RMJ**
Description: **Roots Medium Joint**

Distance (ft): **165.4**
Structural Grade: **0**
O&M Grade: **3**
Clock Start/From: **8**
Clock To:
1st Value:
2nd Value:
Value Percent: **10.000**
Continuous Index: **F03**
Within 8" of Joint: **YES**
Remarks:

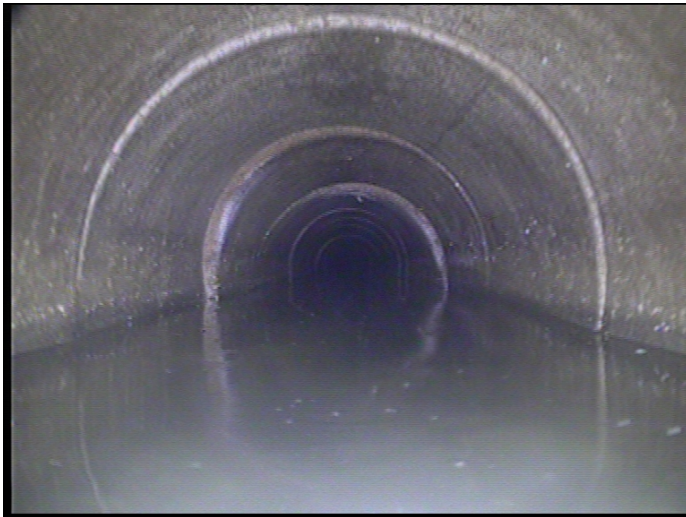
Code: **DSF**
 Description: **Deposits Settled Fine**

Distance (ft): **172.6**
 Structural Grade: **0**
 O&M Grade: **3**
 Clock Start/From: **5**
 Clock To: **7**
 1st Value:
 2nd Value:
 Value Percent: **15.000**
 Continuous Index: **F02**
 Within 8" of Joint: **NO**
 Remarks:

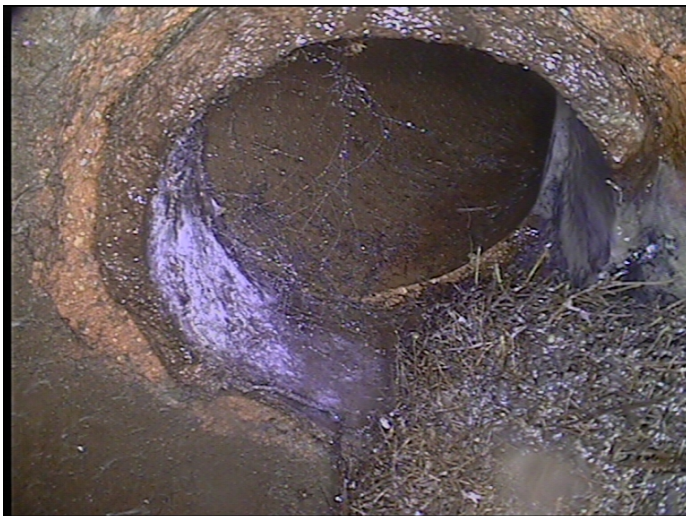
Code: **TBD**
 Description: **Tap Break-in Defective**

Distance (ft): **203.0**
 Structural Grade: **0**
 O&M Grade: **3**
 Clock Start/From: **3**
 Clock To:
 1st Value: **4.000**
 2nd Value:
 Value Percent:
 Continuous Index:
 Within 8" of Joint: **NO**
 Remarks: **Defective**

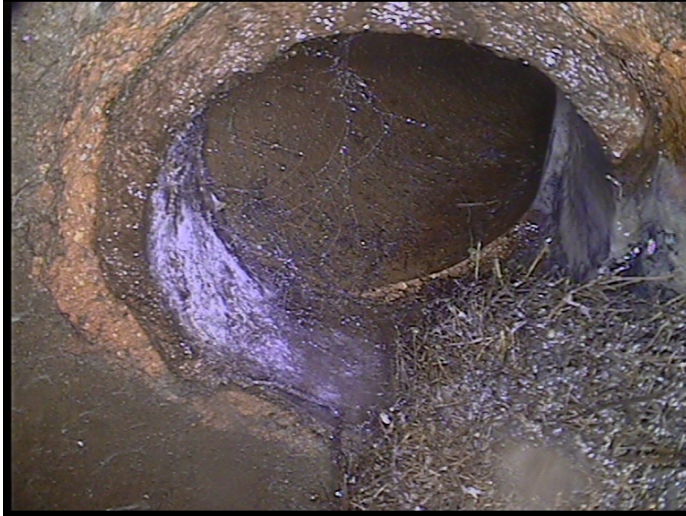
Code: **RML**
Description: **Roots Medium Lateral**

Distance (ft): **203.0**
Structural Grade: **0**
O&M Grade: **3**
Clock Start/From: **3**
Clock To:
1st Value:
2nd Value:
Value Percent: **15.000**
Continuous Index:
Within 8" of Joint: **NO**
Remarks:

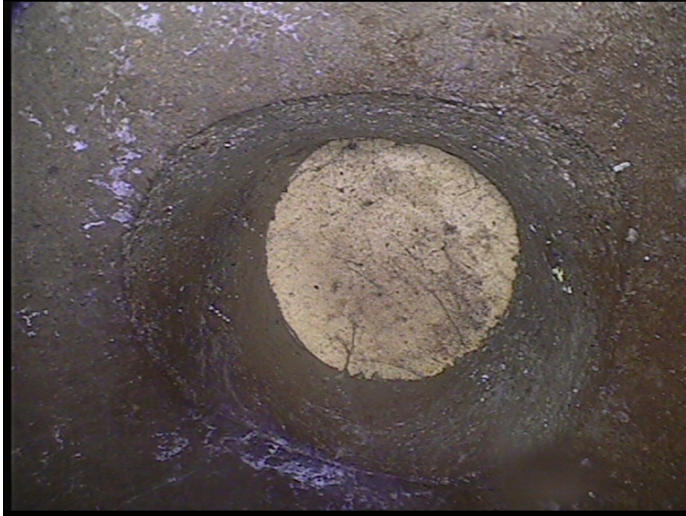
Code: **TFA**
Description: **Tap Factory Active**

Distance (ft): **207.3**
Structural Grade: **0**
O&M Grade: **0**
Clock Start/From: **2**
Clock To:
1st Value: **4.000**
2nd Value:
Value Percent:
Continuous Index:
Within 8" of Joint: **NO**
Remarks:

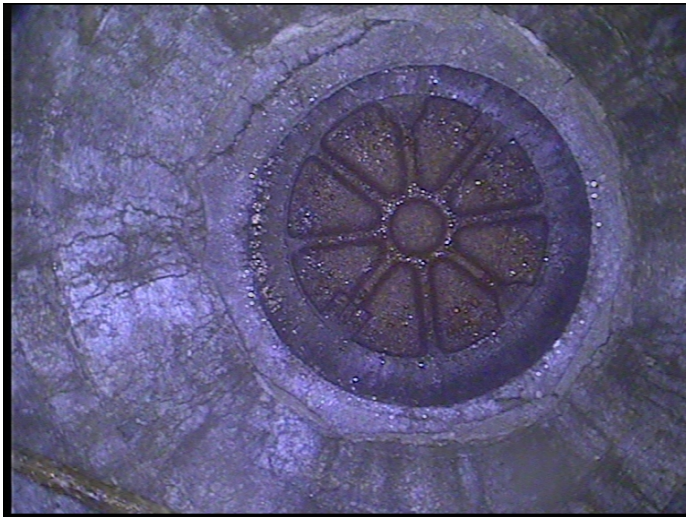
Code: **AMH**
Description: **Manhole**

Distance (ft): **222.7**
Structural Grade: **0**
O&M Grade: **0**
Clock Start/From:
Clock To:
1st Value:
2nd Value:
Value Percent:
Continuous Index:
Within 8" of Joint: **NO**
Remarks: **M-604-060**
