Profile/Photo Observation Report

Date:	04/16/2018	Weather:		Coding:	PACP 6.0
Pipe Length (ft):		Owner:	City of Hobart	Pre Clean:	No Pre-Cleaning
P.O.#:	61-2	Surveyor:	M. Pielacha	PSR:	M-604-060-M-604-061
Customer:	City of Hobart	Clean Date:		Shape:	C

Street:	Connecticut Street	Flow Control:	Not Controlled
City:	Hobart, IN	Year Renewed:	
Location:	Light Highway	Tape/Media #:	DEP 61
Purpose:	Routine Assessment	Dia/Height:	18"
Use:	Sanitary	Material:	VCP
Drain Area:		Lining:	
Category:	NA		
Comment:			
Location Details:		Direction of Survey:	Upstream
US MH:	M-604-060	DS MH:	M-604-061
		Total Length Surveyed (ft):	222.7

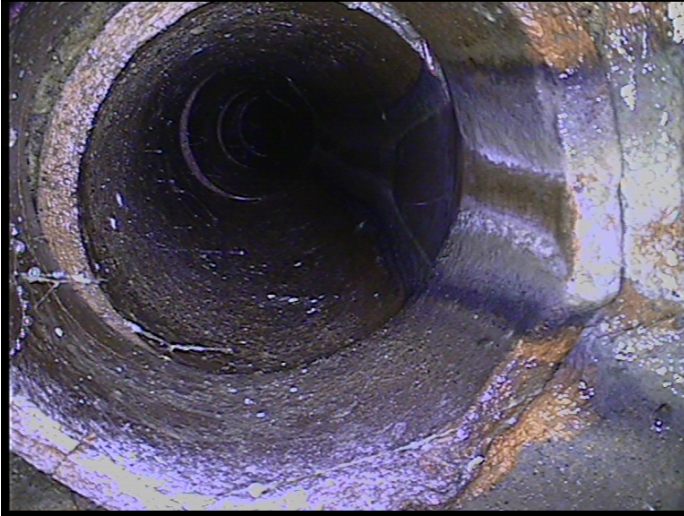
Code: **TB**
Description: **Tap Break-in**

Distance (ft): **62.1**
Structural Grade: **0**
O&M Grade: **0**
Clock Start/From: **3**
Clock To:
1st Value: **4.000**
2nd Value:
Value Percent:
Continuous Index:
Within 8" of Joint: **NO**
Remarks:

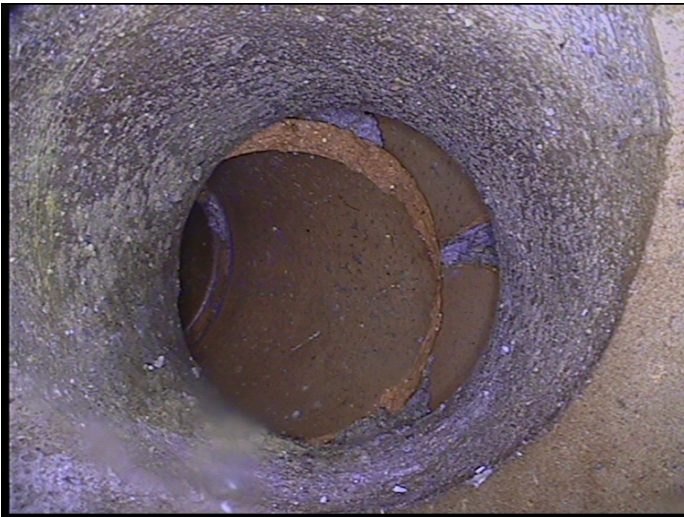
Code: **TF**
Description: **Tap Factory**

Distance (ft): **88.6**
Structural Grade: **0**
O&M Grade: **0**
Clock Start/From: **10**
Clock To:
1st Value: **4.000**
2nd Value:
Value Percent:
Continuous Index:
Within 8" of Joint: **NO**
Remarks:

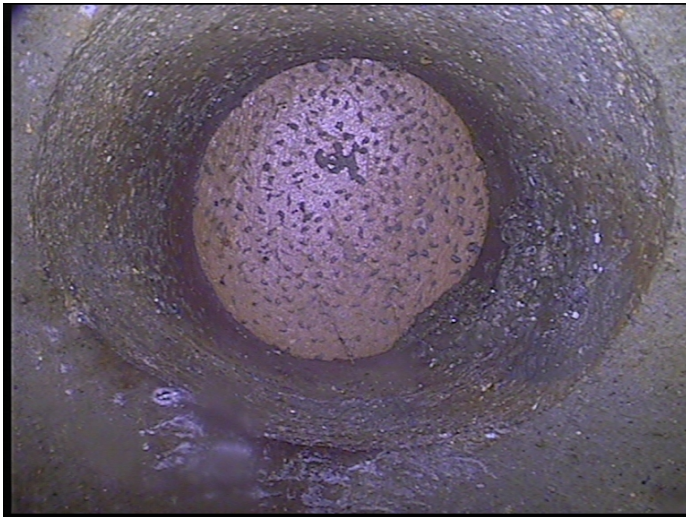
Code: **TFC**
Description: **Tap Factory Capped**

Distance (ft): **90.2**
Structural Grade: **0**
O&M Grade: **0**
Clock Start/From: **2**
Clock To:
1st Value: **4.000**
2nd Value:
Value Percent:
Continuous Index:
Within 8" of Joint: **NO**
Remarks:

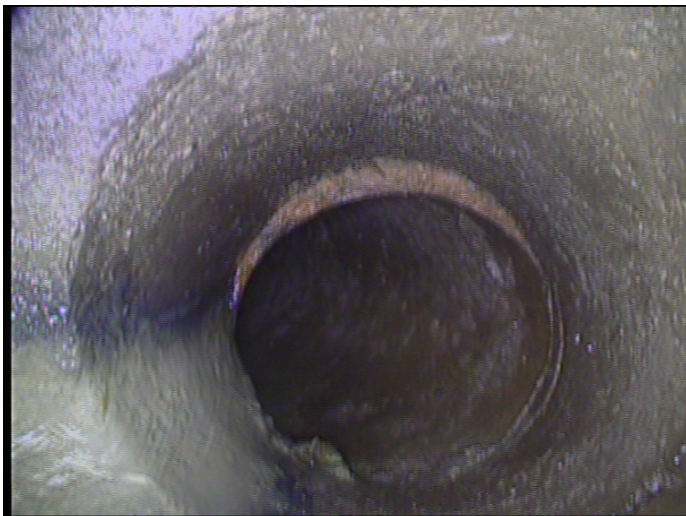
Code: **TF**
Description: **Tap Factory**

Distance (ft): **127.5**
Structural Grade: **0**
O&M Grade: **0**
Clock Start/From: **10**
Clock To:
1st Value: **4.000**
2nd Value:
Value Percent:
Continuous Index:
Within 8" of Joint: **NO**
Remarks:

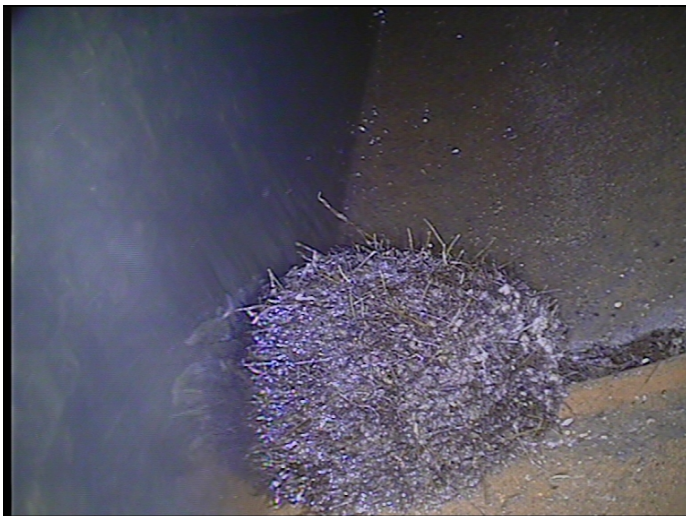
Code: **RMJ**
Description: **Roots Medium Joint**

Distance (ft): **148.6**
Structural Grade: **0**
O&M Grade: **3**
Clock Start/From: **4**
Clock To:
1st Value:
2nd Value:
Value Percent: **5.000**
Continuous Index:
Within 8" of Joint: **YES**
Remarks:

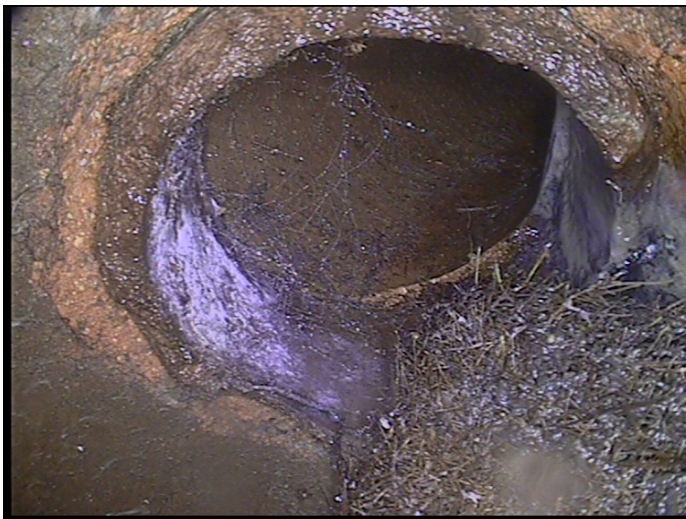
Code: **TBD**
Description: **Tap Break-in Defective**

Distance (ft): **203.0**
Structural Grade: **0**
O&M Grade: **3**
Clock Start/From: **3**
Clock To:
1st Value: **4.000**
2nd Value:
Value Percent:
Continuous Index:
Within 8" of Joint: **NO**
Remarks: **Defective**
