Profile/Photo Observation Report

Date:	04/24/2018	Weather:		Coding:	PACP 6.0
Pipe Length (ft):	226.6	Owner:	NA	Pre Clean:	Not Known
P.O.#:		Surveyor:	Jen Costello	PSR:	P-604-064-040
Customer:		Clean Date:	01/01/1900	Shape:	C

Street:	S Pennsylvania St.	Flow Control:	Not Controlled
City:	Hobart, IN	Year Renewed:	
Location:	Other	Tape/Media #:	
Purpose:	Not Known	Dia/Height:	12"
Use:	Sanitary	Material:	VCP
Drain Area:	NA	Lining:	
Category:	NA		
Comment:			
Location Details:		Direction of Survey:	Downstream
US MH:	M-604-064	DS MH:	M-605-040
		Total Length Surveyed (ft):	201.4

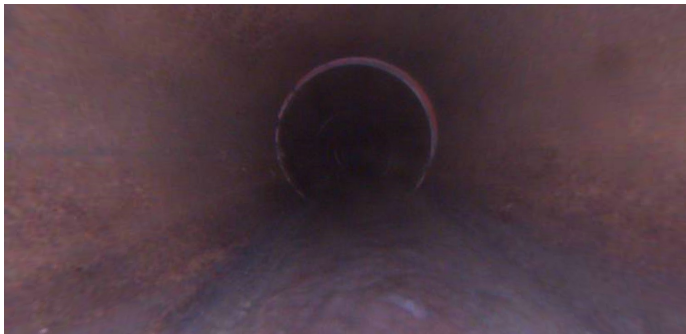
Code: **AMH**
Description: **Manhole**

Distance (ft): **.0**
Structural Grade: **0**
O&M Grade: **0**
Clock Start/From:
Clock To:
1st Value:
2nd Value:
Value Percent:
Continuous Index:
Within 8" of Joint: **NO**
Remarks: **M-604-064**

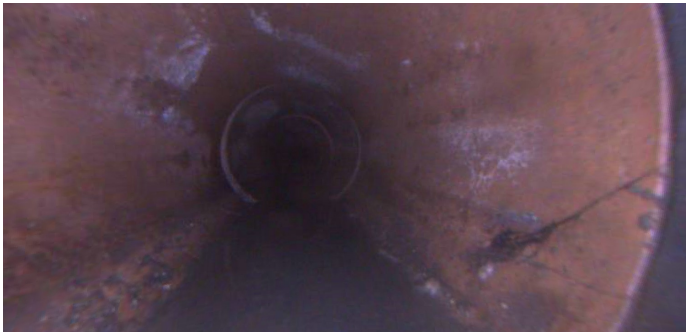
Code: **RFJ**
Description: **Roots Fine Joint**

Distance (ft): **37.1**
Structural Grade: **0**
O&M Grade: **1**
Clock Start/From: **3**
Clock To:
1st Value:
2nd Value:
Value Percent:
Continuous Index:
Within 8" of Joint: **YES**
Remarks:

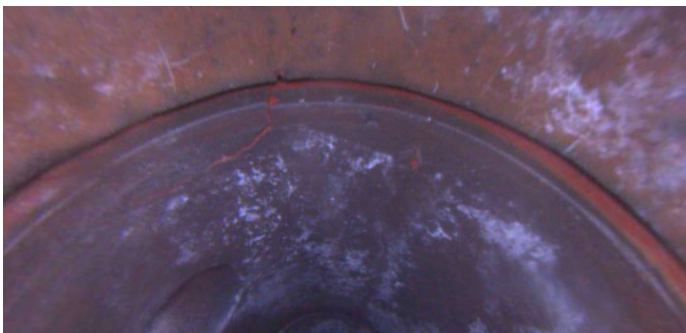
Code: **FM**
Description: **Fracture Multiple**

Distance (ft): **44.6**
Structural Grade: **4**
O&M Grade: **0**
Clock Start/From: **10**
Clock To: **12**
1st Value:
2nd Value:
Value Percent:
Continuous Index:
Within 8" of Joint: **YES**
Remarks:

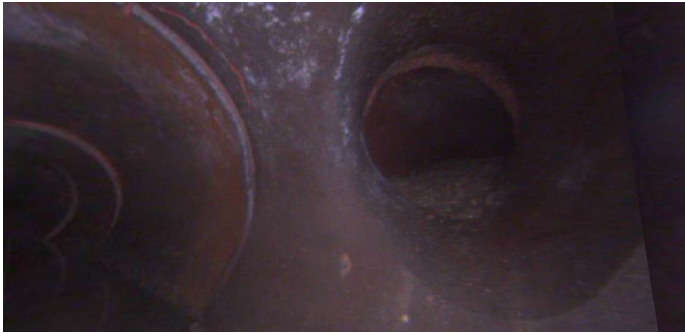
Code: **TF**
Description: **Tap Factory**

Distance (ft): **45.8**
Structural Grade: **0**
O&M Grade: **0**
Clock Start/From: **9**
Clock To:
1st Value: **4.000**
2nd Value:
Value Percent:
Continuous Index:
Within 8" of Joint:
Remarks:

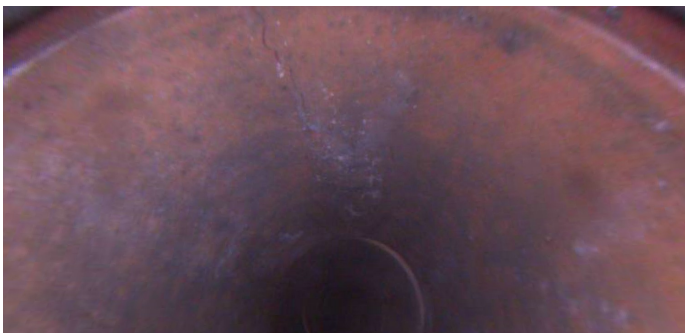
Code: **FL**
Description: **Fracture Longitudinal**

Distance (ft): **48.5**
Structural Grade: **3**
O&M Grade: **0**
Clock Start/From: **12**
Clock To:
1st Value:
2nd Value:
Value Percent:
Continuous Index:
Within 8" of Joint: **YES**
Remarks:

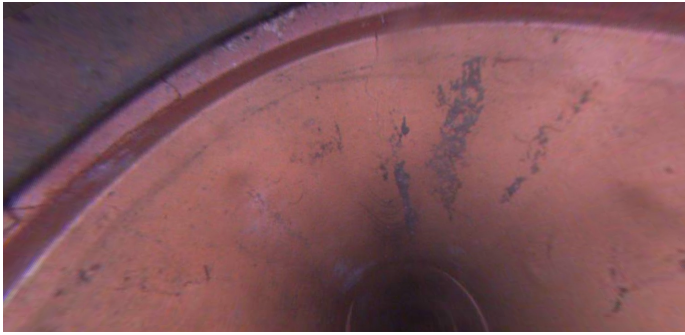
Code: **FM**
Description: **Fracture Multiple**

Distance (ft): **58.2**
Structural Grade: **4**
O&M Grade: **0**
Clock Start/From: **9**
Clock To: **12**
1st Value:
2nd Value:
Value Percent:
Continuous Index:
Within 8" of Joint: **YES**
Remarks:

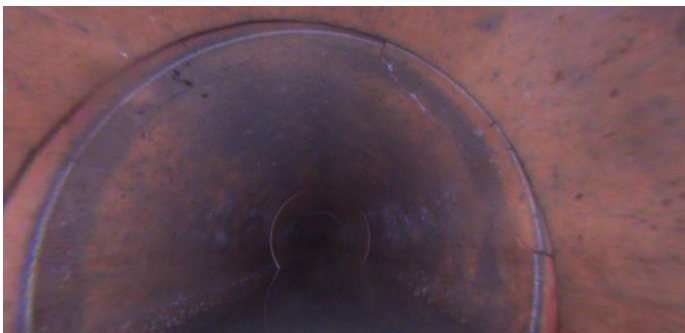
Code: **FM**
Description: **Fracture Multiple**

Distance (ft): **69.5**
Structural Grade: **4**
O&M Grade: **0**
Clock Start/From: **8**
Clock To: **4**
1st Value:
2nd Value:
Value Percent:
Continuous Index: **S01**
Within 8" of Joint: **YES**
Remarks:

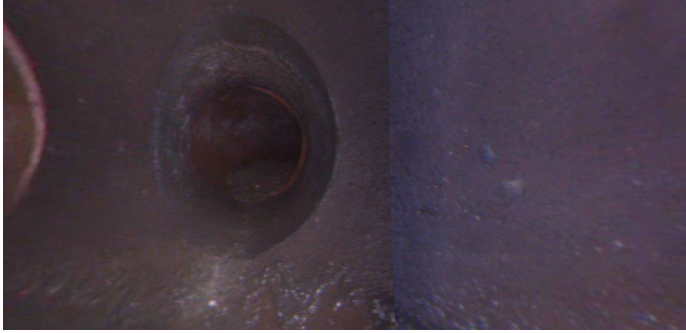
Code: **TF**
Description: **Tap Factory**

Distance (ft): **88.6**
Structural Grade: **0**
O&M Grade: **0**
Clock Start/From: **9**
Clock To:
1st Value: **4.000**
2nd Value:
Value Percent:
Continuous Index:
Within 8" of Joint:
Remarks:

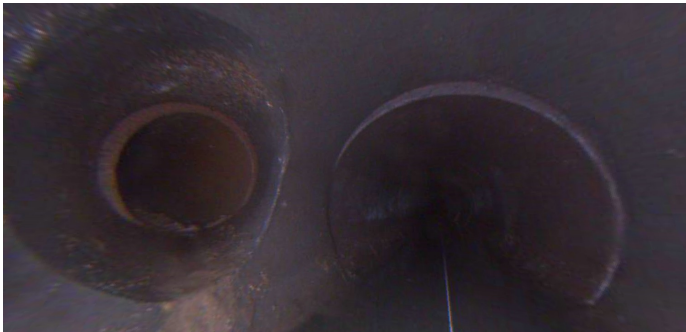
Code: **TF**
Description: **Tap Factory**

Distance (ft): **90.4**
Structural Grade: **0**
O&M Grade: **0**
Clock Start/From: **3**
Clock To:
1st Value: **4.000**
2nd Value:
Value Percent:
Continuous Index:
Within 8" of Joint:
Remarks:

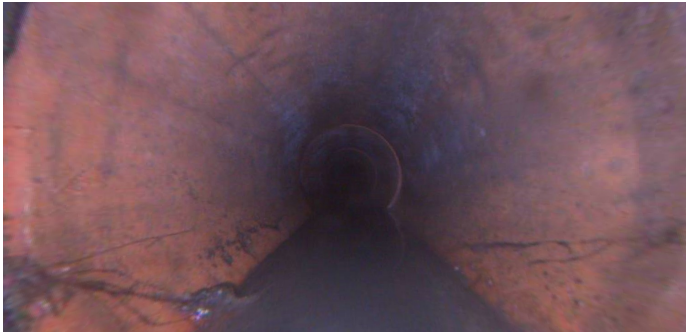
Code: **RFJ**
Description: **Roots Fine Joint**

Distance (ft): **91.1**
Structural Grade: **0**
O&M Grade: **1**
Clock Start/From: **8**
Clock To: **4**
1st Value:
2nd Value:
Value Percent:
Continuous Index:
Within 8" of Joint: **YES**
Remarks:

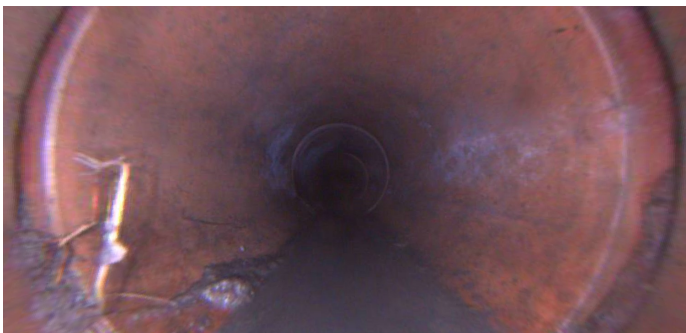
Code: **RFJ**
Description: **Roots Fine Joint**

Distance (ft): **96.8**
Structural Grade: **0**
O&M Grade: **1**
Clock Start/From: **8**
Clock To: **9**
1st Value:
2nd Value:
Value Percent:
Continuous Index:
Within 8" of Joint: **YES**
Remarks:

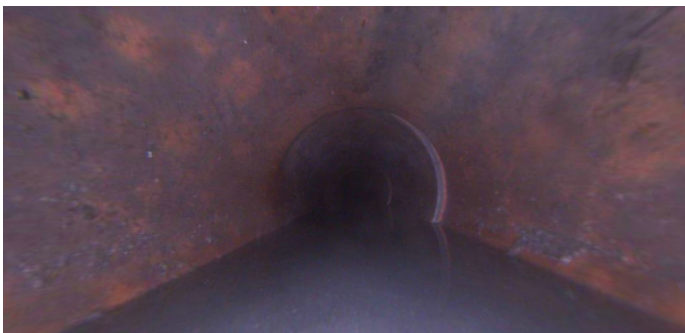
Code: **FM**
Description: **Fracture Multiple**

Distance (ft): **107.6**
Structural Grade: **4**
O&M Grade: **0**
Clock Start/From: **8**
Clock To: **4**
1st Value:
2nd Value:
Value Percent:
Continuous Index: **F01**
Within 8" of Joint: **YES**
Remarks:

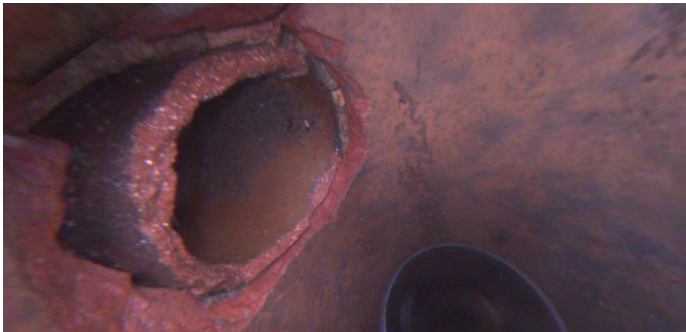
Code: **TBI**
Description: **Tap Break-in Intruding**

Distance (ft): **124.7**
Structural Grade: **0**
O&M Grade: **2**
Clock Start/From: **10**
Clock To:
1st Value: **4.000**
2nd Value: **1.000**
Value Percent:
Continuous Index:
Within 8" of Joint:
Remarks:

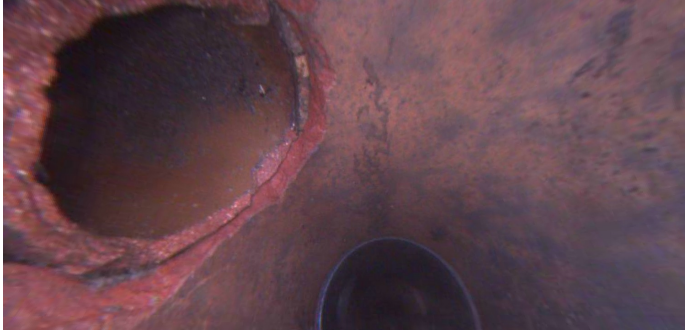
Code: **TBI**
Description: **Tap Break-in Intruding**

Distance (ft): **124.7**
Structural Grade: **0**
O&M Grade: **2**
Clock Start/From: **10**
Clock To:
1st Value: **4.000**
2nd Value: **1.000**
Value Percent:
Continuous Index:
Within 8" of Joint:
Remarks:

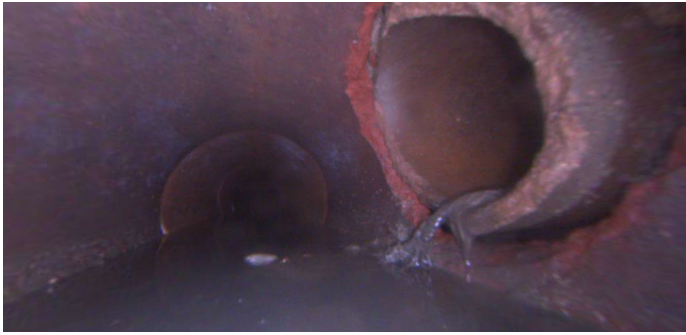
Code: **TBI**
Description: **Tap Break-in Intruding**

Distance (ft): **128.7**
Structural Grade: **0**
O&M Grade: **2**
Clock Start/From: **3**
Clock To:
1st Value: **4.000**
2nd Value: **1.000**
Value Percent:
Continuous Index:
Within 8" of Joint:
Remarks:

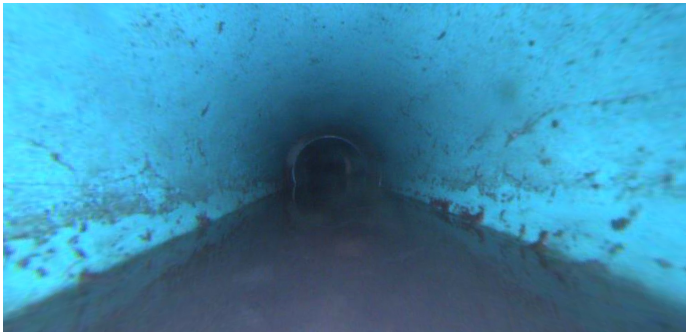
Code: **MWL**
Description: **Water Level**

Distance (ft): **161.7**
Structural Grade: **0**
O&M Grade: **0**
Clock Start/From:
Clock To:
1st Value:
2nd Value:
Value Percent: **40.000**
Continuous Index:
Within 8" of Joint: **NO**
Remarks:

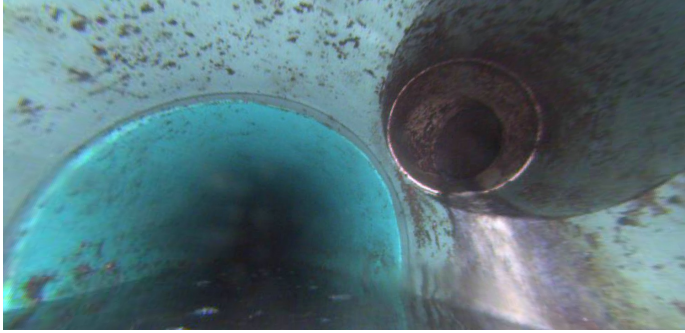
Code: **TFA**
Description: **Tap Factory Active**

Distance (ft): **164.6**
Structural Grade: **0**
O&M Grade: **0**
Clock Start/From: **10**
Clock To:
1st Value: **4.000**
2nd Value:
Value Percent:
Continuous Index:
Within 8" of Joint:
Remarks:

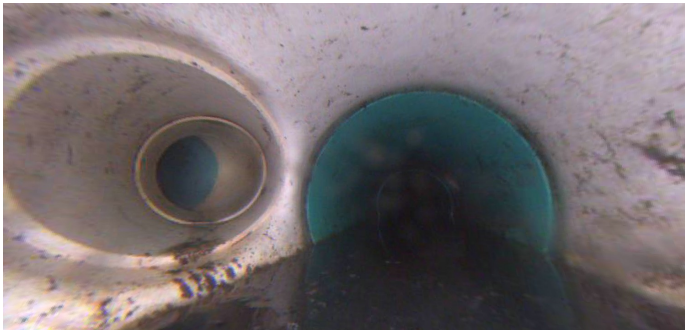
Code: **TF**
Description: **Tap Factory**

Distance (ft): **167.2**
Structural Grade: **0**
O&M Grade: **0**
Clock Start/From: **3**
Clock To:
1st Value: **4.000**
2nd Value:
Value Percent:
Continuous Index:
Within 8" of Joint:
Remarks:

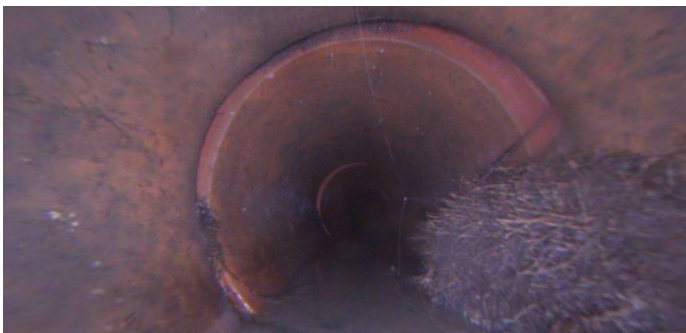
Code: **RMJ**
Description: **Roots Medium Joint**

Distance (ft): **169.2**
Structural Grade: **0**
O&M Grade: **3**
Clock Start/From: **8**
Clock To: **4**
1st Value:
2nd Value:
Value Percent: **10.000**
Continuous Index:
Within 8" of Joint: **YES**
Remarks:

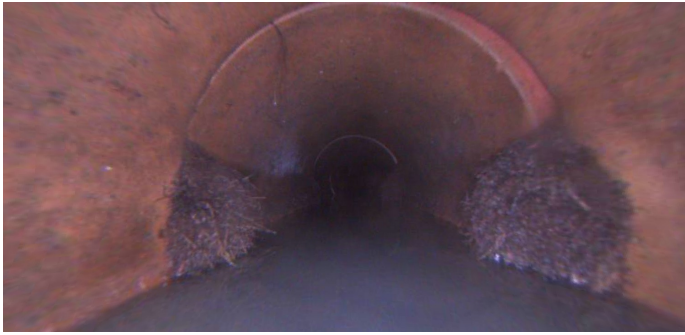
Code: **RMJ**
Description: **Roots Medium Joint**

Distance (ft): **173.3**
Structural Grade: **0**
O&M Grade: **3**
Clock Start/From: **8**
Clock To: **4**
1st Value:
2nd Value:
Value Percent: **10.000**
Continuous Index: **S03**
Within 8" of Joint: **YES**
Remarks:

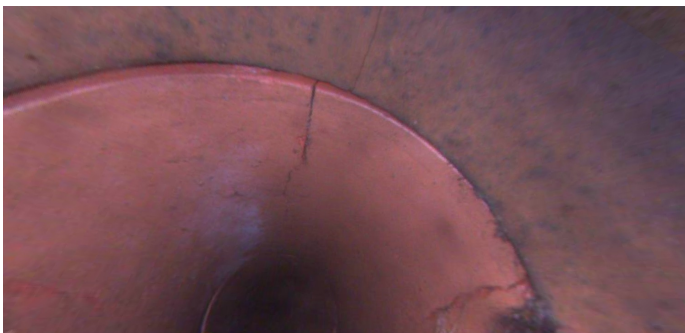
Code: **FM**
Description: **Fracture Multiple**

Distance (ft): **181.5**
Structural Grade: **4**
O&M Grade: **0**
Clock Start/From: **12**
Clock To: **3**
1st Value:
2nd Value:
Value Percent:
Continuous Index:
Within 8" of Joint: **YES**
Remarks:

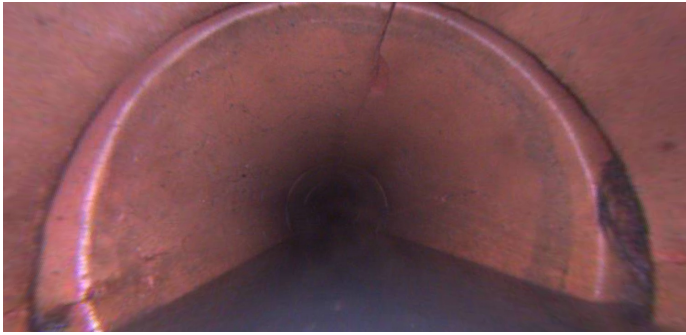
Code: **FM**
Description: **Fracture Multiple**

Distance (ft): **183.4**
Structural Grade: **4**
O&M Grade: **0**
Clock Start/From: **8**
Clock To: **4**
1st Value:
2nd Value:
Value Percent:
Continuous Index: **S04**
Within 8" of Joint: **YES**
Remarks:

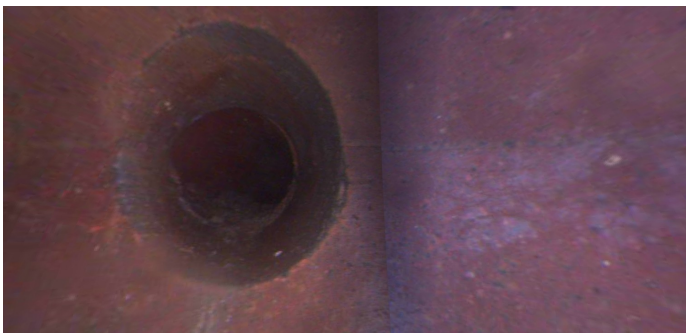
Code: **TF**
Description: **Tap Factory**

Distance (ft): **194.9**
Structural Grade: **0**
O&M Grade: **0**
Clock Start/From: **9**
Clock To:
1st Value: **4.000**
2nd Value:
Value Percent:
Continuous Index:
Within 8" of Joint:
Remarks:

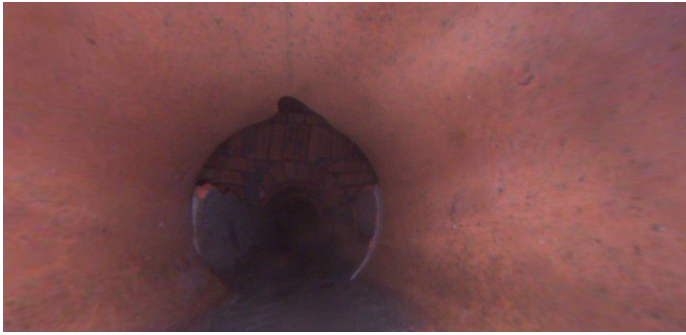
Code: **FM**
Description: **Fracture Multiple**

Distance (ft): **198.4**
Structural Grade: **4**
O&M Grade: **0**
Clock Start/From: **8**
Clock To: **4**
1st Value:
2nd Value:
Value Percent:
Continuous Index: **F04**
Within 8" of Joint: **YES**
Remarks:

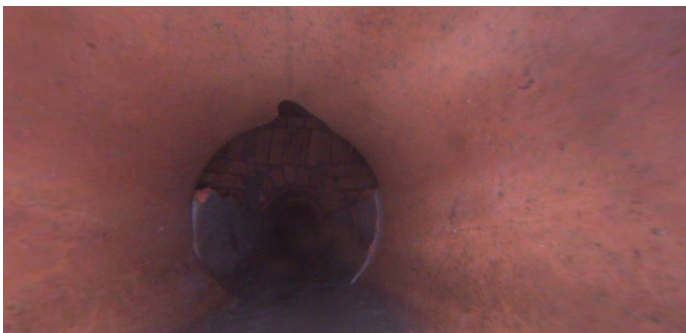
Code: **RMJ**
Description: **Roots Medium Joint**

Distance (ft): **198.4**
Structural Grade: **0**
O&M Grade: **3**
Clock Start/From: **8**
Clock To: **4**
1st Value:
2nd Value:
Value Percent: **10.000**
Continuous Index: **F03**
Within 8" of Joint: **YES**
Remarks:

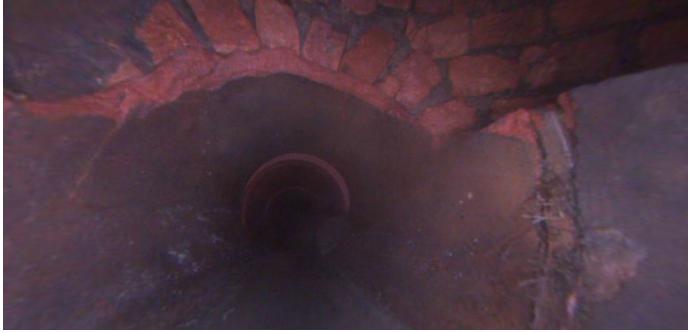
Code:	AMH
Description:	Manhole
Distance (ft):	201.4
Structural Grade:	0
O&M Grade:	0
Clock Start/From:	
Clock To:	
1st Value:	
2nd Value:	
Value Percent:	
Continuous Index:	
Within 8" of Joint:	NO
Remarks:	M-605-040
