## Profile/Photo Observation Report

Street:	<b>S PENNSYLVANIA ST &amp; W CLEVELAN</b>	Flow Control:	<b>Not Controlled</b>
City:	<b>Hobart, IN</b>	Year Renewed:	
Location:	<b>Other</b>	Tape/Media #:	
Purpose:	<b>Not Known</b>	Dia/Height:	<b>12"</b>
Use:	<b>Sanitary</b>	Material:	<b>PVC</b>
Drain Area:	<b>NA</b>	Lining:	
Category:	<b>NA</b>		
Comment:

Location Details:		Direction of Survey:	<b>Upstream</b>
US MH:	<b>M-604-065</b>	DS MH:	<b>M-604-064</b>
		Total Length Surveyed (ft):	<b>30.0</b>

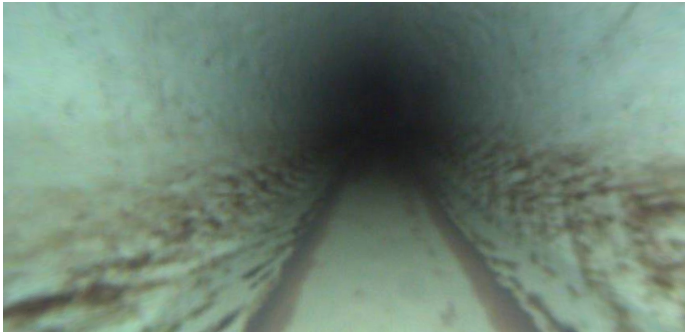
Code:	<b>MWL</b>
Description:	<b>Water Level</b>

Distance (ft):	<b>.0</b>
Structural Grade:	<b>0</b>
O&M Grade:	<b>0</b>
Clock Start/From:	
Clock To:	
1st Value:	
2nd Value:	
Value Percent:	<b>5.000</b>
Continuous Index:	
Within 8" of Joint:	<b>NO</b>
Remarks:

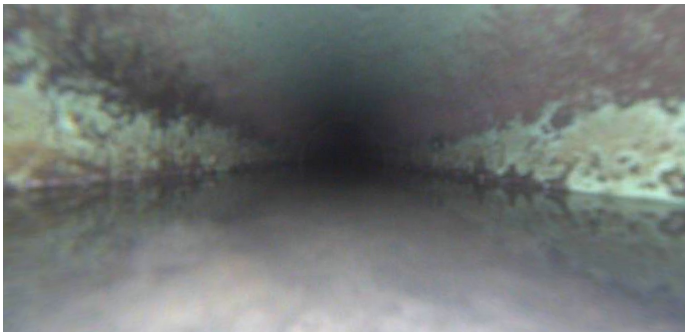
Code:	<b>MWL</b>
Description:	<b>Water Level</b>

Distance (ft):	<b>24.4</b>
Structural Grade:	<b>0</b>
O&M Grade:	<b>0</b>
Clock Start/From:	
Clock To:	
1st Value:	
2nd Value:	
Value Percent:	<b>40.000</b>
Continuous Index:	
Within 8" of Joint:	<b>NO</b>
Remarks:

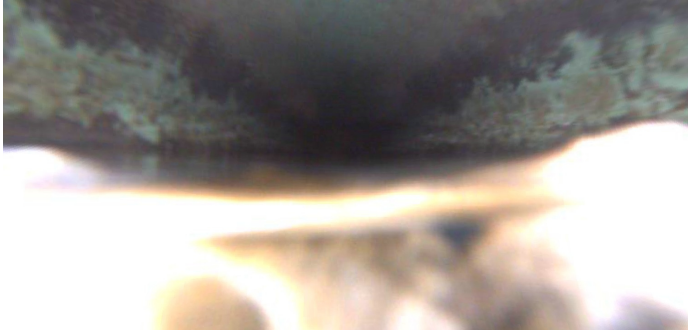
Code:	<b>MSA</b>
Description:	<b>Abandoned Survey</b>
Distance (ft):	<b>30.0</b>
Structural Grade:	<b>0</b>
O&M Grade:	<b>0</b>
Clock Start/From:	
Clock To:	
1st Value:	
2nd Value:	
Value Percent:	
Continuous Index:	
Within 8" of Joint:	<b>NO</b>
Remarks:	<b>high water</b>
