Profile/Photo Observation Report

Street:	S Pennsylvania St.	Flow Control:	Not Controlled
City:	Hobart, IN	Year Renewed:	
Location:	Other	Tape/Media #:	
Purpose:	Not Known	Dia/Height:	12"
Use:	Sanitary	Material:	VCP
Drain Area:	NA	Lining:	
Category:	NA		
Comment:

Location Details:		Direction of Survey:	Upstream
US MH:	M-604-067	DS MH:	M-604-066
		Total Length Surveyed (ft):	3.7

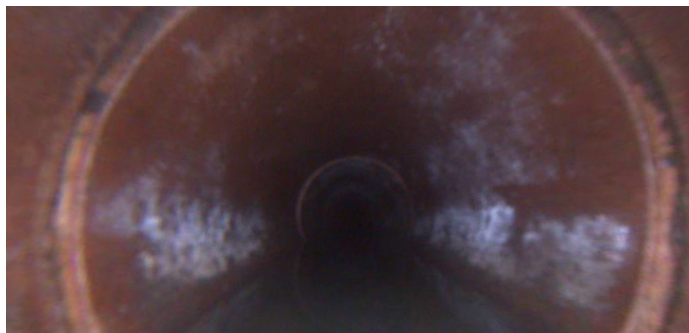
Code: **AMH**
Description: **Manhole**

Distance (ft): **.0**
Structural Grade: **0**
O&M Grade: **0**
Clock Start/From:
Clock To:
1st Value:
2nd Value:
Value Percent:
Continuous Index:
Within 8" of Joint: **NO**
Remarks: **M-604-066**

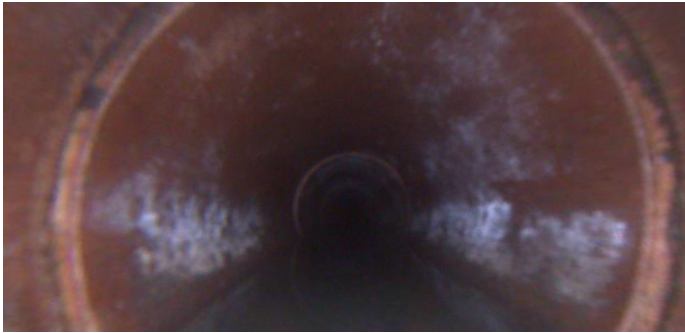
Code:	MWL
Description:	Water Level

Distance (ft):	.0
Structural Grade:	0
O&M Grade:	0
Clock Start/From:	
Clock To:	
1st Value:	
2nd Value:	
Value Percent:	10.000
Continuous Index:	
Within 8" of Joint:	NO
Remarks:

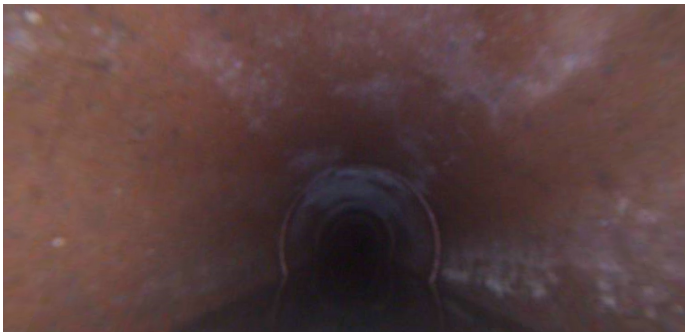
Code:	MSA
Description:	Abandoned Survey

Distance (ft):	3.7
Structural Grade:	0
O&M Grade:	0
Clock Start/From:	
Clock To:	
1st Value:	
2nd Value:	
Value Percent:	
Continuous Index:	
Within 8" of Joint:	NO
Remarks:	DEBRIS UNDER WATER
