Street:	N PENNSYLVANIA ST & W HOME AV		Flow Control:	Not Controlled	
City:	Hobart, IN		Year Renewed:		
Location:	Light Highway		Tape/Media #:		
Purpose:	Not Known		Dia/Height:	12"	
Use:	Sanitary		Material:	VCP	
Drain Area:	NA		Lining:		
Category:	NA				
Comment:					
Location Details:			Direction of Survey:	Downstream	
US MH:	M-604-068	DS MH:	M-604-067	Total Length Surveyed (ft):	292.0

M-604-067

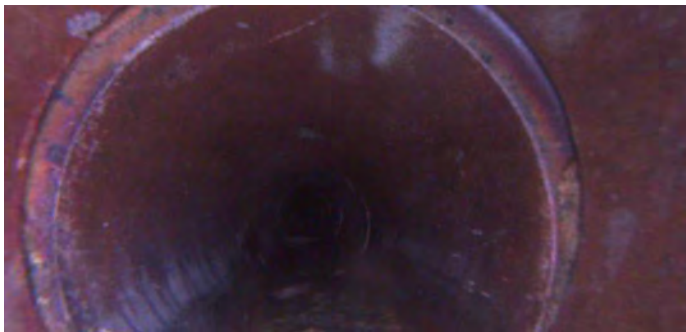
Code: **AMH**
Description: **Manhole**

Distance (ft): **.0**
Structural Grade: **0**
O&M Grade: **0**
Clock Start/From:
Clock To:
1st Value:
2nd Value:
Value Percent:
Continuous Index:
Within 8" of Joint: **NO**
Remarks: **M-604-068**

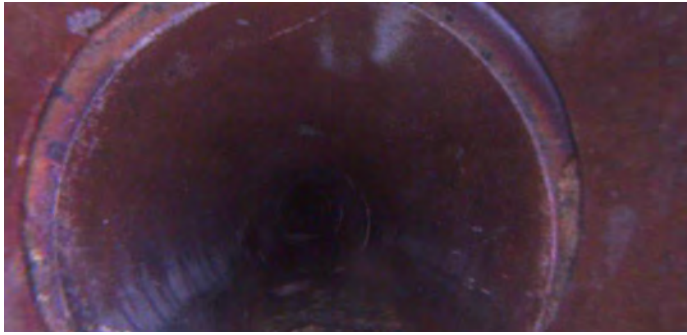
Code:	MWL
Description:	Water Level
Distance (ft):	.0
Structural Grade:	0
O&M Grade:	0
Clock Start/From:	
Clock To:	
1st Value:	
2nd Value:	
Value Percent:	5.000
Continuous Index:	
Within 8" of Joint:	NO
Remarks:

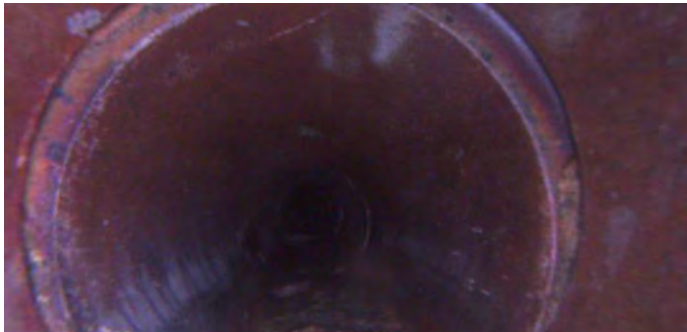
Code:	CM
Description:	Crack Multiple
Distance (ft):	.0
Structural Grade:	3
O&M Grade:	0
Clock Start/From:	8
Clock To:	4
1st Value:	
2nd Value:	
Value Percent:	
Continuous Index:	S06
Within 8" of Joint:	YES
Remarks:

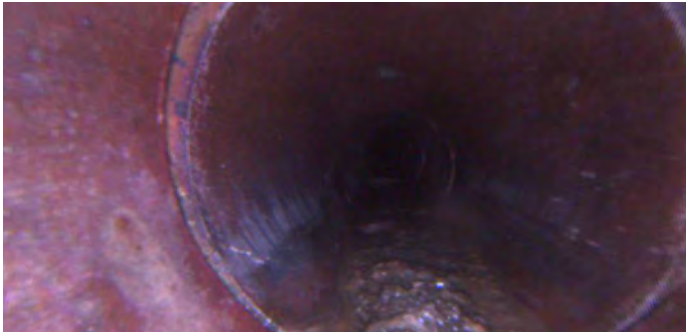
Code: **DSF**
Description: **Deposits Settled Fine**

Distance (ft): **.0**
Structural Grade: **0**
O&M Grade: **2**
Clock Start/From: **6**
Clock To:
1st Value:
2nd Value:
Value Percent: **5.000**
Continuous Index: **S01**
Within 8" of Joint: **YES**
Remarks: **WANDER**

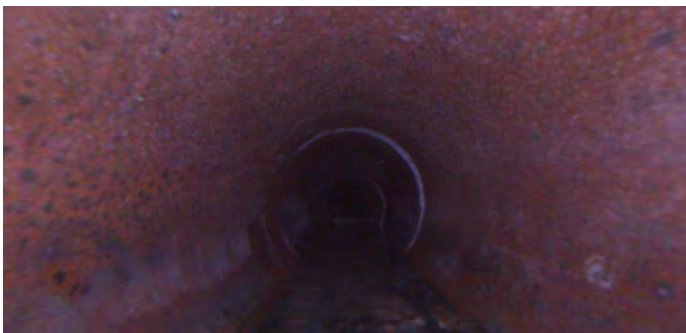
Code: **DSF**
Description: **Deposits Settled Fine**

Distance (ft): **5.7**
Structural Grade: **0**
O&M Grade: **2**
Clock Start/From: **6**
Clock To:
1st Value:
2nd Value:
Value Percent: **5.000**
Continuous Index: **F01**
Within 8" of Joint: **YES**
Remarks: **WANDER**

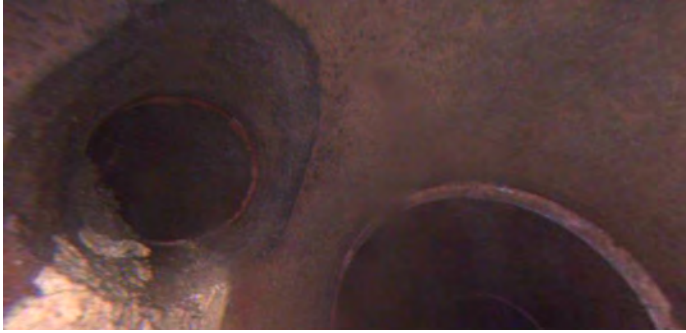
Code: **TF**
Description: **Tap Factory**

Distance (ft): **18.8**
Structural Grade: **0**
O&M Grade: **0**
Clock Start/From: **2**
Clock To:
1st Value: **4.000**
2nd Value:
Value Percent:
Continuous Index:
Within 8" of Joint:
Remarks:

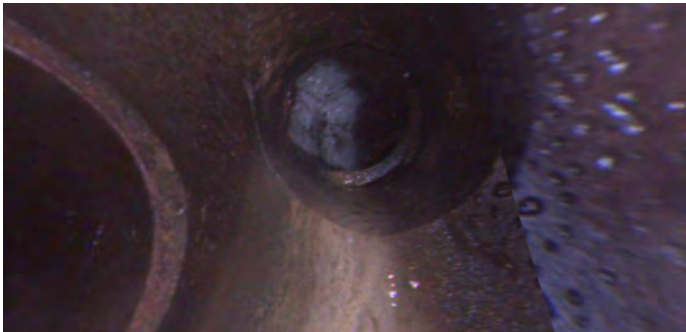
Code: **TF**
Description: **Tap Factory**

Distance (ft): **54.7**
Structural Grade: **0**
O&M Grade: **0**
Clock Start/From: **10**
Clock To:
1st Value: **4.000**
2nd Value:
Value Percent:
Continuous Index:
Within 8" of Joint:
Remarks:

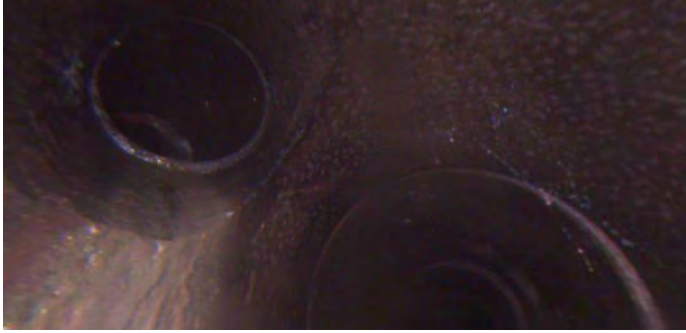
Code: **TFA**
Description: **Tap Factory Active**

Distance (ft): **56.9**
Structural Grade: **0**
O&M Grade: **0**
Clock Start/From: **2**
Clock To:
1st Value: **4.000**
2nd Value:
Value Percent:
Continuous Index:
Within 8" of Joint:
Remarks:

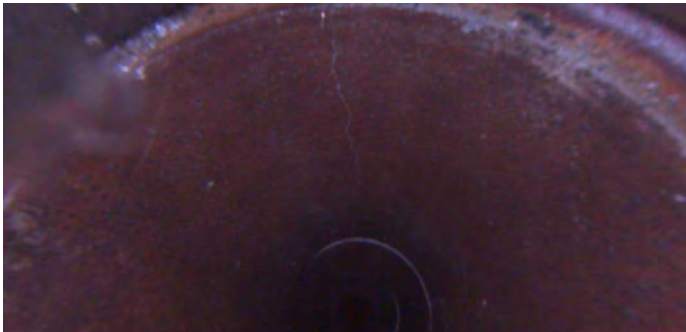
Code: **CM**
Description: **Crack Multiple**

Distance (ft): **57.4**
Structural Grade: **3**
O&M Grade: **0**
Clock Start/From: **10**
Clock To: **12**
1st Value:
2nd Value:
Value Percent:
Continuous Index:
Within 8" of Joint: **YES**
Remarks:

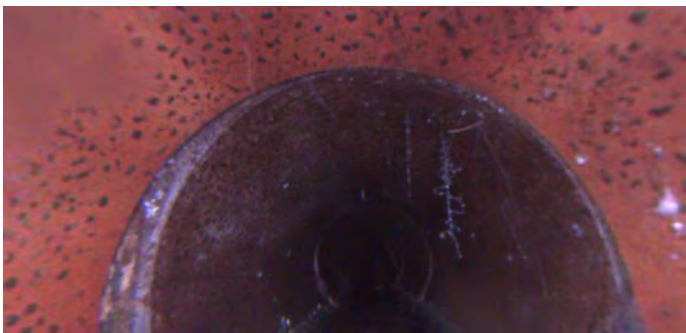
Code: **RFJ**
Description: **Roots Fine Joint**

Distance (ft): **77.4**
Structural Grade: **0**
O&M Grade: **1**
Clock Start/From: **8**
Clock To: **4**
1st Value:
2nd Value:
Value Percent:
Continuous Index:
Within 8" of Joint: **YES**
Remarks:

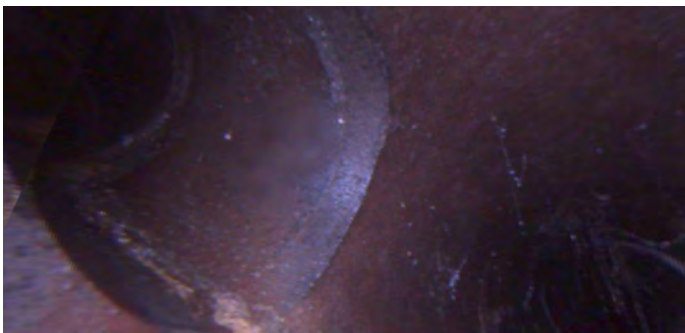
Code: **TF**
Description: **Tap Factory**

Distance (ft): **86.6**
Structural Grade: **0**
O&M Grade: **0**
Clock Start/From: **10**
Clock To:
1st Value: **4.000**
2nd Value:
Value Percent:
Continuous Index:
Within 8" of Joint:
Remarks:

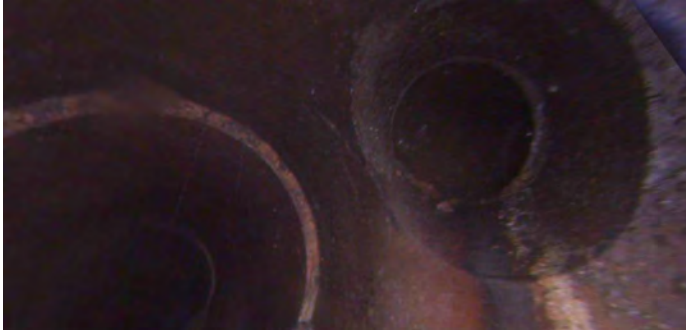
Code: **TF**
Description: **Tap Factory**

Distance (ft): **87.1**
Structural Grade: **0**
O&M Grade: **0**
Clock Start/From: **10**
Clock To:
1st Value: **4.000**
2nd Value:
Value Percent:
Continuous Index:
Within 8" of Joint:
Remarks:

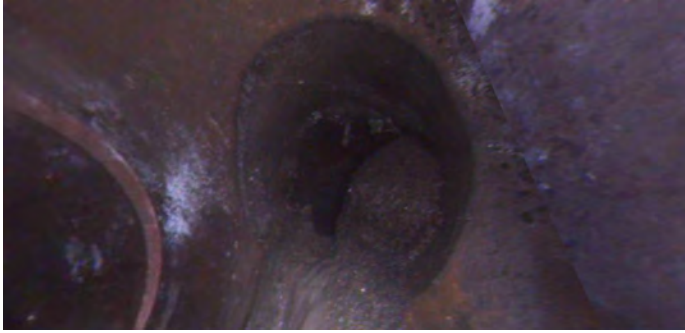
Code: **TFD**
Description: **Tap Factory Defective**

Distance (ft): **133.6**
Structural Grade: **0**
O&M Grade: **2**
Clock Start/From: **10**
Clock To:
1st Value: **4.000**
2nd Value:
Value Percent:
Continuous Index:
Within 8" of Joint:
Remarks: **roots**

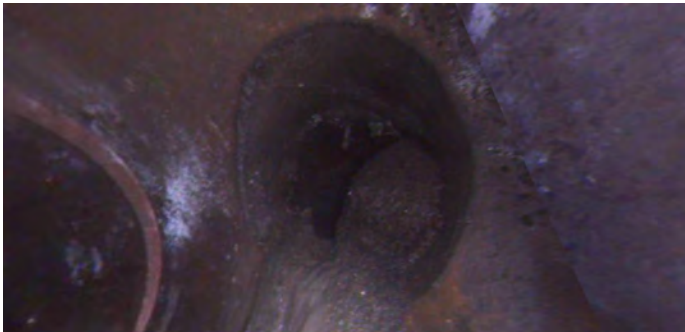
Code: **RML**
Description: **Roots Medium Lateral**

Distance (ft): **133.6**
Structural Grade: **0**
O&M Grade: **3**
Clock Start/From: **8**
Clock To: **9**
1st Value:
2nd Value:
Value Percent: **5.000**
Continuous Index:
Within 8" of Joint: **NO**
Remarks:

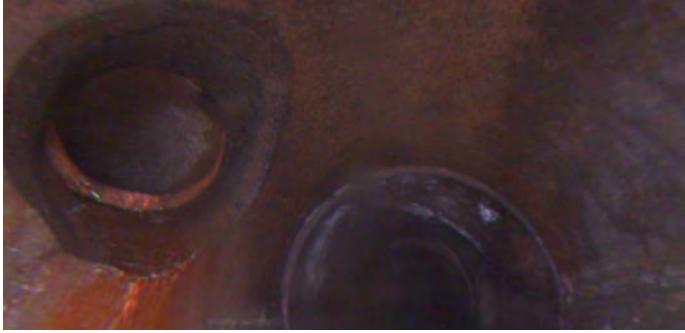
Code: **TFA**
Description: **Tap Factory Active**

Distance (ft): **135.8**
Structural Grade: **0**
O&M Grade: **0**
Clock Start/From: **2**
Clock To:
1st Value: **4.000**
2nd Value:
Value Percent:
Continuous Index:
Within 8" of Joint:
Remarks:

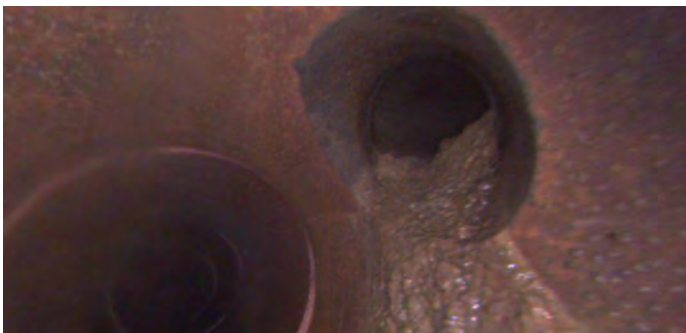
Code: **TFD**
Description: **Tap Factory Defective**

Distance (ft): **174.2**
Structural Grade: **0**
O&M Grade: **2**
Clock Start/From: **10**
Clock To:
1st Value: **4.000**
2nd Value:
Value Percent:
Continuous Index:
Within 8" of Joint:
Remarks: **DAGS**

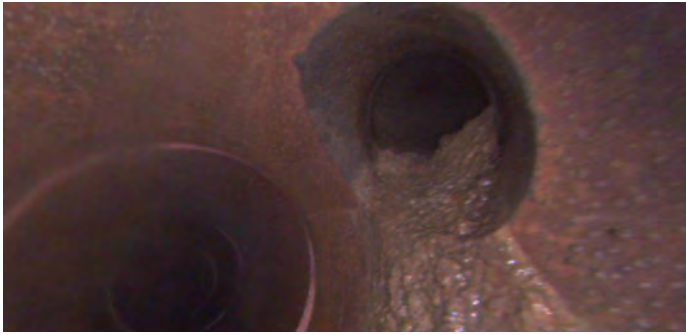
Code: **DAGS**
Description: **Deposits Attached Grease**

Distance (ft): **174.2**
Structural Grade: **0**
O&M Grade: **2**
Clock Start/From: **8**
Clock To: **9**
1st Value:
2nd Value:
Value Percent: **5.000**
Continuous Index:
Within 8" of Joint: **NO**
Remarks:

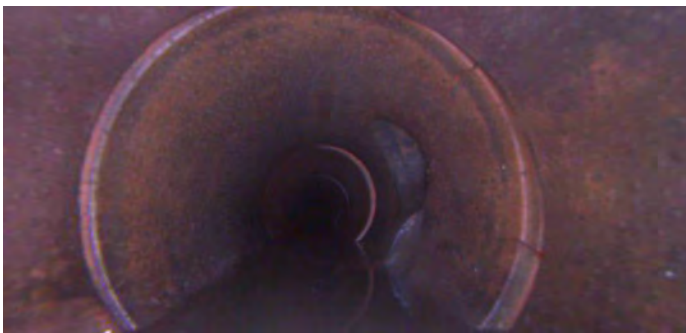
Code: **FM**
Description: **Fracture Multiple**

Distance (ft): **174.2**
Structural Grade: **4**
O&M Grade: **0**
Clock Start/From: **1**
Clock To: **3**
1st Value:
2nd Value:
Value Percent:
Continuous Index:
Within 8" of Joint: **YES**
Remarks:

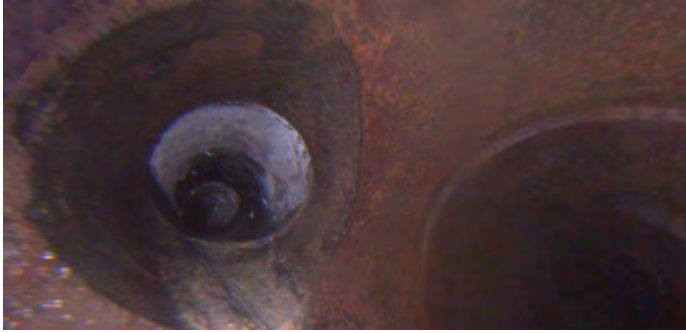
Code: **TFA**
Description: **Tap Factory Active**

Distance (ft): **176.0**
Structural Grade: **0**
O&M Grade: **0**
Clock Start/From: **2**
Clock To:
1st Value: **4.000**
2nd Value:
Value Percent:
Continuous Index:
Within 8" of Joint:
Remarks:

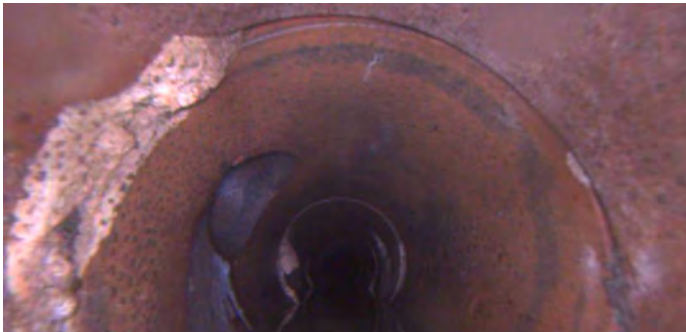
Code: **DAE**
Description: **Deposits Attached Encrustation**

Distance (ft): **209.0**
Structural Grade: **0**
O&M Grade: **2**
Clock Start/From: **9**
Clock To: **11**
1st Value:
2nd Value:
Value Percent: **5.000**
Continuous Index:
Within 8" of Joint: **YES**
Remarks:

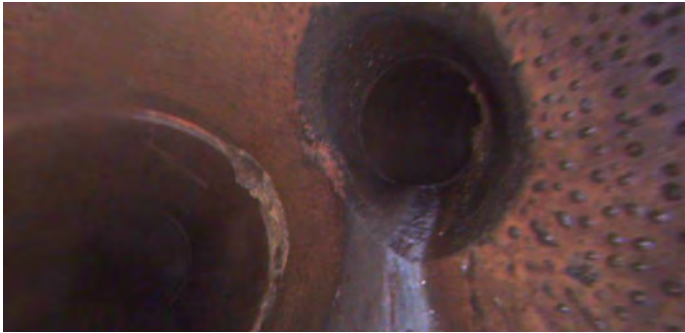
Code: **TFA**
Description: **Tap Factory Active**

Distance (ft): **210.7**
Structural Grade: **0**
O&M Grade: **0**
Clock Start/From: **10**
Clock To:
1st Value: **4.000**
2nd Value:
Value Percent:
Continuous Index:
Within 8" of Joint:
Remarks:

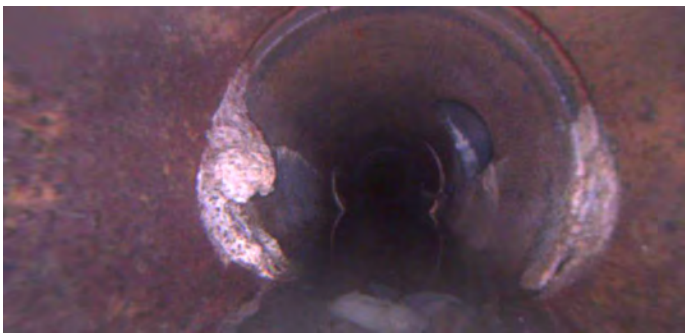
Code: **DAE**
Description: **Deposits Attached Encrustation**

Distance (ft): **210.7**
Structural Grade: **0**
O&M Grade: **2**
Clock Start/From: **8**
Clock To: **4**
1st Value:
2nd Value:
Value Percent: **10.000**
Continuous Index:
Within 8" of Joint: **YES**
Remarks:

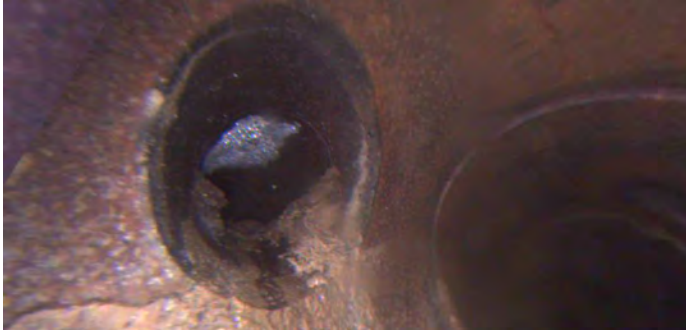
Code: **TF**
Description: **Tap Factory**

Distance (ft): **212.7**
Structural Grade: **0**
O&M Grade: **0**
Clock Start/From: **2**
Clock To:
1st Value: **4.000**
2nd Value:
Value Percent:
Continuous Index:
Within 8" of Joint:
Remarks:

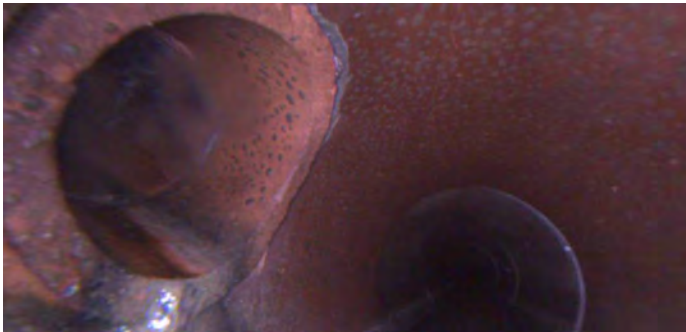
Code: **TBI**
Description: **Tap Break-in Intruding**

Distance (ft): **230.0**
Structural Grade: **0**
O&M Grade: **2**
Clock Start/From: **10**
Clock To:
1st Value: **4.000**
2nd Value: **1.000**
Value Percent:
Continuous Index:
Within 8" of Joint:
Remarks:

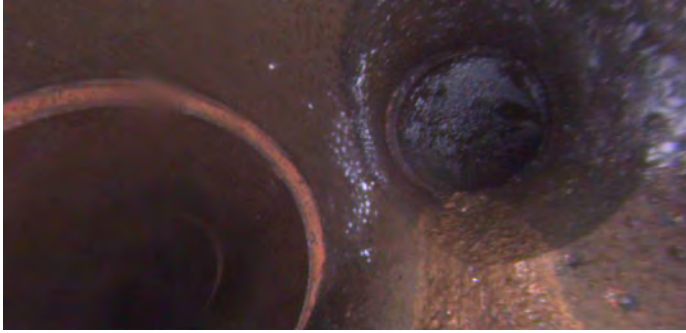
Code: **TF**
Description: **Tap Factory**

Distance (ft): **248.9**
Structural Grade: **0**
O&M Grade: **0**
Clock Start/From: **10**
Clock To:
1st Value: **4.000**
2nd Value:
Value Percent:
Continuous Index:
Within 8" of Joint:
Remarks:

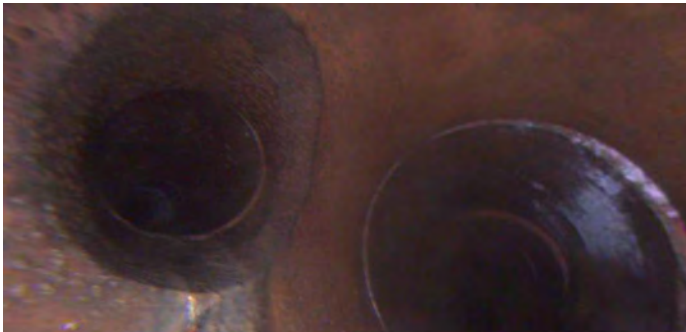
Code: **TFA**
Description: **Tap Factory Active**

Distance (ft): **251.1**
Structural Grade: **0**
O&M Grade: **0**
Clock Start/From: **2**
Clock To:
1st Value: **4.000**
2nd Value:
Value Percent:
Continuous Index:
Within 8" of Joint:
Remarks:

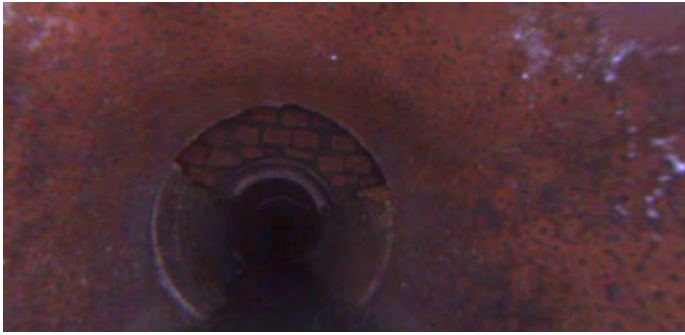
Code: **CM**
Description: **Crack Multiple**

Distance (ft): **288.9**
Structural Grade: **3**
O&M Grade: **0**
Clock Start/From: **8**
Clock To: **4**
1st Value:
2nd Value:
Value Percent:
Continuous Index: **F06**
Within 8" of Joint: **YES**
Remarks:

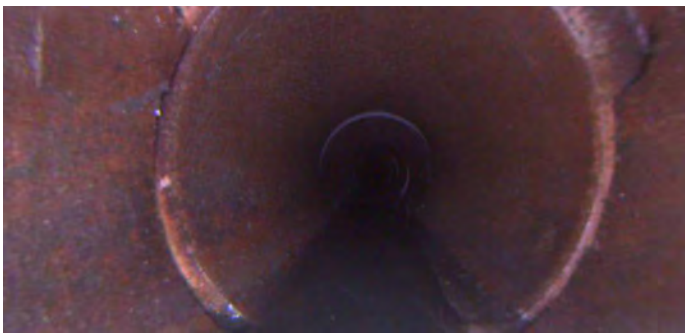
Code: **AMH**
Description: **Manhole**

Distance (ft): **292.0**
Structural Grade: **0**
O&M Grade: **0**
Clock Start/From:
Clock To:
1st Value:
2nd Value:
Value Percent:
Continuous Index:
Within 8" of Joint: **NO**
Remarks: **M-604-067**
