Profile/Photo Observation Report

Street:	N PENNSYLVANIA ST	Flow Control:	Not Controlled
City:	Hobart, IN	Year Renewed:	
Location:	Light Highway	Tape/Media #:	
Purpose:	Not Known	Dia/Height:	10"
Use:	Sanitary	Material:	VCP
Drain Area:	NA	Lining:	
Category:	NA		
Comment:

Location Details:		Direction of Survey:	Upstream
US MH:	M-604-068	DS MH:	M-604-069
		Total Length Surveyed (ft):	10.0

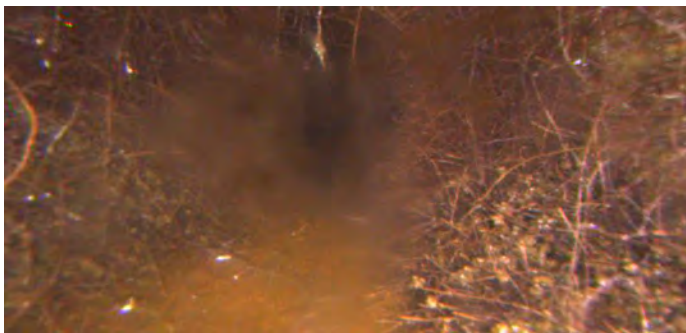
Code: **AMH**
Description: **Manhole**

Distance (ft): **.0**
Structural Grade: **0**
O&M Grade: **0**
Clock Start/From:
Clock To:
1st Value:
2nd Value:
Value Percent:
Continuous Index:
Within 8" of Joint: **NO**
Remarks: **M-604-068**

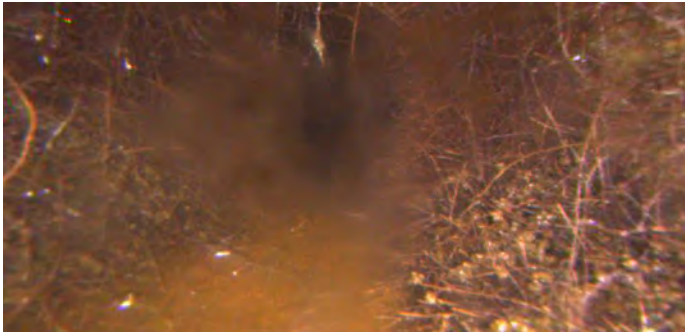
Code:	MWL
Description:	Water Level

Distance (ft):	.0
Structural Grade:	0
O&M Grade:	0
Clock Start/From:	
Clock To:	
1st Value:	
2nd Value:	
Value Percent:	5.000
Continuous Index:	
Within 8" of Joint:	NO
Remarks:

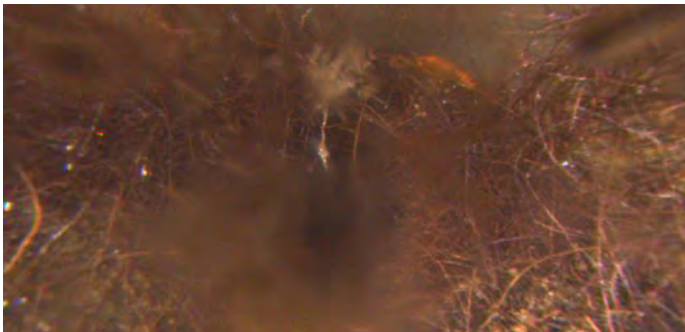
Code:	RBJ
Description:	Roots Ball Joint

Distance (ft):	.0
Structural Grade:	0
O&M Grade:	4
Clock Start/From:	7
Clock To:	5
1st Value:	
2nd Value:	
Value Percent:	70.000
Continuous Index:	
Within 8" of Joint:	YES
Remarks:

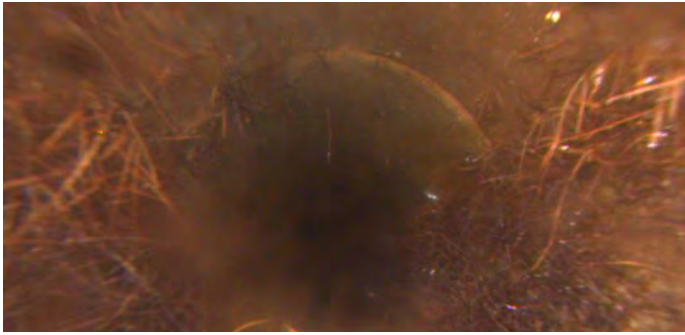
Code: **RMJ**
Description: **Roots Medium Joint**

Distance (ft): **3.4**
Structural Grade: **0**
O&M Grade: **3**
Clock Start/From: **7**
Clock To: **5**
1st Value:
2nd Value:
Value Percent: **30.000**
Continuous Index:
Within 8" of Joint: **YES**
Remarks:

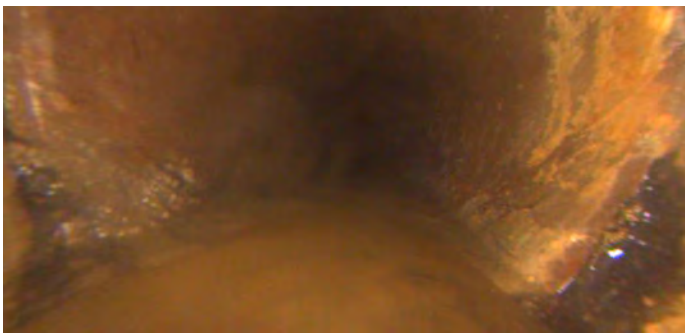
Code: **IW**
Description: **Infil Weeper**

Distance (ft): **5.6**
Structural Grade: **0**
O&M Grade: **2**
Clock Start/From: **8**
Clock To: **4**
1st Value:
2nd Value:
Value Percent:
Continuous Index:
Within 8" of Joint: **YES**
Remarks:

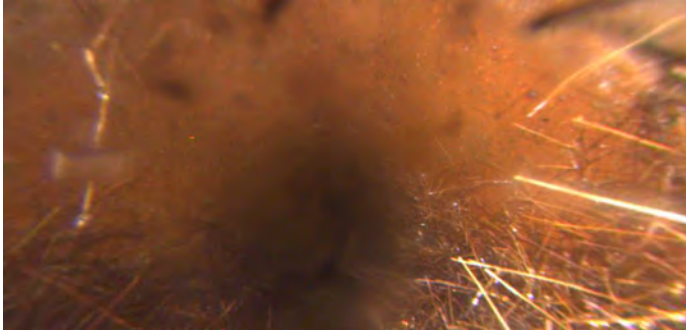
Code: **RMJ**
Description: **Roots Medium Joint**

Distance (ft): **7.9**
Structural Grade: **0**
O&M Grade: **3**
Clock Start/From: **3**
Clock To: **9**
1st Value:
2nd Value:
Value Percent: **20.000**
Continuous Index:
Within 8" of Joint: **YES**
Remarks:

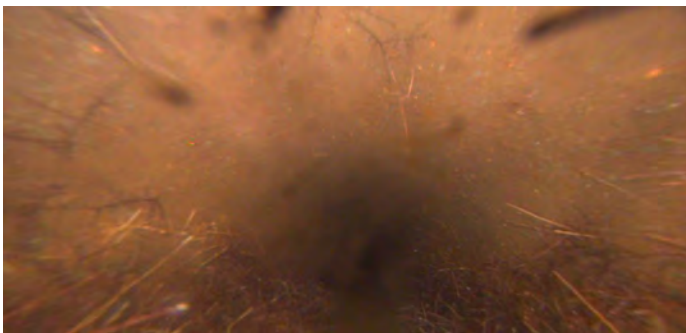
Code: **MSA**
Description: **Abandoned Survey**

Distance (ft): **10.0**
Structural Grade: **0**
O&M Grade: **0**
Clock Start/From:
Clock To:
1st Value:
2nd Value:
Value Percent:
Continuous Index:
Within 8" of Joint: **NO**
Remarks: **rmj**
