Profile/Photo Observation Report

Date:	04/20/2018	Weather:		Coding:	PACP 6.0
Pipe Length (ft):	270.1	Owner:	NA	Pre Clean:	Not Known
P.O.#:		Surveyor:	Jen Costello	PSR:	P-604-069-068
Customer:		Clean Date:	01/01/1900	Shape:	C

Street:	Summerlin	Flow Control:	Not Controlled
City:	Hobart, IN	Year Renewed:	
Location:	Light Highway	Tape/Media #:	
Purpose:	Not Known	Dia/Height:	10"
Use:	Sanitary	Material:	VCP
Drain Area:	NA	Lining:	
Category:	NA		
Comment:

Location Details:		Direction of Survey:	Upstream
US MH:	M-604-068	DS MH:	M-604-069
		Total Length Surveyed (ft):	10.0

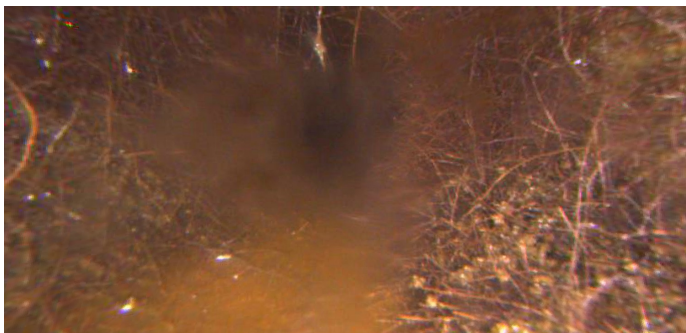
Code: **AMH**
Description: **Manhole**

Distance (ft): **.0**
Structural Grade: **0**
O&M Grade: **0**
Clock Start/From:
Clock To:
1st Value:
2nd Value:
Value Percent:
Continuous Index:
Within 8" of Joint: **NO**
Remarks: **M-604-068**

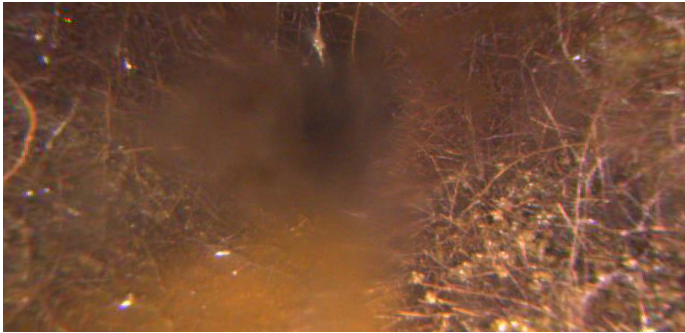
Code:	MWL
Description:	Water Level

Distance (ft):	.0
Structural Grade:	0
O&M Grade:	0
Clock Start/From:	
Clock To:	
1st Value:	
2nd Value:	
Value Percent:	5.000
Continuous Index:	
Within 8" of Joint:	NO
Remarks:

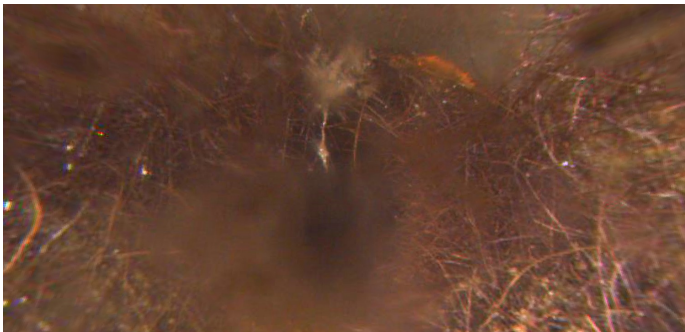
Code:	RBJ
Description:	Roots Ball Joint

Distance (ft):	.0
Structural Grade:	0
O&M Grade:	4
Clock Start/From:	7
Clock To:	5
1st Value:	
2nd Value:	
Value Percent:	70.000
Continuous Index:	
Within 8" of Joint:	YES
Remarks:

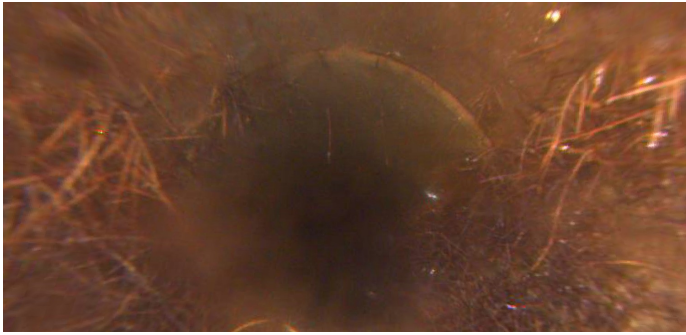
Code: **RMJ**
Description: **Roots Medium Joint**

Distance (ft): **3.4**
Structural Grade: **0**
O&M Grade: **3**
Clock Start/From: **7**
Clock To: **5**
1st Value:
2nd Value:
Value Percent: **30.000**
Continuous Index:
Within 8" of Joint: **YES**
Remarks:

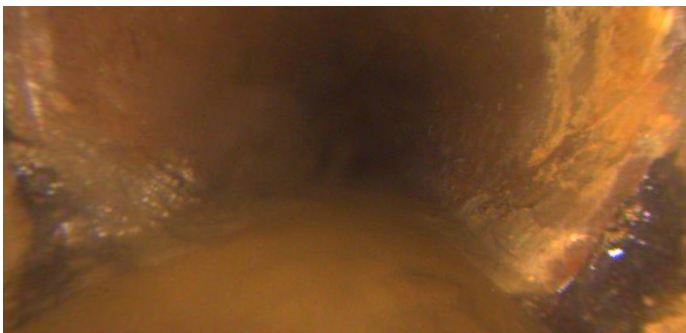
Code: **IW**
Description: **Infil Weeper**

Distance (ft): **5.6**
Structural Grade: **0**
O&M Grade: **2**
Clock Start/From: **8**
Clock To: **4**
1st Value:
2nd Value:
Value Percent:
Continuous Index:
Within 8" of Joint: **YES**
Remarks:

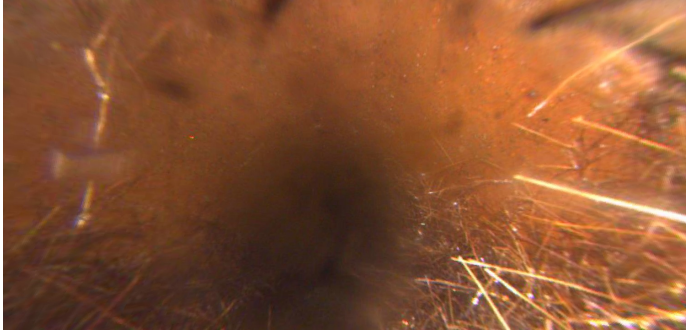
Code: **RMJ**
Description: **Roots Medium Joint**

Distance (ft): **7.9**
Structural Grade: **0**
O&M Grade: **3**
Clock Start/From: **3**
Clock To: **9**
1st Value:
2nd Value:
Value Percent: **20.000**
Continuous Index:
Within 8" of Joint: **YES**
Remarks:

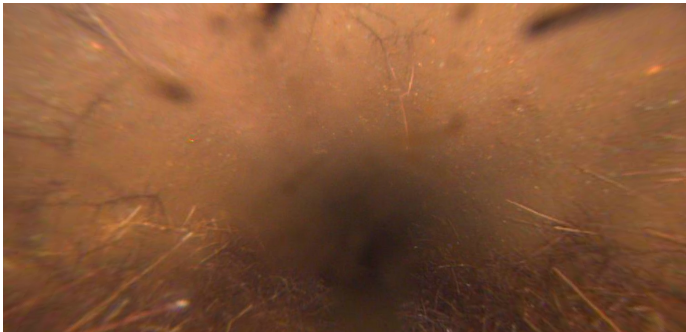
Code: **MSA**
Description: **Abandoned Survey**

Distance (ft): **10.0**
Structural Grade: **0**
O&M Grade: **0**
Clock Start/From:
Clock To:
1st Value:
2nd Value:
Value Percent:
Continuous Index:
Within 8" of Joint: **NO**
Remarks: **rmj**
