Profile/Photo Observation Report

Street:	N WASHINGTON ST & W CLEVELAND	Flow Control:	Not Controlled
City:	Hobart, IN	Year Renewed:	
Location:	Light Highway	Tape/Media #:	
Purpose:	Not Known	Dia/Height:	12"
Use:	Sanitary	Material:	VCP
Drain Area:	NA	Lining:	
Category:	NA		
Comment:

Location Details:		Direction of Survey:	Downstream
US MH:	M-604-070	DS MH:	M-605-046
		Total Length Surveyed (ft):	23.7

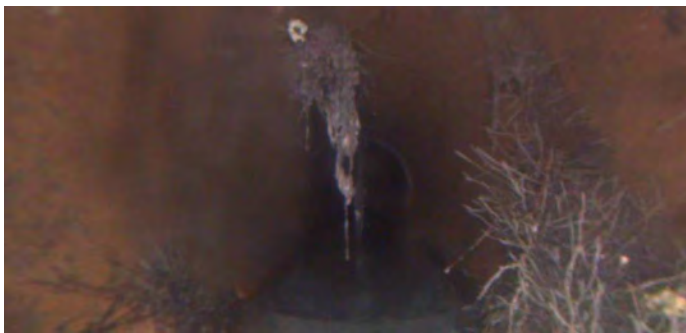
Code: **AMH**
Description: **Manhole**

Distance (ft): **.0**
Structural Grade: **0**
O&M Grade: **0**
Clock Start/From:
Clock To:
1st Value:
2nd Value:
Value Percent:
Continuous Index:
Within 8" of Joint: **NO**
Remarks: **M-604-070**

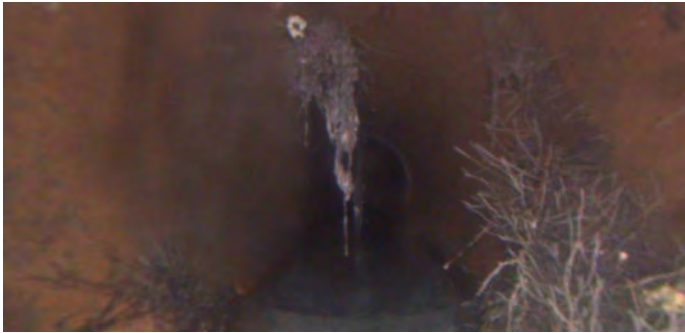
Code:	MWL
Description:	Water Level

Distance (ft):	.0
Structural Grade:	0
O&M Grade:	0
Clock Start/From:	
Clock To:	
1st Value:	
2nd Value:	
Value Percent:	5.000
Continuous Index:	
Within 8" of Joint:	NO
Remarks:

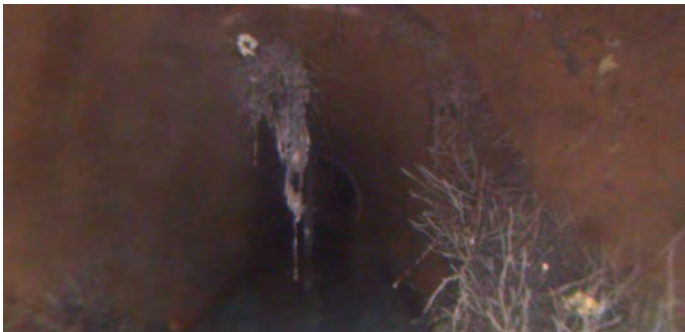
Code:	RMJ
Description:	Roots Medium Joint

Distance (ft):	.0
Structural Grade:	0
O&M Grade:	3
Clock Start/From:	8
Clock To:	4
1st Value:	
2nd Value:	
Value Percent:	10.000
Continuous Index:	
Within 8" of Joint:	YES
Remarks:

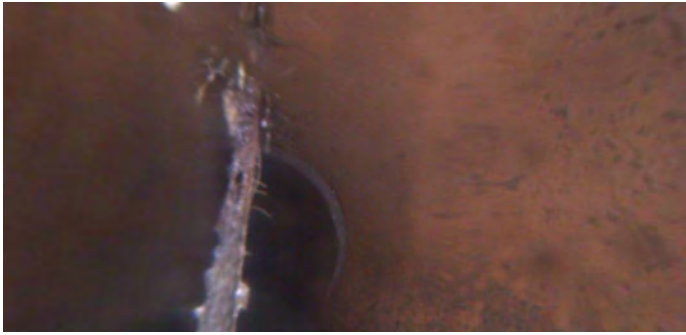
Code: **FL**
Description: **Fracture Longitudinal**

Distance (ft): **2.6**
Structural Grade: **3**
O&M Grade: **0**
Clock Start/From: **12**
Clock To:
1st Value:
2nd Value:
Value Percent:
Continuous Index: **S01**
Within 8" of Joint: **YES**
Remarks:

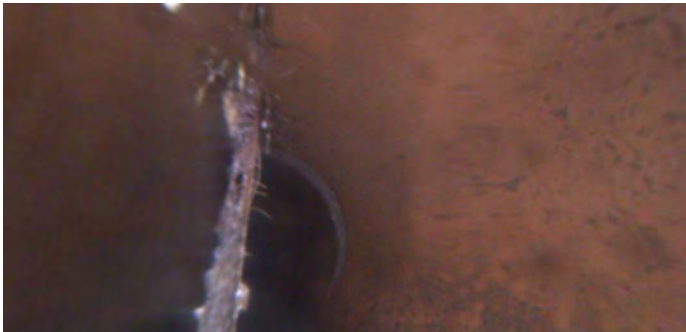
Code: **RMB**
Description: **Roots Medium Barrel**

Distance (ft): **2.6**
Structural Grade: **0**
O&M Grade: **4**
Clock Start/From: **12**
Clock To:
1st Value:
2nd Value:
Value Percent: **5.000**
Continuous Index:
Within 8" of Joint: **NO**
Remarks:

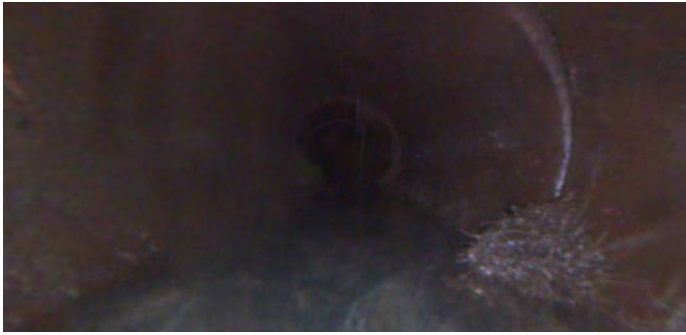
Code: **RMJ**
Description: **Roots Medium Joint**

Distance (ft): **5.3**
Structural Grade: **0**
O&M Grade: **3**
Clock Start/From: **8**
Clock To: **4**
1st Value:
2nd Value:
Value Percent: **5.000**
Continuous Index: **S02**
Within 8" of Joint: **YES**
Remarks:

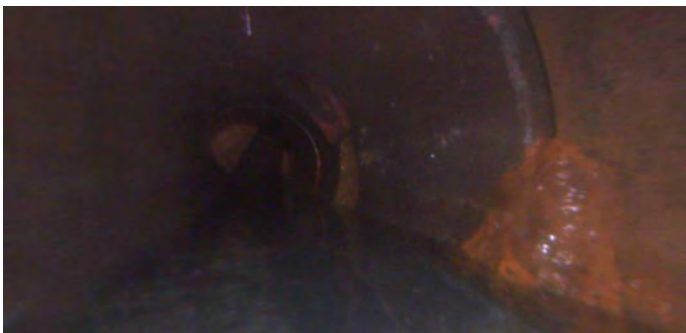
Code: **DAE**
Description: **Deposits Attached Encrustation**

Distance (ft): **9.7**
Structural Grade: **0**
O&M Grade: **2**
Clock Start/From: **3**
Clock To: **4**
1st Value:
2nd Value:
Value Percent: **5.000**
Continuous Index:
Within 8" of Joint: **YES**
Remarks:

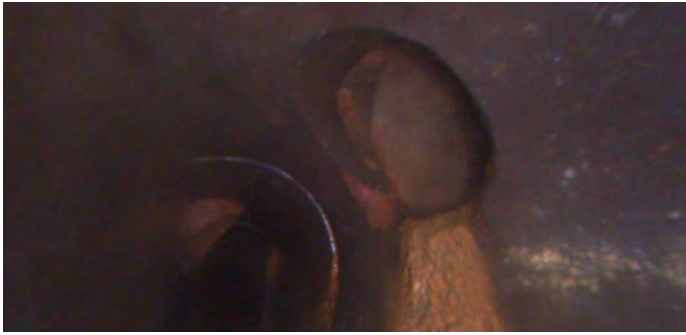
Code: **TFD**
Description: **Tap Factory Defective**

Distance (ft): **10.6**
Structural Grade: **0**
O&M Grade: **2**
Clock Start/From: **2**
Clock To:
1st Value: **4.000**
2nd Value:
Value Percent:
Continuous Index:
Within 8" of Joint:
Remarks: **dae**

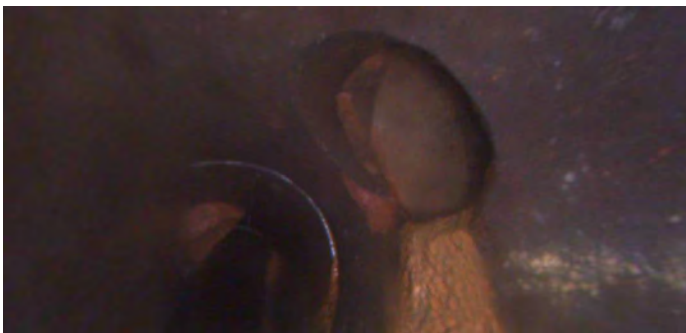
Code: **DAE**
Description: **Deposits Attached Encrustation**

Distance (ft): **10.6**
Structural Grade: **0**
O&M Grade: **2**
Clock Start/From: **3**
Clock To: **4**
1st Value:
2nd Value:
Value Percent: **5.000**
Continuous Index:
Within 8" of Joint: **NO**
Remarks:

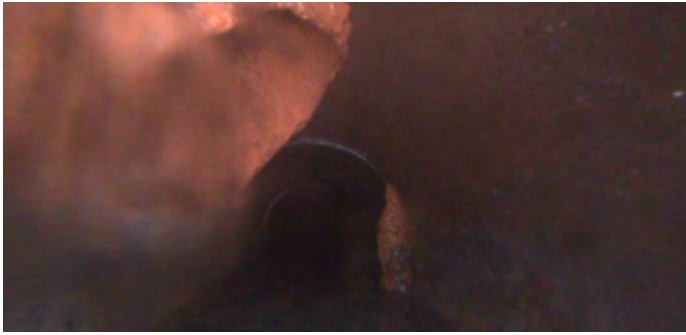
Code: **TBI**
Description: **Tap Break-in Intruding**

Distance (ft): **12.6**
Structural Grade: **0**
O&M Grade: **2**
Clock Start/From: **10**
Clock To:
1st Value: **4.000**
2nd Value: **2.000**
Value Percent:
Continuous Index:
Within 8" of Joint:
Remarks:

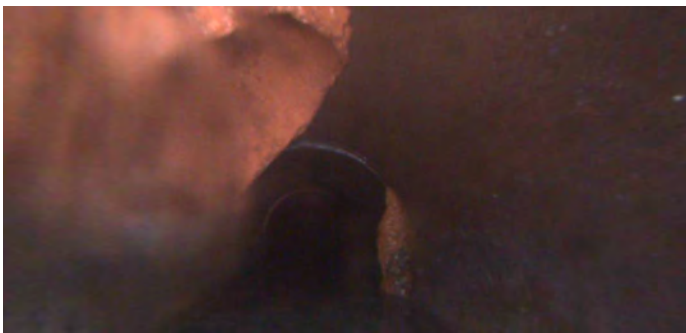
Code: **FL**
Description: **Fracture Longitudinal**

Distance (ft): **12.6**
Structural Grade: **3**
O&M Grade: **0**
Clock Start/From: **12**
Clock To:
1st Value:
2nd Value:
Value Percent:
Continuous Index: **F01**
Within 8" of Joint: **YES**
Remarks:

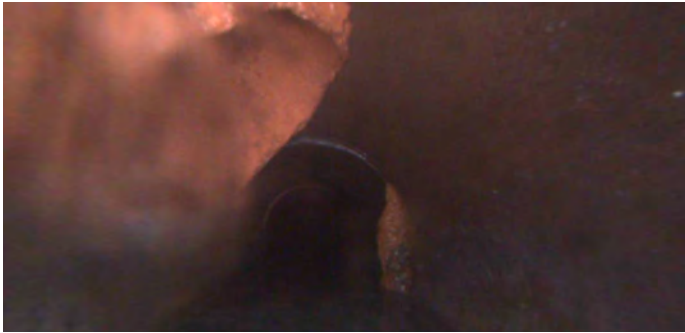
Code: **RMJ**
Description: **Roots Medium Joint**

Distance (ft): **12.6**
Structural Grade: **0**
O&M Grade: **3**
Clock Start/From: **8**
Clock To: **4**
1st Value:
2nd Value:
Value Percent: **5.000**
Continuous Index: **F02**
Within 8" of Joint: **YES**
Remarks:

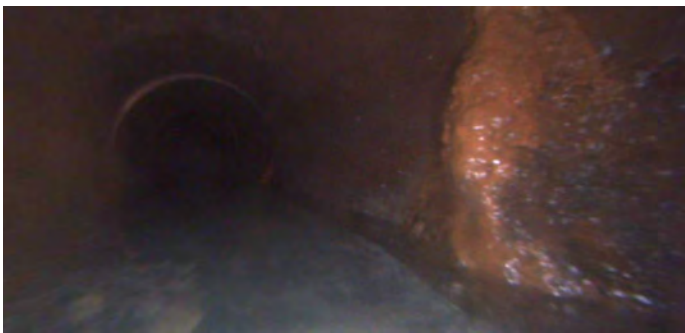
Code: **DAE**
Description: **Deposits Attached Encrustation**

Distance (ft): **13.7**
Structural Grade: **0**
O&M Grade: **2**
Clock Start/From: **3**
Clock To: **4**
1st Value:
2nd Value:
Value Percent: **10.000**
Continuous Index:
Within 8" of Joint: **YES**
Remarks:

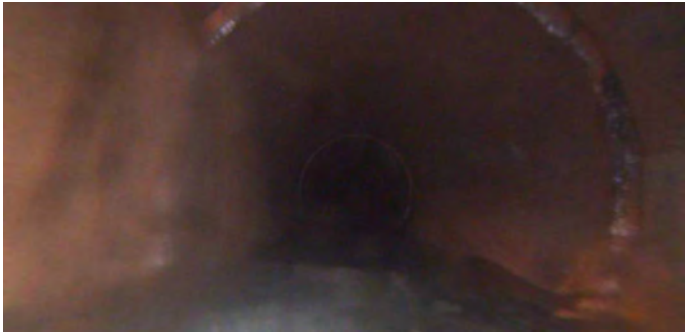
Code: **IW**
Description: **Infil Weeper**

Distance (ft): **15.5**
Structural Grade: **0**
O&M Grade: **2**
Clock Start/From: **8**
Clock To: **4**
1st Value:
2nd Value:
Value Percent:
Continuous Index: **S03**
Within 8" of Joint: **YES**
Remarks:

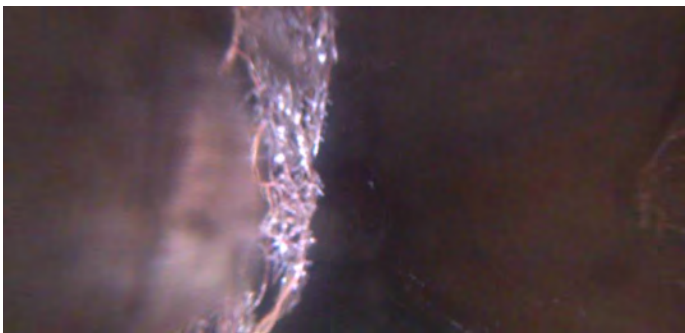
Code: **RMJ**
Description: **Roots Medium Joint**

Distance (ft): **22.0**
Structural Grade: **0**
O&M Grade: **3**
Clock Start/From: **8**
Clock To: **4**
1st Value:
2nd Value:
Value Percent: **10.000**
Continuous Index:
Within 8" of Joint: **YES**
Remarks:

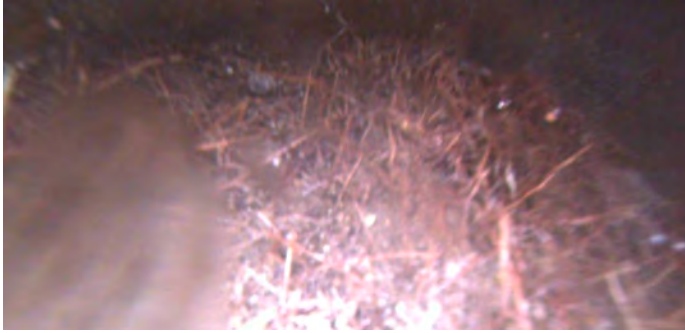
Code: **RBJ**
Description: **Roots Ball Joint**

Distance (ft): **23.7**
Structural Grade: **0**
O&M Grade: **4**
Clock Start/From: **12**
Clock To: **12**
1st Value:
2nd Value:
Value Percent: **90.000**
Continuous Index:
Within 8" of Joint: **YES**
Remarks:

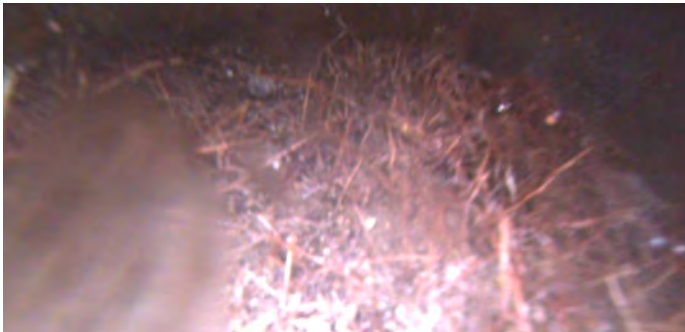
Code: **MSA**
Description: **Abandoned Survey**

Distance (ft): **23.7**
Structural Grade: **0**
O&M Grade: **0**
Clock Start/From:
Clock To:
1st Value:
2nd Value:
Value Percent:
Continuous Index:
Within 8" of Joint: **NO**
Remarks: **roots**

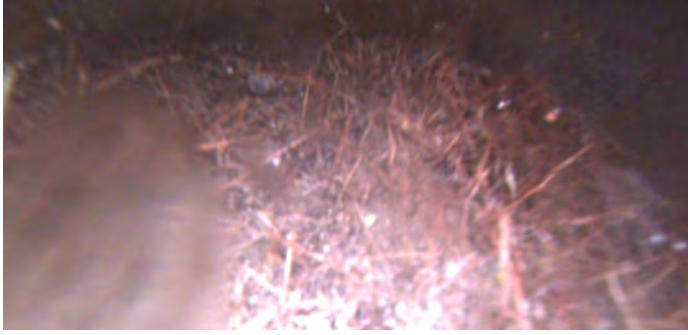
Code:	IW
Description:	Infil Weeper
Distance (ft):	23.7
Structural Grade:	0
O&M Grade:	2
Clock Start/From:	8
Clock To:	4
1st Value:	
2nd Value:	
Value Percent:	
Continuous Index:	F03
Within 8" of Joint:	YES
Remarks:
