## Profile/Photo Observation Report

Street:	<b>Summerlin</b>	Flow Control:	<b>Not Controlled</b>
City:	<b>Hobart, IN</b>	Year Renewed:	
Location:	<b>Light Highway</b>	Tape/Media #:	
Purpose:	<b>Not Known</b>	Dia/Height:	<b>12"</b>
Use:	<b>Sanitary</b>	Material:	<b>VCP</b>
Drain Area:	<b>NA</b>	Lining:	
Category:	<b>NA</b>		
Comment:

Location Details:		Direction of Survey:	<b>Downstream</b>
US MH:	<b>M-604-072</b>	DS MH:	<b>M-604-071</b>
		Total Length Surveyed (ft):	<b>12.2</b>

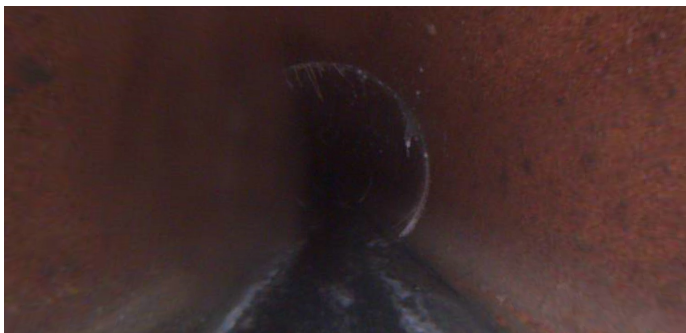
Code: **AMH**  
Description: **Manhole**

Distance (ft): **.0**  
Structural Grade: **0**  
O&M Grade: **0**  
Clock Start/From:  
Clock To:  
1st Value:  
2nd Value:  
Value Percent:  
Continuous Index:  
Within 8" of Joint: **NO**  
Remarks: **M-604-072**

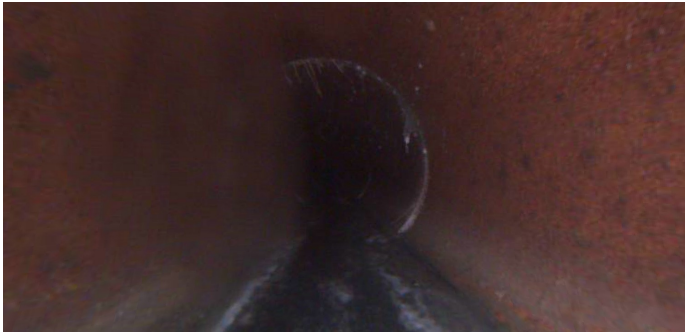
Code:	<b>MWL</b>
Description:	<b>Water Level</b>

Distance (ft):	<b>.0</b>
Structural Grade:	<b>0</b>
O&M Grade:	<b>0</b>
Clock Start/From:	
Clock To:	
1st Value:	
2nd Value:	
Value Percent:	<b>5.000</b>
Continuous Index:	
Within 8" of Joint:	<b>NO</b>
Remarks:

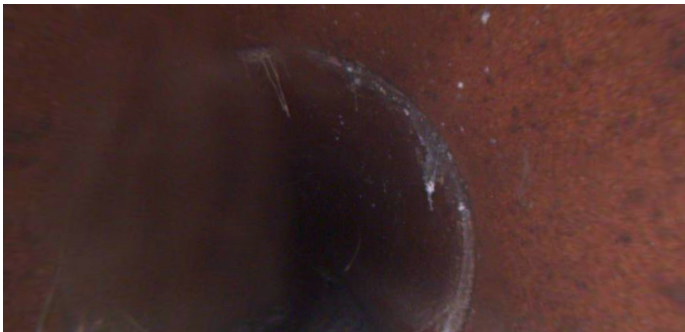
Code:	<b>RFJ</b>
Description:	<b>Roots Fine Joint</b>

Distance (ft):	<b>1.3</b>
Structural Grade:	<b>0</b>
O&M Grade:	<b>1</b>
Clock Start/From:	<b>7</b>
Clock To:	<b>5</b>
1st Value:	
2nd Value:	
Value Percent:	
Continuous Index:	
Within 8" of Joint:	<b>YES</b>
Remarks:

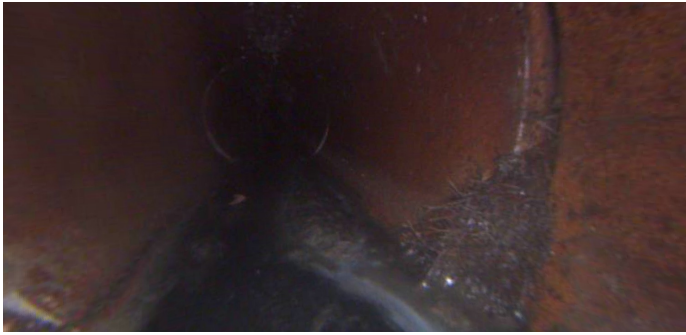
Code: **RFJ**  
Description: **Roots Fine Joint**

Distance (ft): **7.9**  
Structural Grade: **0**  
O&M Grade: **1**  
Clock Start/From: **3**  
Clock To: **4**  
1st Value:  
2nd Value:  
Value Percent:  
Continuous Index:  
Within 8" of Joint: **YES**  
Remarks:

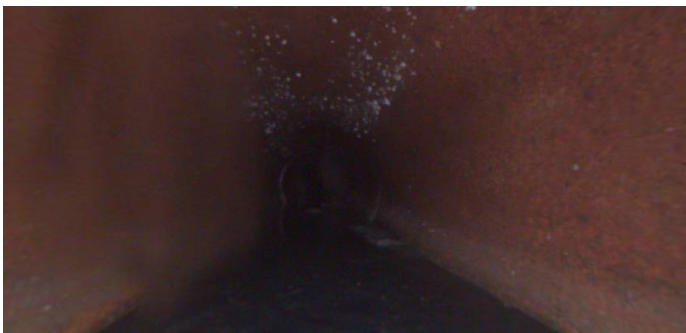
Code: **MSA**  
Description: **Abandoned Survey**

Distance (ft): **12.2**  
Structural Grade: **0**  
O&M Grade: **0**  
Clock Start/From:  
Clock To:  
1st Value:  
2nd Value:  
Value Percent:  
Continuous Index:  
Within 8" of Joint: **NO**  
Remarks: **UNKNOWN**
