Profile/Photo Observation Report

Street:	N WASHINGTON ST & W HOME AVE	Flow Control:	Not Controlled
City:	Hobart, IN	Year Renewed:	
Location:	Light Highway	Tape/Media #:	
Purpose:	Not Known	Dia/Height:	12"
Use:	Sanitary	Material:	VCP
Drain Area:	NA	Lining:	
Category:	NA		
Comment:

Location Details:		Direction of Survey:	Downstream
US MH:	M-604-073	DS MH:	M-604-072
		Total Length Surveyed (ft):	4.4

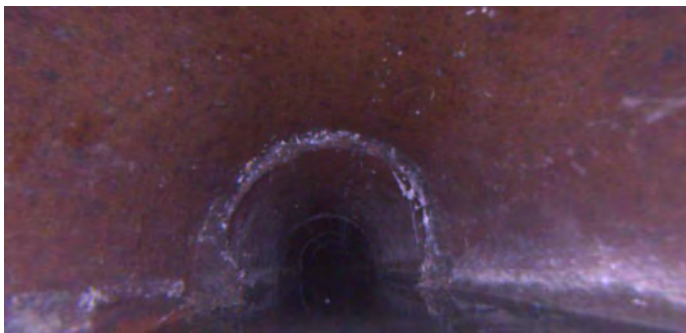
Code: **AMH**
Description: **Manhole**

Distance (ft): **.0**
Structural Grade: **0**
O&M Grade: **0**
Clock Start/From:
Clock To:
1st Value:
2nd Value:
Value Percent:
Continuous Index:
Within 8" of Joint: **NO**
Remarks: **M-604-073**

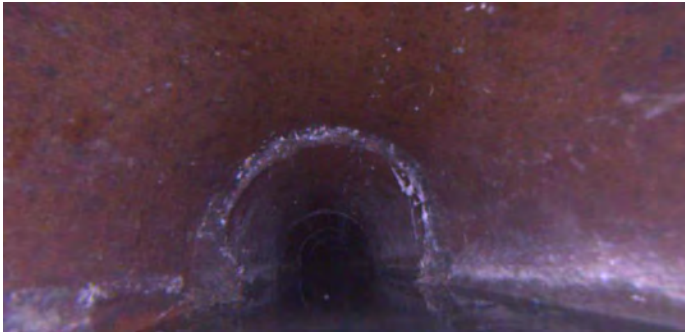
Code:	MWL
Description:	Water Level

Distance (ft):	.0
Structural Grade:	0
O&M Grade:	0
Clock Start/From:	
Clock To:	
1st Value:	
2nd Value:	
Value Percent:	30.000
Continuous Index:	
Within 8" of Joint:	NO
Remarks:

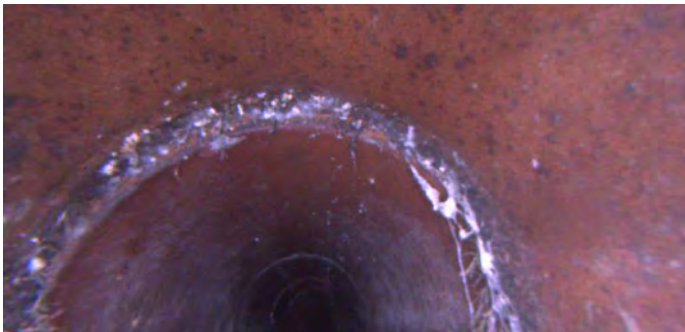
Code:	RMJ
Description:	Roots Medium Joint

Distance (ft):	1.3
Structural Grade:	0
O&M Grade:	3
Clock Start/From:	8
Clock To:	4
1st Value:	
2nd Value:	
Value Percent:	5.000
Continuous Index:	
Within 8" of Joint:	YES
Remarks:

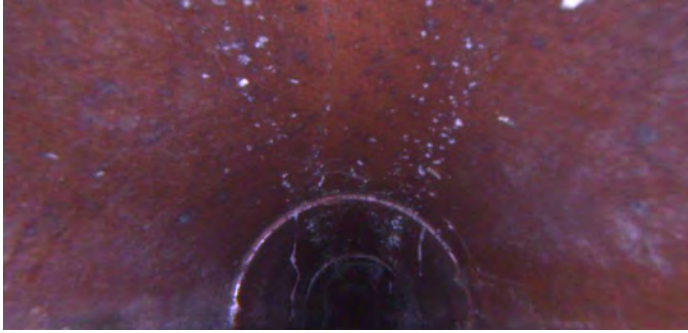
Code:	MSA
Description:	Abandoned Survey
Distance (ft):	4.4
Structural Grade:	0
O&M Grade:	0
Clock Start/From:	
Clock To:	
1st Value:	
2nd Value:	
Value Percent:	
Continuous Index:	
Within 8" of Joint:	NO
Remarks:	roots
