## Profile/Photo Observation Report

Street:	<b>Summerlin</b>	Flow Control:	<b>Not Controlled</b>
City:	<b>Hobart, IN</b>	Year Renewed:	
Location:	<b>Light Highway</b>	Tape/Media #:	
Purpose:	<b>Not Known</b>	Dia/Height:	<b>12"</b>
Use:	<b>Sanitary</b>	Material:	<b>VCP</b>
Drain Area:	<b>NA</b>	Lining:	
Category:	<b>NA</b>		
Comment:

Location Details:		Direction of Survey:	<b>Downstream</b>
US MH:	<b>M-604-073</b>	DS MH:	<b>M-604-072</b>
		Total Length Surveyed (ft):	<b>4.4</b>

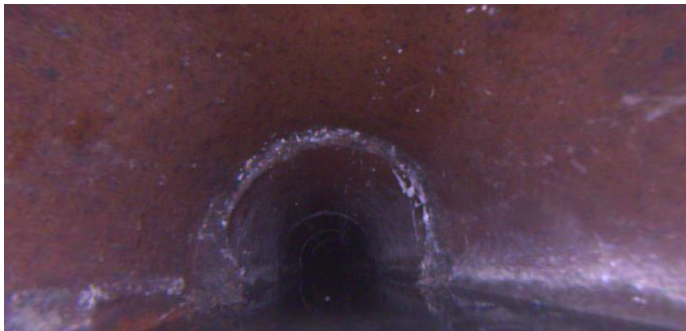
Code: **AMH**  
Description: **Manhole**

Distance (ft): **.0**  
Structural Grade: **0**  
O&M Grade: **0**  
Clock Start/From:  
Clock To:  
1st Value:  
2nd Value:  
Value Percent:  
Continuous Index:  
Within 8" of Joint: **NO**  
Remarks: **M-604-073**

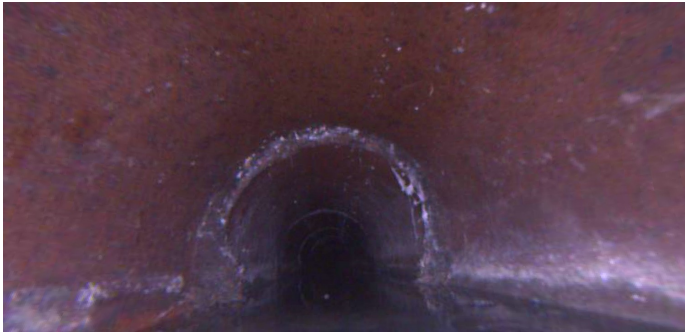
Code:	<b>MWL</b>
Description:	<b>Water Level</b>

Distance (ft):	<b>.0</b>
Structural Grade:	<b>0</b>
O&M Grade:	<b>0</b>
Clock Start/From:	
Clock To:	
1st Value:	
2nd Value:	
Value Percent:	<b>30.000</b>
Continuous Index:	
Within 8" of Joint:	<b>NO</b>
Remarks:

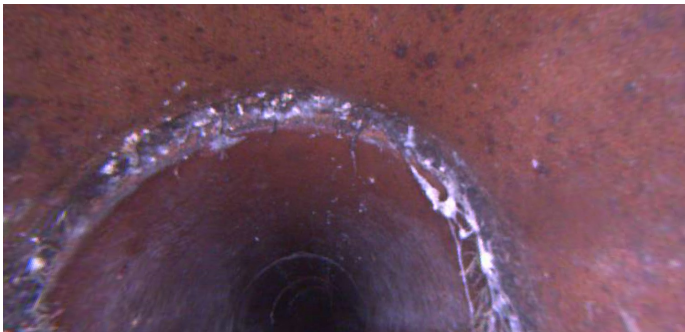
Code:	<b>RMJ</b>
Description:	<b>Roots Medium Joint</b>

Distance (ft):	<b>1.3</b>
Structural Grade:	<b>0</b>
O&M Grade:	<b>3</b>
Clock Start/From:	<b>8</b>
Clock To:	<b>4</b>
1st Value:	
2nd Value:	
Value Percent:	<b>5.000</b>
Continuous Index:	
Within 8" of Joint:	<b>YES</b>
Remarks:

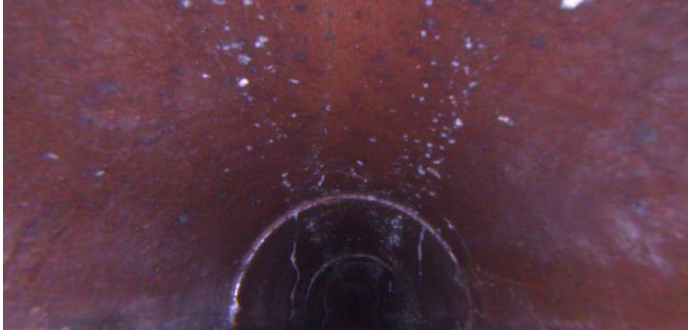
Code:	<b>MSA</b>
Description:	<b>Abandoned Survey</b>
Distance (ft):	<b>4.4</b>
Structural Grade:	<b>0</b>
O&M Grade:	<b>0</b>
Clock Start/From:	
Clock To:	
1st Value:	
2nd Value:	
Value Percent:	
Continuous Index:	
Within 8" of Joint:	<b>NO</b>
Remarks:	<b>roots</b>
