## Profile/Photo Observation Report

Street:	<b>N WASHINGTON ST &amp; W HOME AVE</b>	Flow Control:	<b>Not Controlled</b>
City:	<b>Hobart, IN</b>	Year Renewed:	
Location:	<b>Light Highway</b>	Tape/Media #:	
Purpose:	<b>Not Known</b>	Dia/Height:	<b>12"</b>
Use:	<b>Sanitary</b>	Material:	<b>VCP</b>
Drain Area:	<b>NA</b>	Lining:	
Category:	<b>NA</b>		
Comment:

Location Details:		Direction of Survey:	<b>Upstream</b>
US MH:	<b>M-604-074</b>	DS MH:	<b>M-604-073</b>
		Total Length Surveyed (ft):	<b>39.7</b>

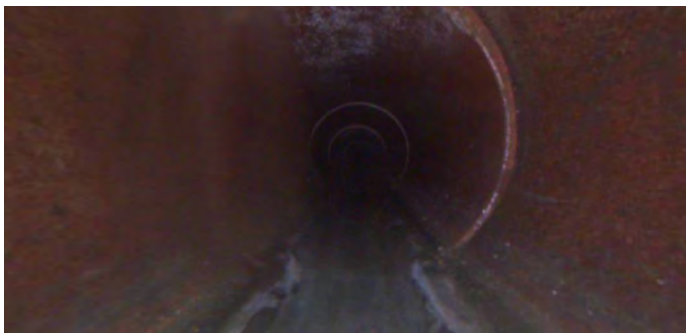
Code: **AMH**  
Description: **Manhole**

Distance (ft): **.0**  
Structural Grade: **0**  
O&M Grade: **0**  
Clock Start/From:  
Clock To:  
1st Value:  
2nd Value:  
Value Percent:  
Continuous Index:  
Within 8" of Joint: **NO**  
Remarks: **M-604-074**

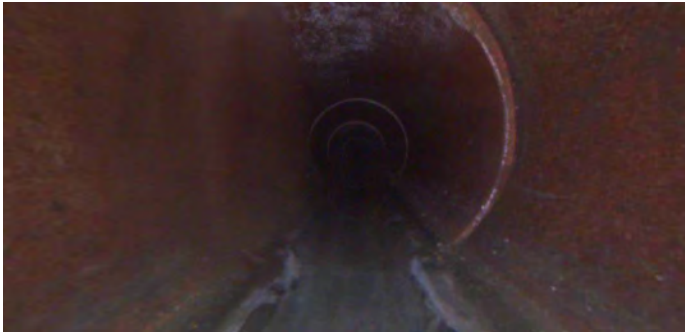
Code:	<b>MWL</b>
Description:	<b>Water Level</b>

Distance (ft):	<b>.0</b>
Structural Grade:	<b>0</b>
O&M Grade:	<b>0</b>
Clock Start/From:	
Clock To:	
1st Value:	
2nd Value:	
Value Percent:	<b>5.000</b>
Continuous Index:	
Within 8" of Joint:	<b>NO</b>
Remarks:

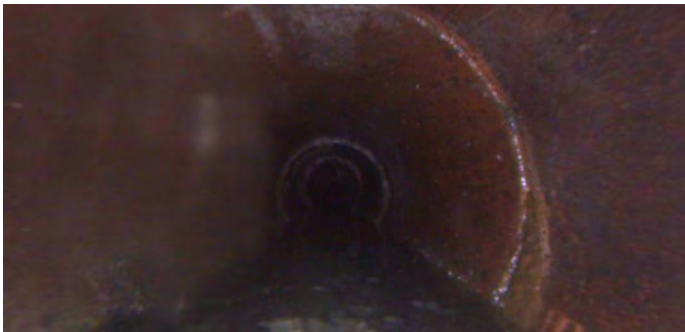
Code:	<b>IW</b>
Description:	<b>Infil Weeper</b>

Distance (ft):	<b>7.4</b>
Structural Grade:	<b>0</b>
O&M Grade:	<b>2</b>
Clock Start/From:	<b>3</b>
Clock To:	<b>4</b>
1st Value:	
2nd Value:	
Value Percent:	
Continuous Index:	
Within 8" of Joint:	<b>YES</b>
Remarks:

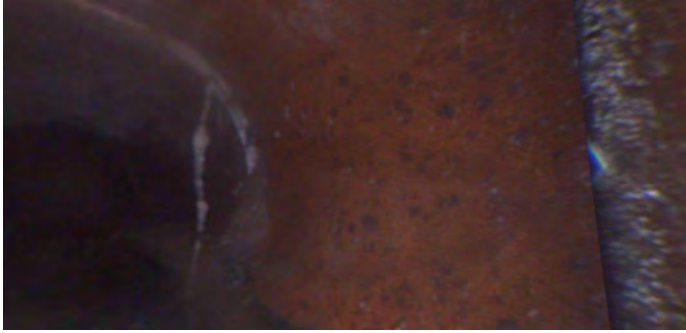
Code: **RFJ**  
Description: **Roots Fine Joint**

Distance (ft): **9.1**  
Structural Grade: **0**  
O&M Grade: **1**  
Clock Start/From: **8**  
Clock To: **10**  
1st Value:  
2nd Value:  
Value Percent:  
Continuous Index:  
Within 8" of Joint: **YES**  
Remarks:

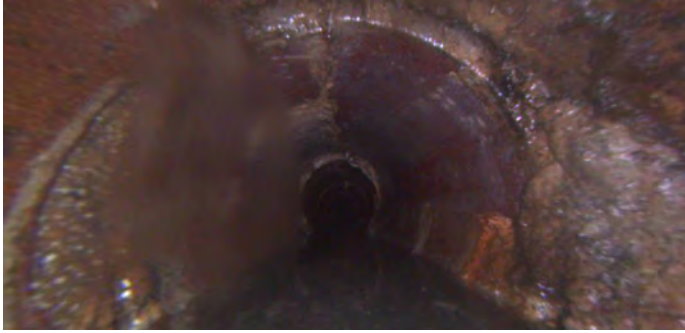
Code: **IW**  
Description: **Infil Weeper**

Distance (ft): **9.7**  
Structural Grade: **0**  
O&M Grade: **2**  
Clock Start/From: **8**  
Clock To: **4**  
1st Value:  
2nd Value:  
Value Percent:  
Continuous Index:  
Within 8" of Joint: **YES**  
Remarks:

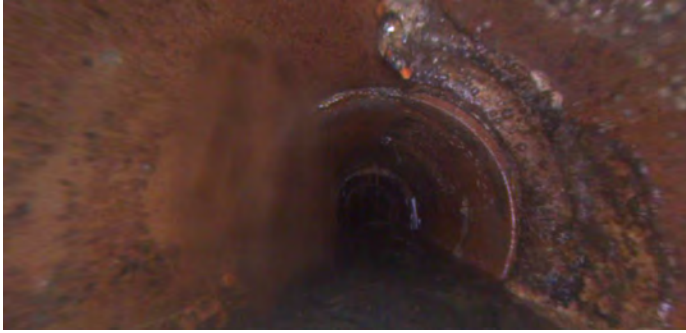
Code: ID  
Description: Infil Dripper

Distance (ft): 13.4  
Structural Grade: 0  
O&M Grade: 3  
Clock Start/From: 12  
Clock To:  
1st Value:  
2nd Value:  
Value Percent:  
Continuous Index:  
Within 8" of Joint:  
Remarks:

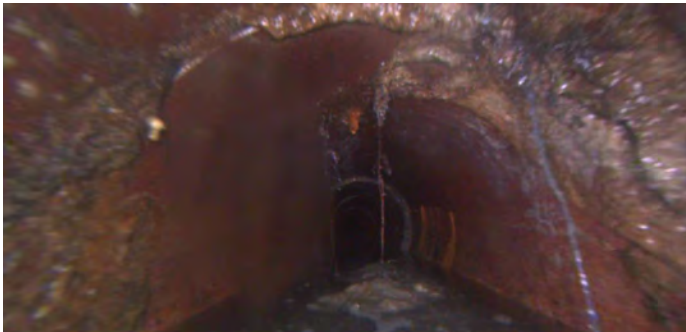
Code: RFJ  
Description: Roots Fine Joint

Distance (ft): 15.9  
Structural Grade: 0  
O&M Grade: 1  
Clock Start/From: 8  
Clock To: 4  
1st Value:  
2nd Value:  
Value Percent:  
Continuous Index: S03  
Within 8" of Joint: YES  
Remarks:

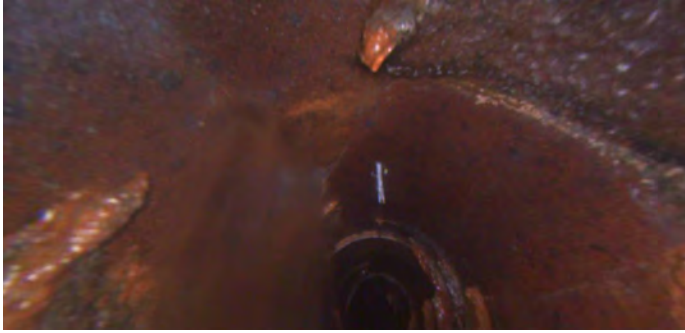
Code: ID  
Description: Infil Dripper

Distance (ft): 28.7  
Structural Grade: 0  
O&M Grade: 3  
Clock Start/From: 12  
Clock To:  
1st Value:  
2nd Value:  
Value Percent:  
Continuous Index:  
Within 8" of Joint:  
Remarks:

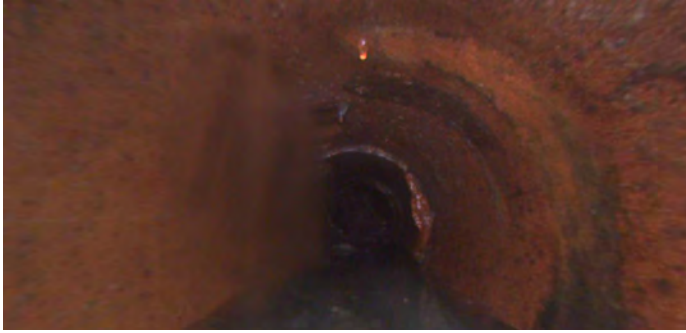
Code: ID  
Description: Infil Dripper

Distance (ft): 35.2  
Structural Grade: 0  
O&M Grade: 3  
Clock Start/From: 12  
Clock To:  
1st Value:  
2nd Value:  
Value Percent:  
Continuous Index:  
Within 8" of Joint:  
Remarks:

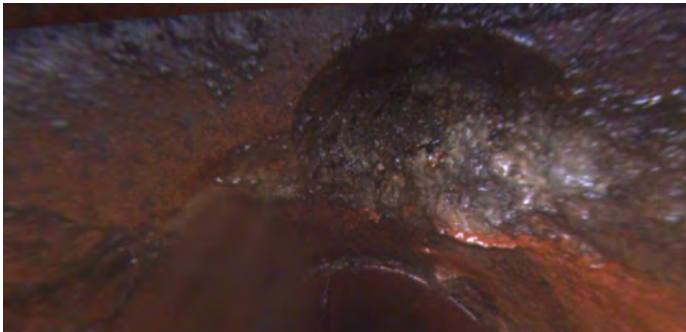
Code: TFD  
Description: Tap Factory Defective

Distance (ft): 37.8  
Structural Grade: 0  
O&M Grade: 2  
Clock Start/From: 12  
Clock To:  
1st Value: 4.000  
2nd Value:  
Value Percent:  
Continuous Index:  
Within 8" of Joint:  
Remarks: DAE

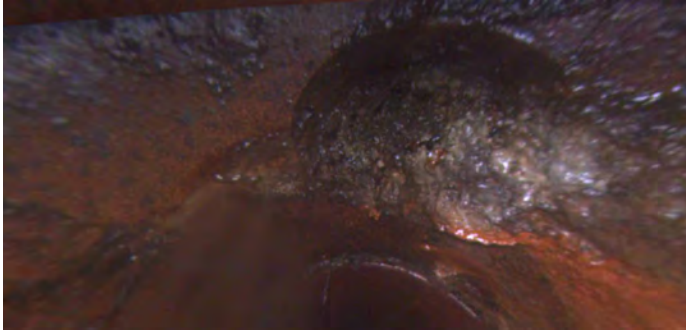
Code: **DAE**  
Description: **Deposits Attached Encrustation**

Distance (ft): **37.8**  
Structural Grade: **0**  
O&M Grade: **2**  
Clock Start/From: **12**  
Clock To: **1**  
1st Value:  
2nd Value:  
Value Percent: **5.000**  
Continuous Index:  
Within 8" of Joint: **NO**  
Remarks:

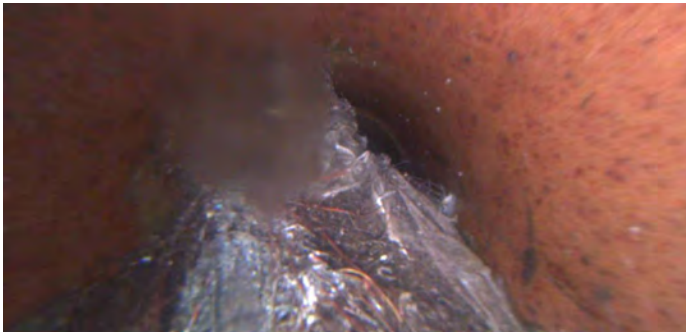
Code: **RBB**  
Description: **Roots Ball Barrel**

Distance (ft): **39.2**  
Structural Grade: **0**  
O&M Grade: **5**  
Clock Start/From: **3**  
Clock To: **12**  
1st Value:  
2nd Value:  
Value Percent: **90.000**  
Continuous Index:  
Within 8" of Joint: **NO**  
Remarks:

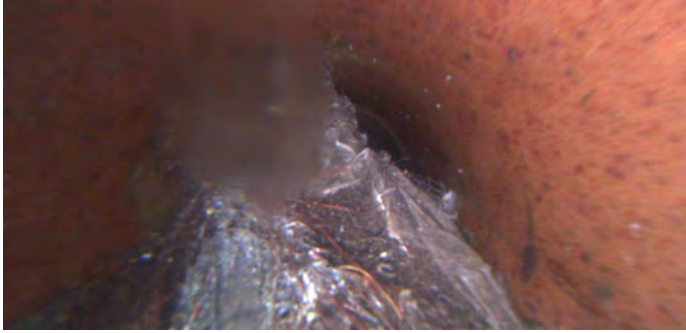
Code: **DAE**  
Description: **Deposits Attached Encrustation**

Distance (ft): **39.2**  
Structural Grade: **0**  
O&M Grade: **2**  
Clock Start/From: **8**  
Clock To: **4**  
1st Value:  
2nd Value:  
Value Percent: **10.000**  
Continuous Index: **F02**  
Within 8" of Joint: **YES**  
Remarks:

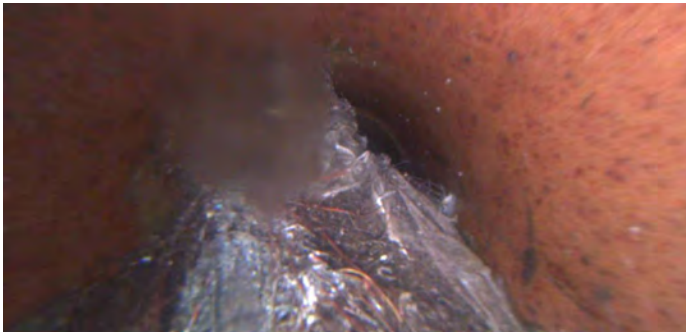
Code: **RFJ**  
Description: **Roots Fine Joint**

Distance (ft): **39.2**  
Structural Grade: **0**  
O&M Grade: **1**  
Clock Start/From: **8**  
Clock To: **4**  
1st Value:  
2nd Value:  
Value Percent:  
Continuous Index: **F03**  
Within 8" of Joint: **YES**  
Remarks:

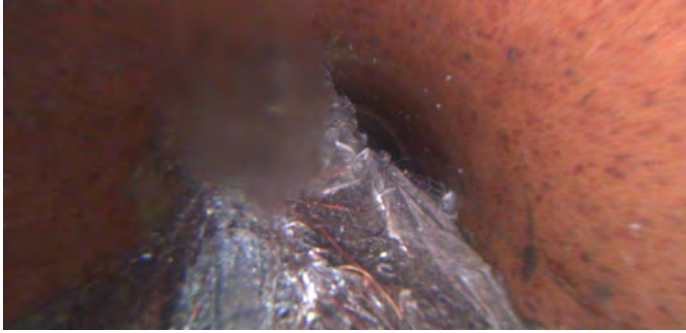
Code: **FM**  
Description: **Fracture Multiple**

Distance (ft): **39.2**  
Structural Grade: **4**  
O&M Grade: **0**  
Clock Start/From: **8**  
Clock To: **4**  
1st Value:  
2nd Value:  
Value Percent:  
Continuous Index: **F01**  
Within 8" of Joint: **YES**  
Remarks:

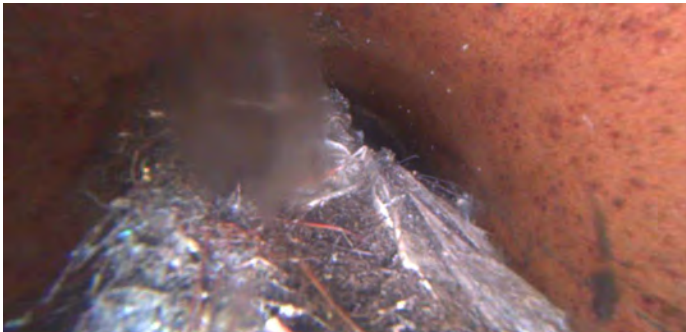
Code: **MSA**  
Description: **Abandoned Survey**

Distance (ft): **39.7**  
Structural Grade: **0**  
O&M Grade: **0**  
Clock Start/From:  
Clock To:  
1st Value:  
2nd Value:  
Value Percent:  
Continuous Index:  
Within 8" of Joint: **NO**  
Remarks: **ROOTS**
