Profile/Photo Observation Report

Street:	Summerlin	Flow Control:	Not Controlled
City:	Hobart, IN	Year Renewed:	
Location:	Light Highway	Tape/Media #:	
Purpose:	Not Known	Dia/Height:	12"
Use:	Sanitary	Material:	VCP
Drain Area:	NA	Lining:	
Category:	NA		
Comment:

Location Details:		Direction of Survey:	Upstream
US MH:	M-604-074	DS MH:	M-604-073
		Total Length Surveyed (ft):	39.7

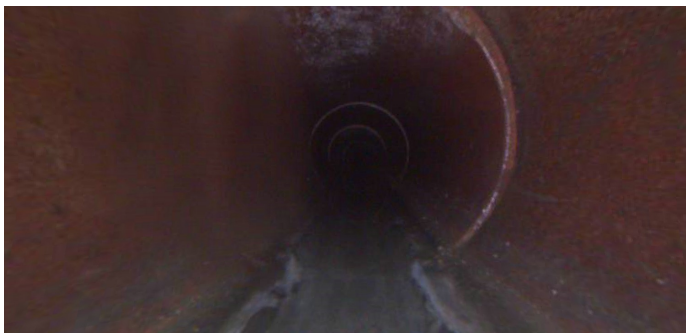
Code: **AMH**
Description: **Manhole**

Distance (ft): **.0**
Structural Grade: **0**
O&M Grade: **0**
Clock Start/From:
Clock To:
1st Value:
2nd Value:
Value Percent:
Continuous Index:
Within 8" of Joint: **NO**
Remarks: **M-604-074**

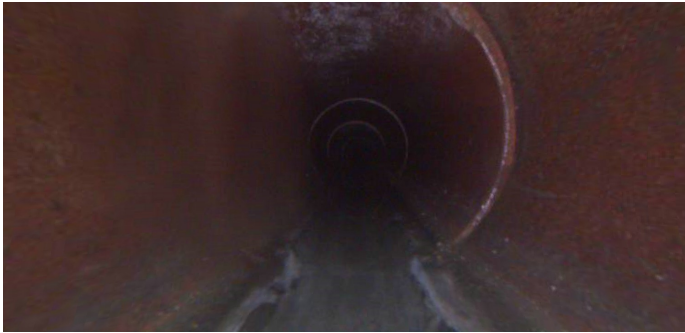
Code:	MWL
Description:	Water Level

Distance (ft):	.0
Structural Grade:	0
O&M Grade:	0
Clock Start/From:	
Clock To:	
1st Value:	
2nd Value:	
Value Percent:	5.000
Continuous Index:	
Within 8" of Joint:	NO
Remarks:

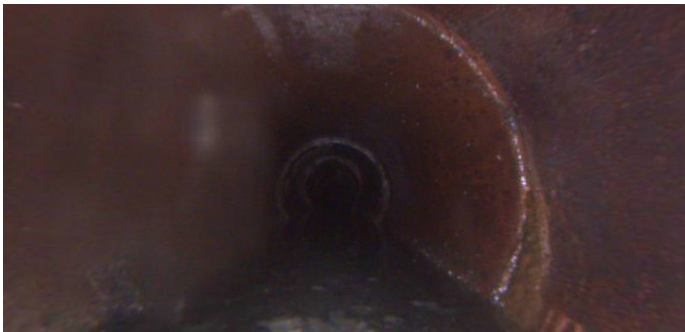
Code:	IW
Description:	Infil Weeper

Distance (ft):	7.4
Structural Grade:	0
O&M Grade:	2
Clock Start/From:	3
Clock To:	4
1st Value:	
2nd Value:	
Value Percent:	
Continuous Index:	
Within 8" of Joint:	YES
Remarks:

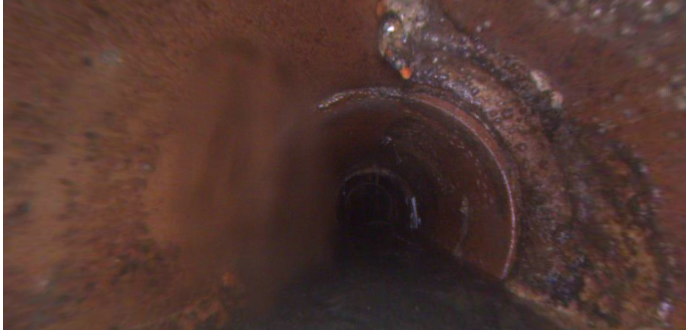
Code: **ID**
Description: **Infil Dripper**

Distance (ft): **13.4**
Structural Grade: **0**
O&M Grade: **3**
Clock Start/From: **12**
Clock To:
1st Value:
2nd Value:
Value Percent:
Continuous Index:
Within 8" of Joint:
Remarks:

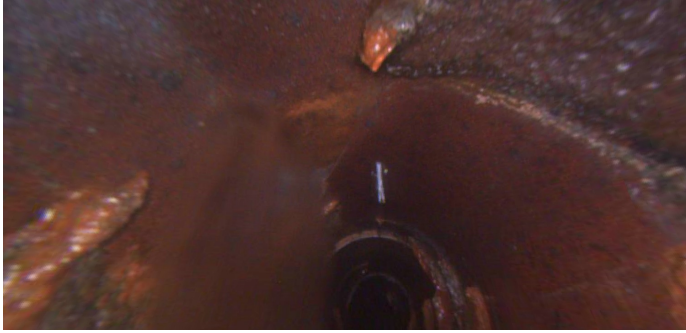
Code: ID
Description: Infil Dripper

Distance (ft): 28.7
Structural Grade: 0
O&M Grade: 3
Clock Start/From: 12
Clock To:
1st Value:
2nd Value:
Value Percent:
Continuous Index:
Within 8" of Joint:
Remarks:

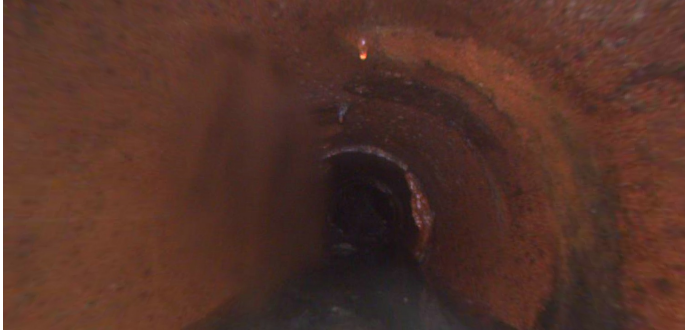
Code: ID
Description: Infil Dripper

Distance (ft): 35.2
Structural Grade: 0
O&M Grade: 3
Clock Start/From: 12
Clock To:
1st Value:
2nd Value:
Value Percent:
Continuous Index:
Within 8" of Joint:
Remarks:

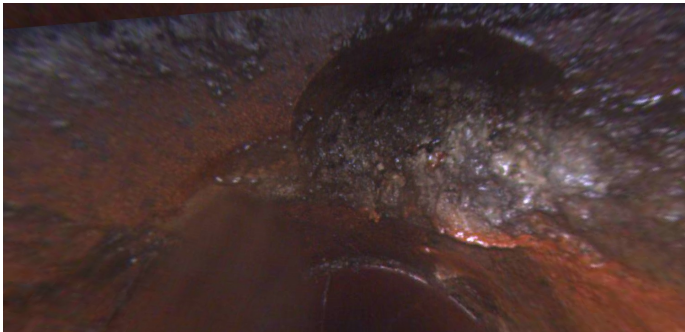
Code: TFD
Description: Tap Factory Defective

Distance (ft): 37.8
Structural Grade: 0
O&M Grade: 2
Clock Start/From: 12
Clock To:
1st Value: 4.000
2nd Value:
Value Percent:
Continuous Index:
Within 8" of Joint:
Remarks: DAE

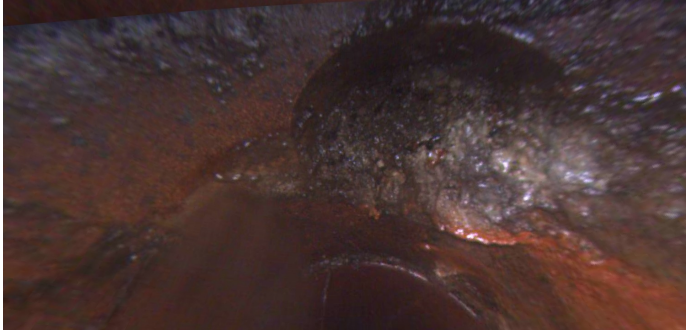
Code: **DAE**
Description: **Deposits Attached Encrustation**

Distance (ft): **37.8**
Structural Grade: **0**
O&M Grade: **2**
Clock Start/From: **12**
Clock To: **1**
1st Value:
2nd Value:
Value Percent: **5.000**
Continuous Index:
Within 8" of Joint: **NO**
Remarks:

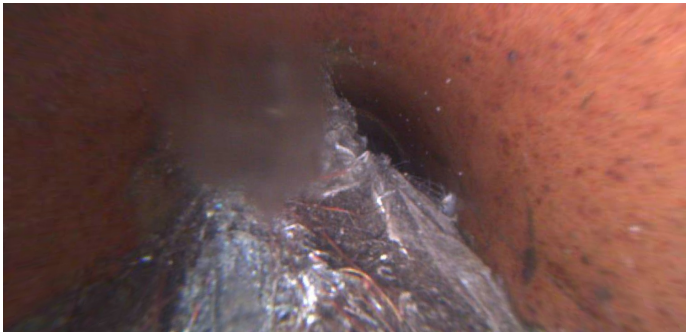
Code: **RBB**
Description: **Roots Ball Barrel**

Distance (ft): **39.2**
Structural Grade: **0**
O&M Grade: **5**
Clock Start/From: **3**
Clock To: **12**
1st Value:
2nd Value:
Value Percent: **90.000**
Continuous Index:
Within 8" of Joint: **NO**
Remarks:

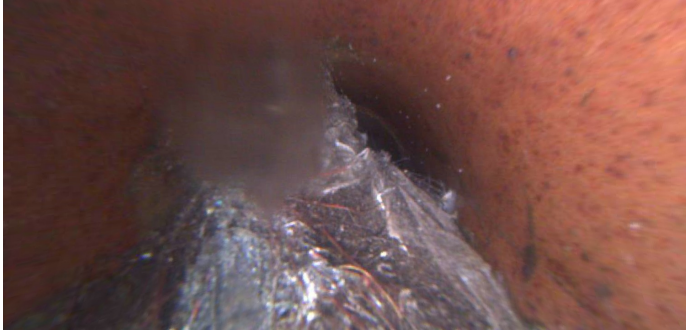
Code: **DAE**
Description: **Deposits Attached Encrustation**

Distance (ft): **39.2**
Structural Grade: **0**
O&M Grade: **2**
Clock Start/From: **8**
Clock To: **4**
1st Value:
2nd Value:
Value Percent: **10.000**
Continuous Index: **F02**
Within 8" of Joint: **YES**
Remarks:

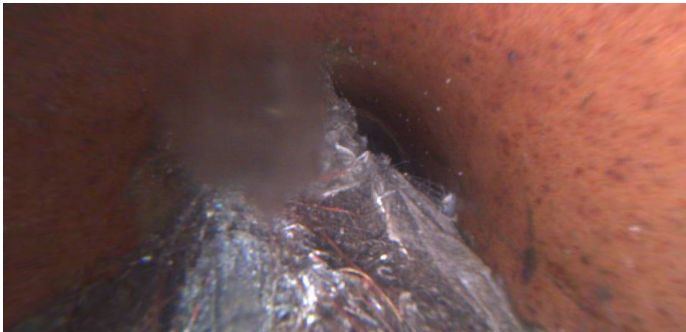
Code: **RFJ**
Description: **Roots Fine Joint**

Distance (ft): **39.2**
Structural Grade: **0**
O&M Grade: **1**
Clock Start/From: **8**
Clock To: **4**
1st Value:
2nd Value:
Value Percent:
Continuous Index: **F03**
Within 8" of Joint: **YES**
Remarks:

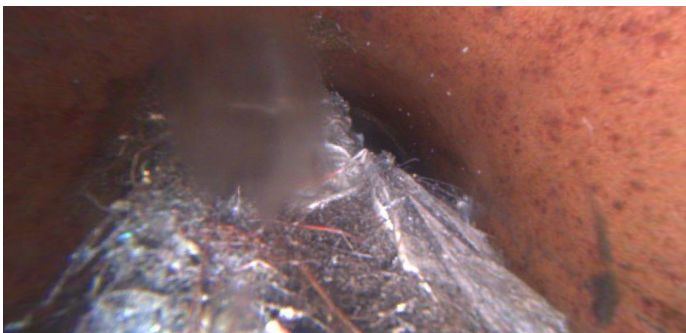
Code: **MSA**
Description: **Abandoned Survey**

Distance (ft): **39.7**
Structural Grade: **0**
O&M Grade: **0**
Clock Start/From:
Clock To:
1st Value:
2nd Value:
Value Percent:
Continuous Index:
Within 8" of Joint: **NO**
Remarks: **ROOTS**
