Profile/Photo Observation Report

Street:	Summerlin	Flow Control:	Not Controlled
City:	Hobart, IN	Year Renewed:	
Location:	Light Highway	Tape/Media #:	
Purpose:	Not Known	Dia/Height:	12"
Use:	Sanitary	Material:	PVC
Drain Area:	NA	Lining:	
Category:	NA		
Comment:

Location Details:		Direction of Survey:	Downstream
US MH:	M-604-085	DS MH:	M-604-086
		Total Length Surveyed (ft):	133.3

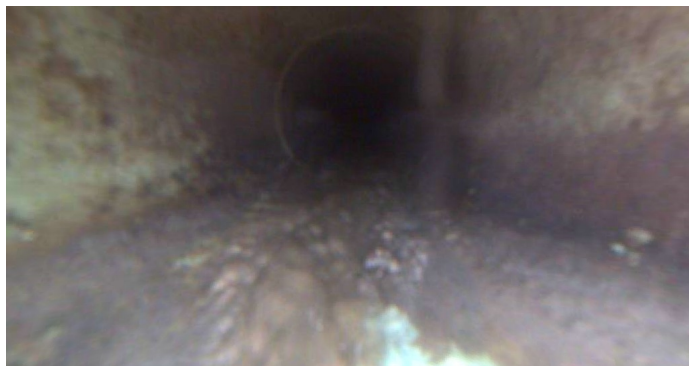
Code: **AMH**
 Description: **Manhole**

Distance (ft): **.0**
 Structural Grade: **0**
 O&M Grade: **0**
 Clock Start/From:
 Clock To:
 1st Value:
 2nd Value:
 Value Percent:
 Continuous Index:
 Within 8" of Joint: **NO**
 Remarks: **M-604-085**

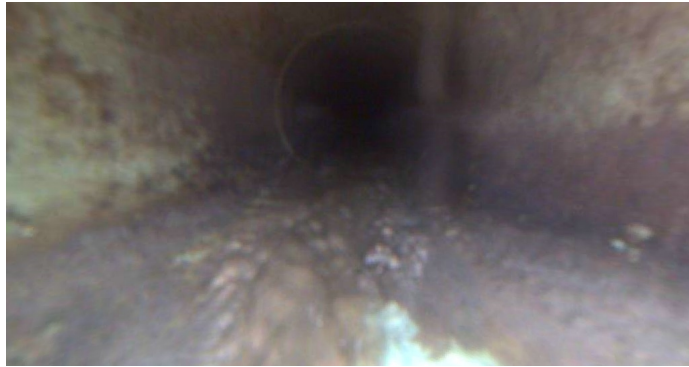
Code:	MWL
Description:	Water Level
Distance (ft):	.0
Structural Grade:	0
O&M Grade:	0
Clock Start/From:	
Clock To:	
1st Value:	
2nd Value:	
Value Percent:	10.000
Continuous Index:	
Within 8" of Joint:	NO
Remarks:

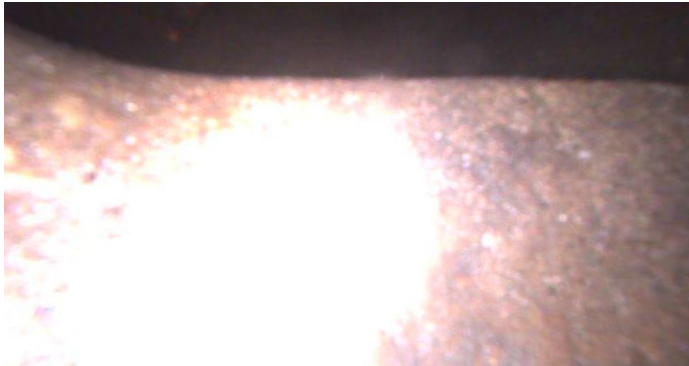
Code:	AMH
Description:	Manhole
Distance (ft):	133.3
Structural Grade:	0
O&M Grade:	0
Clock Start/From:	
Clock To:	
1st Value:	
2nd Value:	
Value Percent:	
Continuous Index:	
Within 8" of Joint:	NO
Remarks:	M-604-086
