Profile/Photo Observation Report

Street:	N WASHINGTON ST & W OLD RIDGE	Flow Control:	Not Controlled
City:	Hobart, IN	Year Renewed:	
Location:	Light Highway	Tape/Media #:	
Purpose:	Not Known	Dia/Height:	12"
Use:	Sanitary	Material:	PVC
Drain Area:	NA	Lining:	
Category:	NA		
Comment:

Location Details:		Direction of Survey:	Downstream
US MH:	M-604-086	DS MH:	M-604-021
		Total Length Surveyed (ft):	112.3

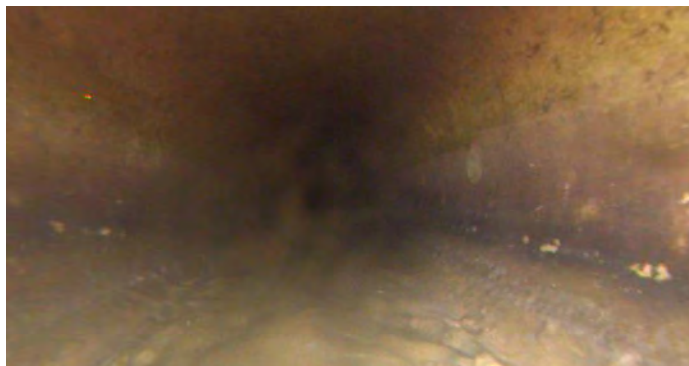
Code: **AMH**
 Description: **Manhole**

Distance (ft): **.0**
 Structural Grade: **0**
 O&M Grade: **0**
 Clock Start/From:
 Clock To:
 1st Value:
 2nd Value:
 Value Percent:
 Continuous Index:
 Within 8" of Joint: **NO**
 Remarks: **M-604-086**

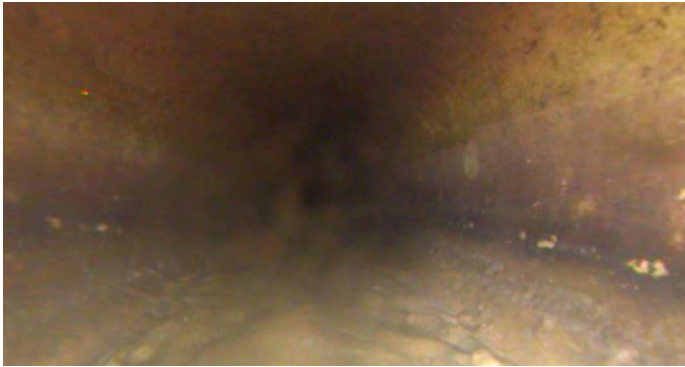
Code:	MWL
Description:	Water Level

Distance (ft):	.0
Structural Grade:	0
O&M Grade:	0
Clock Start/From:	
Clock To:	
1st Value:	
2nd Value:	
Value Percent:	10.000
Continuous Index:	
Within 8" of Joint:	NO
Remarks:
