Profile/Photo Observation Report

Location Details:		Direction of Survey:	Downstream
US MH:	M-604-086	DS MH:	M-604-021
		Total Length Surveyed (ft):	112.3

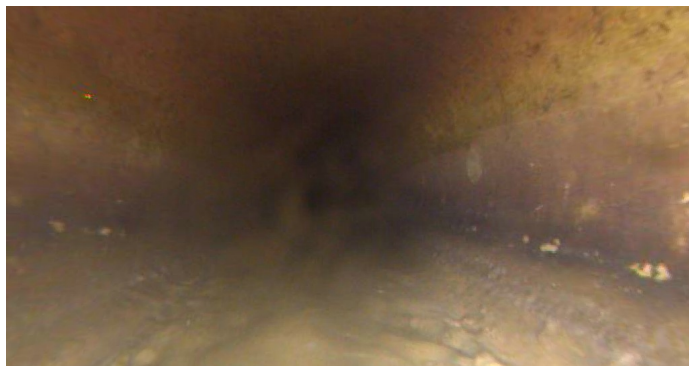
Code: **AMH**
 Description: **Manhole**

Distance (ft): **.0**
 Structural Grade: **0**
 O&M Grade: **0**
 Clock Start/From:
 Clock To:
 1st Value:
 2nd Value:
 Value Percent:
 Continuous Index:
 Within 8" of Joint: **NO**
 Remarks: **M-604-086**

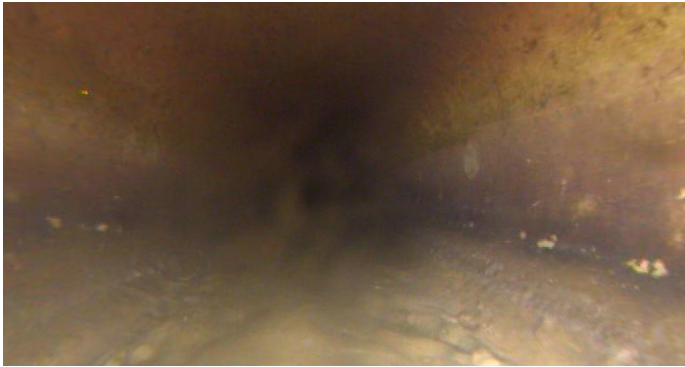
Code:	MWL
Description:	Water Level

Distance (ft):	.0
Structural Grade:	0
O&M Grade:	0
Clock Start/From:	
Clock To:	
1st Value:	
2nd Value:	
Value Percent:	10.000
Continuous Index:	
Within 8" of Joint:	NO
Remarks:

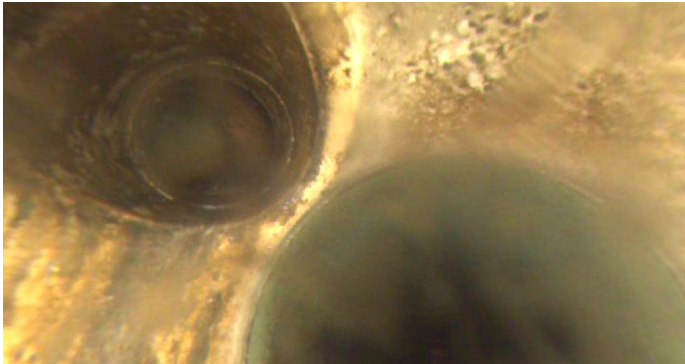
Code:	TF
Description:	Tap Factory

Distance (ft):	21.2
Structural Grade:	0
O&M Grade:	0
Clock Start/From:	2
Clock To:	
1st Value:	4.000
2nd Value:	
Value Percent:	
Continuous Index:	
Within 8" of Joint:	
Remarks:

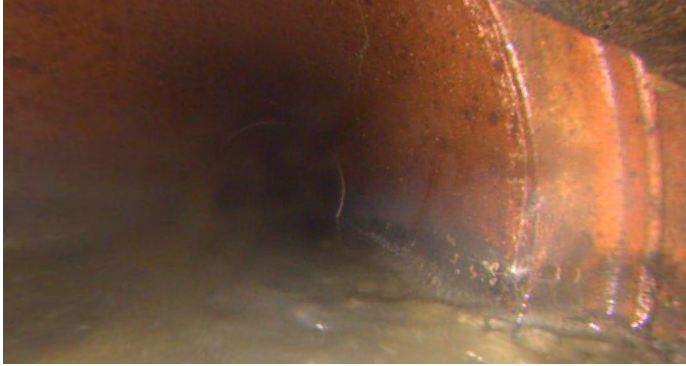
Code:	AMH
Description:	Manhole
Distance (ft):	112.3
Structural Grade:	0
O&M Grade:	0
Clock Start/From:	
Clock To:	
1st Value:	
2nd Value:	
Value Percent:	
Continuous Index:	
Within 8" of Joint:	NO
Remarks:	M-604-021
