Profile/Photo Observation Report

Street:	N PENNSYLVANIA ST	Flow Control:	Not Controlled
City:	Hobart, IN	Year Renewed:	
Location:	Light Highway	Tape/Media #:	
Purpose:	Not Known	Dia/Height:	12"
Use:	Sanitary	Material:	VCP
Drain Area:	NA	Lining:	
Category:	NA		
Comment:

Location Details:		Direction of Survey:	Downstream
US MH:	M-604-088	DS MH:	M-604-087
		Total Length Surveyed (ft):	4.9

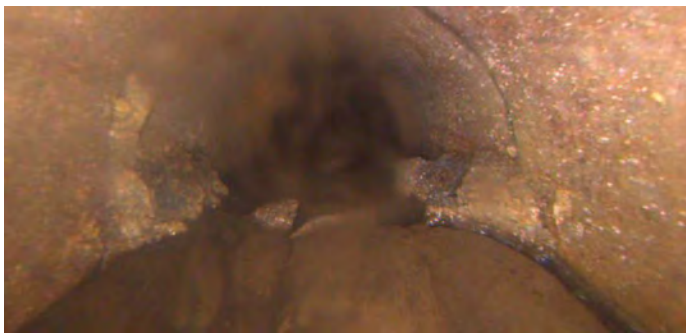
Code: **AMH**
Description: **Manhole**

Distance (ft): **.0**
Structural Grade: **0**
O&M Grade: **0**
Clock Start/From:
Clock To:
1st Value:
2nd Value:
Value Percent:
Continuous Index:
Within 8" of Joint: **NO**
Remarks: **M-604-088**

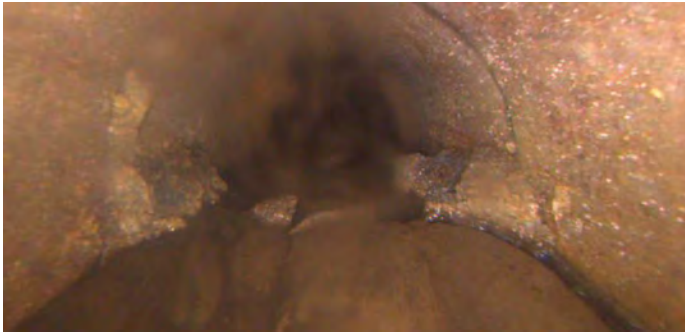
Code:	MWL
Description:	Water Level

Distance (ft):	.0
Structural Grade:	0
O&M Grade:	0
Clock Start/From:	
Clock To:	
1st Value:	
2nd Value:	
Value Percent:	30.000
Continuous Index:	
Within 8" of Joint:	NO
Remarks:

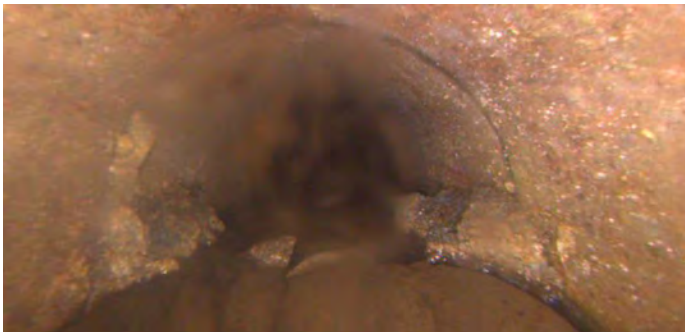
Code:	DAZ
Description:	Deposits Attached Other

Distance (ft):	.0
Structural Grade:	0
O&M Grade:	2
Clock Start/From:	8
Clock To:	4
1st Value:	
2nd Value:	
Value Percent:	10.000
Continuous Index:	
Within 8" of Joint:	YES
Remarks:

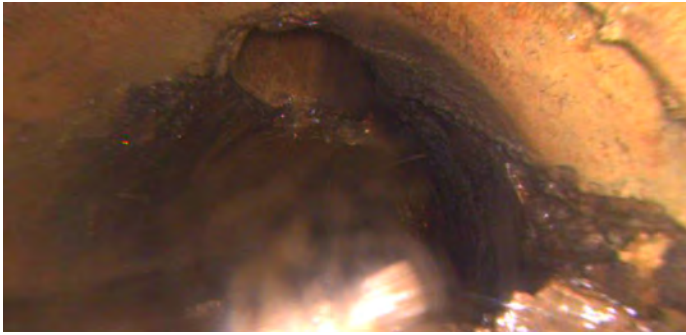
Code: **FM**
Description: **Fracture Multiple**

Distance (ft): **4.7**
Structural Grade: **4**
O&M Grade: **0**
Clock Start/From: **8**
Clock To: **4**
1st Value:
2nd Value:
Value Percent:
Continuous Index:
Within 8" of Joint: **YES**
Remarks:

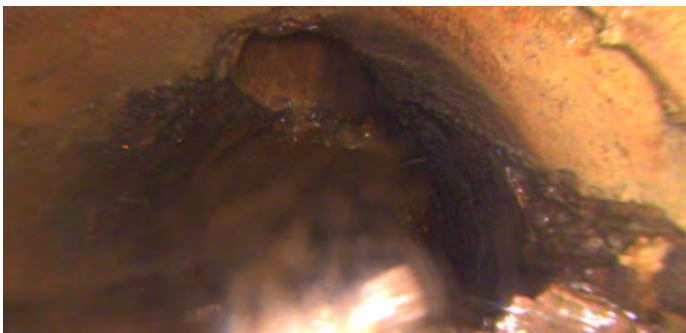
Code: **IW**
Description: **Infil Weeper**

Distance (ft): **4.7**
Structural Grade: **0**
O&M Grade: **2**
Clock Start/From: **8**
Clock To: **4**
1st Value:
2nd Value:
Value Percent:
Continuous Index:
Within 8" of Joint: **YES**
Remarks:

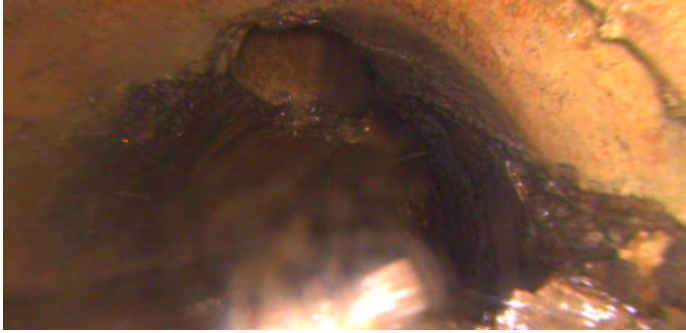
Code: **TF**
Description: **Tap Factory**

Distance (ft): **4.7**
Structural Grade: **0**
O&M Grade: **0**
Clock Start/From: **12**
Clock To:
1st Value: **4.000**
2nd Value:
Value Percent:
Continuous Index:
Within 8" of Joint: **NO**
Remarks:

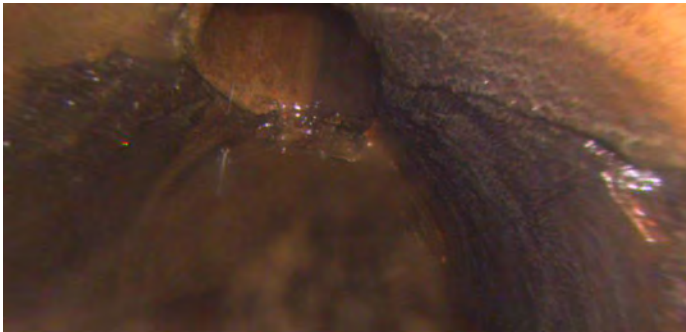
Code: **MSA**
Description: **Abandoned Survey**

Distance (ft): **4.9**
Structural Grade: **0**
O&M Grade: **0**
Clock Start/From:
Clock To:
1st Value:
2nd Value:
Value Percent:
Continuous Index:
Within 8" of Joint: **NO**
Remarks: **DEBRIS UNDER WATER**
