## Profile/Photo Observation Report

Street:	<b>N PENNSYLVANIA ST</b>	Flow Control:	<b>Not Controlled</b>
City:	<b>Hobart, IN</b>	Year Renewed:	
Location:	<b>Light Highway</b>	Tape/Media #:	
Purpose:	<b>Not Known</b>	Dia/Height:	<b>12"</b>
Use:	<b>Sanitary</b>	Material:	<b>VCP</b>
Drain Area:	<b>NA</b>	Lining:	
Category:	<b>NA</b>		
Comment:

Location Details:		Direction of Survey:	<b>Upstream</b>
US MH:	<b>M-604-088</b>	DS MH:	<b>M-604-087</b>
		Total Length Surveyed (ft):	<b>40.4</b>

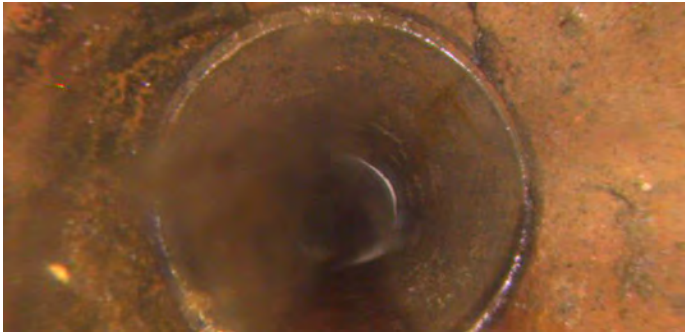
Code: **FM**  
Description: **Fracture Multiple**

Distance (ft): **18.4**  
Structural Grade: **4**  
O&M Grade: **0**  
Clock Start/From: **8**  
Clock To: **4**  
1st Value:  
2nd Value:  
Value Percent:  
Continuous Index:  
Within 8" of Joint: **YES**  
Remarks:

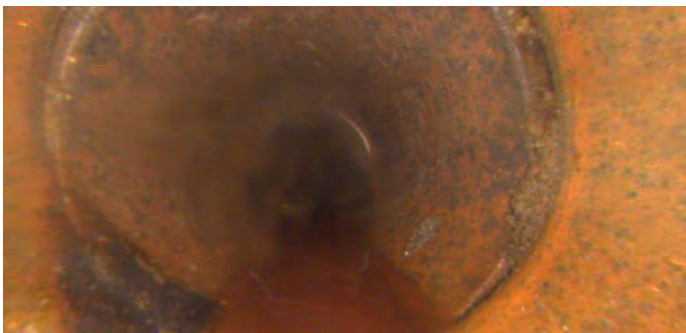
Code: **IW**  
Description: **Infil Weeper**

Distance (ft): **32.9**  
Structural Grade: **0**  
O&M Grade: **2**  
Clock Start/From: **8**  
Clock To: **9**  
1st Value:  
2nd Value:  
Value Percent:  
Continuous Index:  
Within 8" of Joint: **YES**  
Remarks:
